THE MORTON PARTNERSHIP LTD.

**LIMITED STRUCTURAL ASSESSMENT REPORT
OF
ST. JOHN THE BAPTIST CHURCH
COLD OVERTON
LEICESTERSHIRE**

Date: April 2017

Reference: EJM/HH/17840~srep rev 0

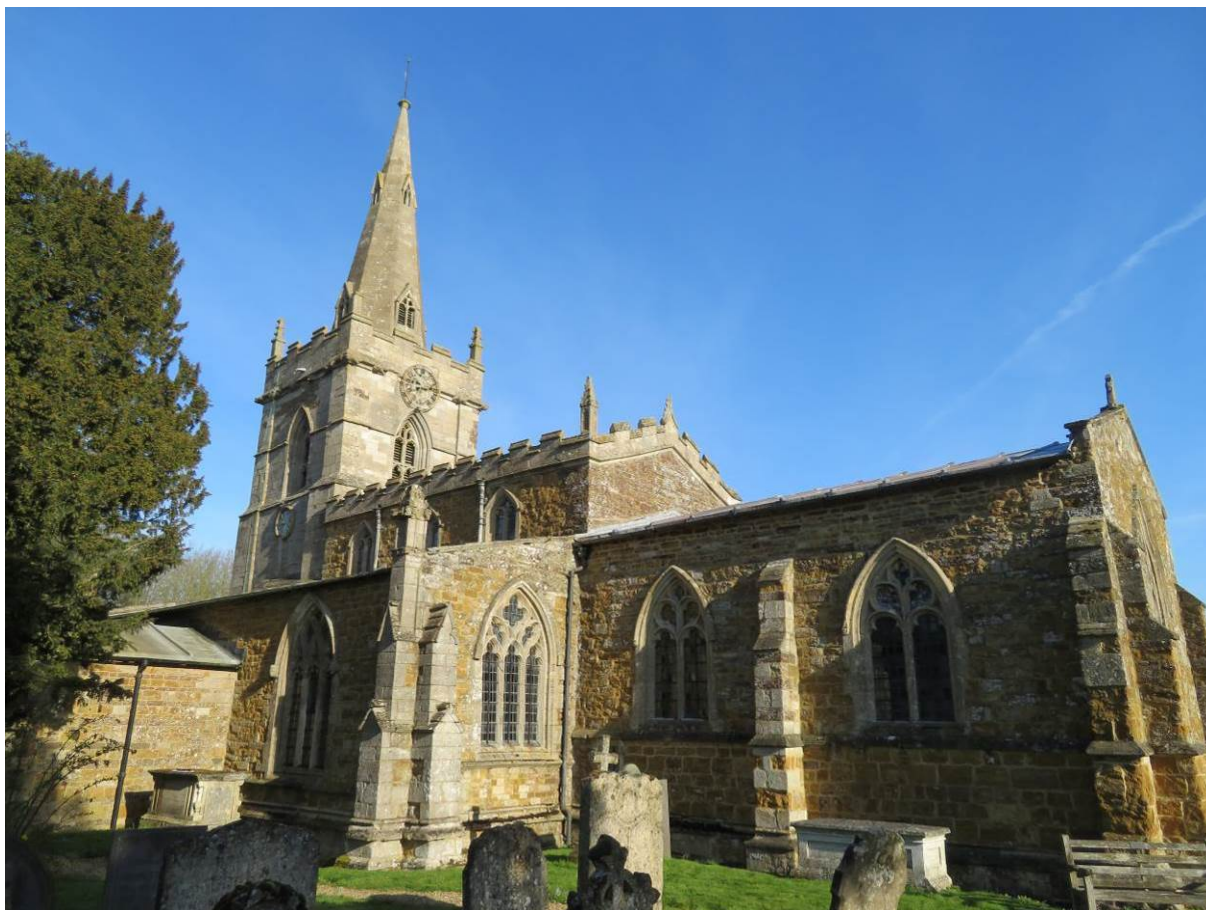
Photograph 1: View of church from south east

- 2.1 The Church (see photograph 1) is Grade I listed of special architectural or of historic interest, with the list description taken from Historic England's Heritage List for England listing repeated below, although these listings are not always accurate.

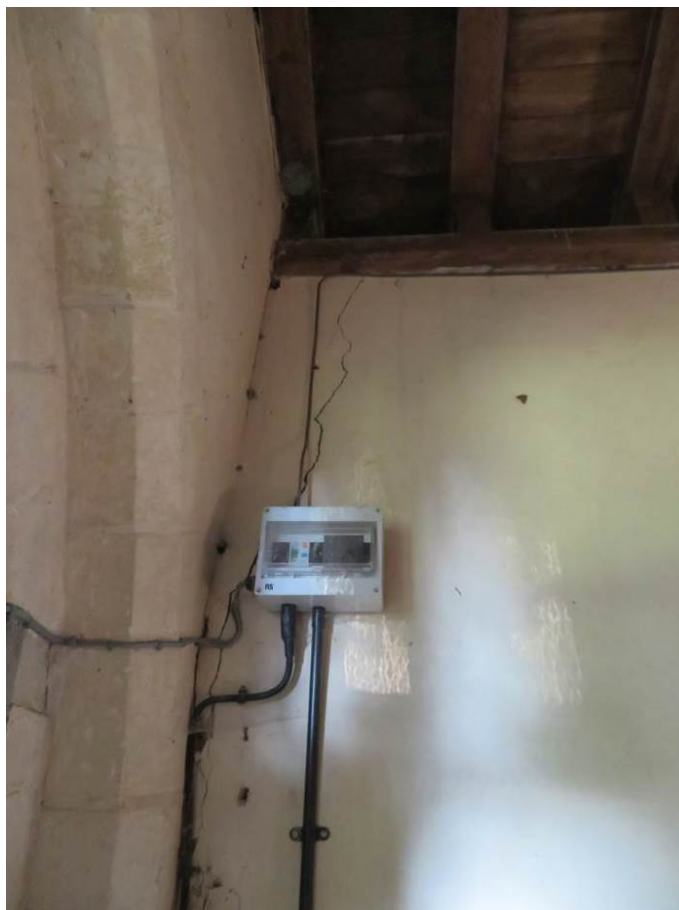
Photograph 11: Crack to east wall of porch

- 4.4 With regards to the south porch, there is clearly movement of a more recent nature which can be dated to post the application of the internal plaster, but I would describe this movement as minor in nature and is clearly not evident externally, which appears to have been repointed post the internal plastering. This certainly provides comfort that no recent movement has occurred.

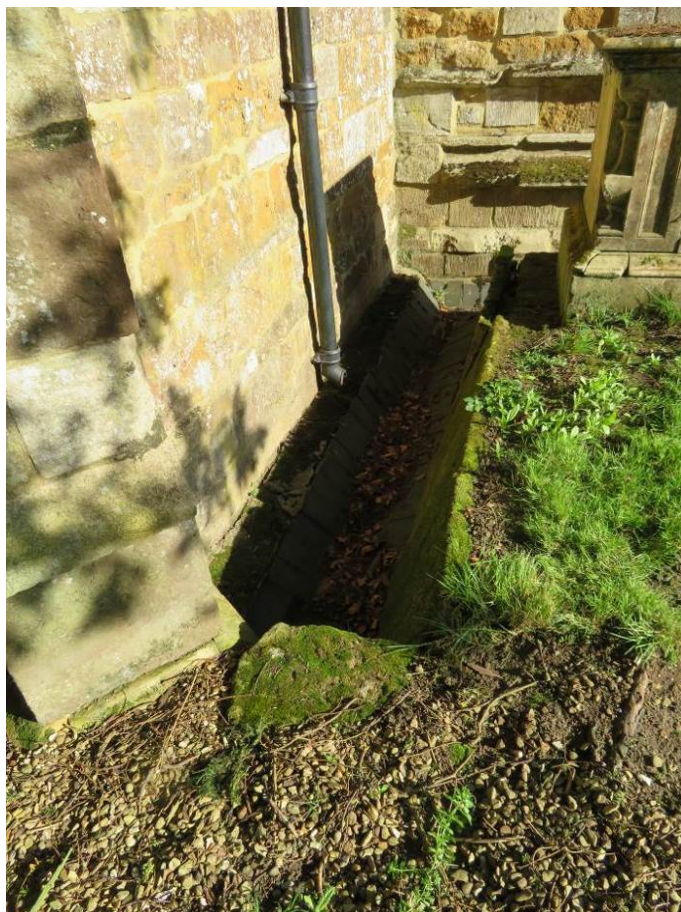
Photograph 13: Drainage collection channel to east side of porch

- 3.1.4 A deep surface water channel has been constructed around the east side of the porch (see photograph 13), which then continues around the aisle and chancel and also collects rain water from the roofs. There is a gully at the south end of the section alongside the porch, however the brickwork forming the collection channel is open jointed and thus, will be allowing water to leach through into the sub-soils alongside the porch. It was also noted that there is a significant yew tree within around 5-6 metres of the porch to the south (see photograph 14).

- 4.5 Following any initial construction settlement, likely causes for more recent movement could relate to subsoil conditions, which may be clay and thus, with the potential for shrinkage and swelling, and then possibly aggravated by the nearby yew tree and also the surface water drains and associated gullies.

- 4.6 Certainly, it would be sensible to ensure that the gullies are working correctly to help transport water away. This applies also to the west side where the rainwater butt appears to overflow on to the ground and ideally, this needs to be managed to remove this further away from the Church, or a gully put in to take the water away.

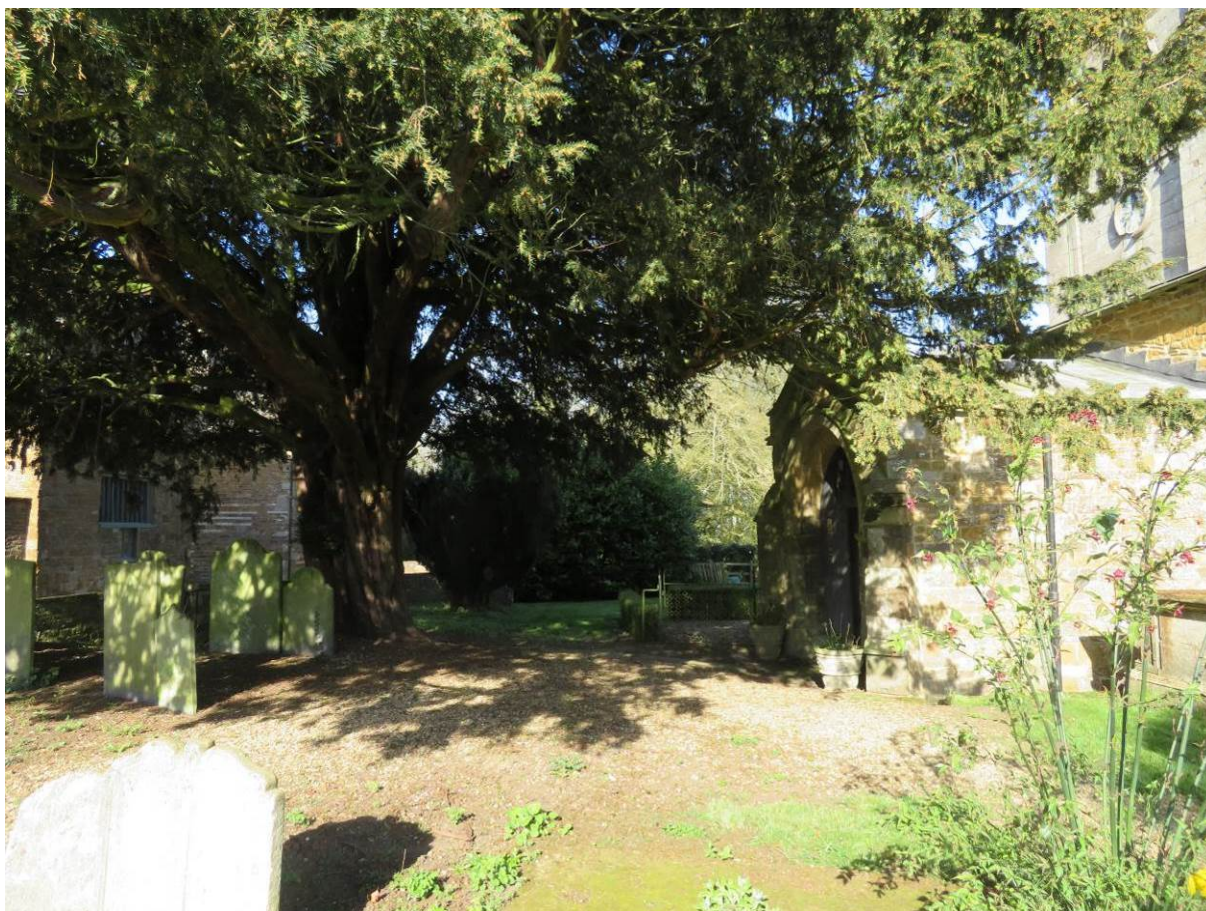
Photograph 14: Yew tree to south of porch

- 3.1.7 Obviously both surface water and gullies can cause local issues of water saturation to the sub-soil below foundations and which may affect movement. This can be aggravated by nearby trees, in this case the yew, drawing further moisture from the ground.

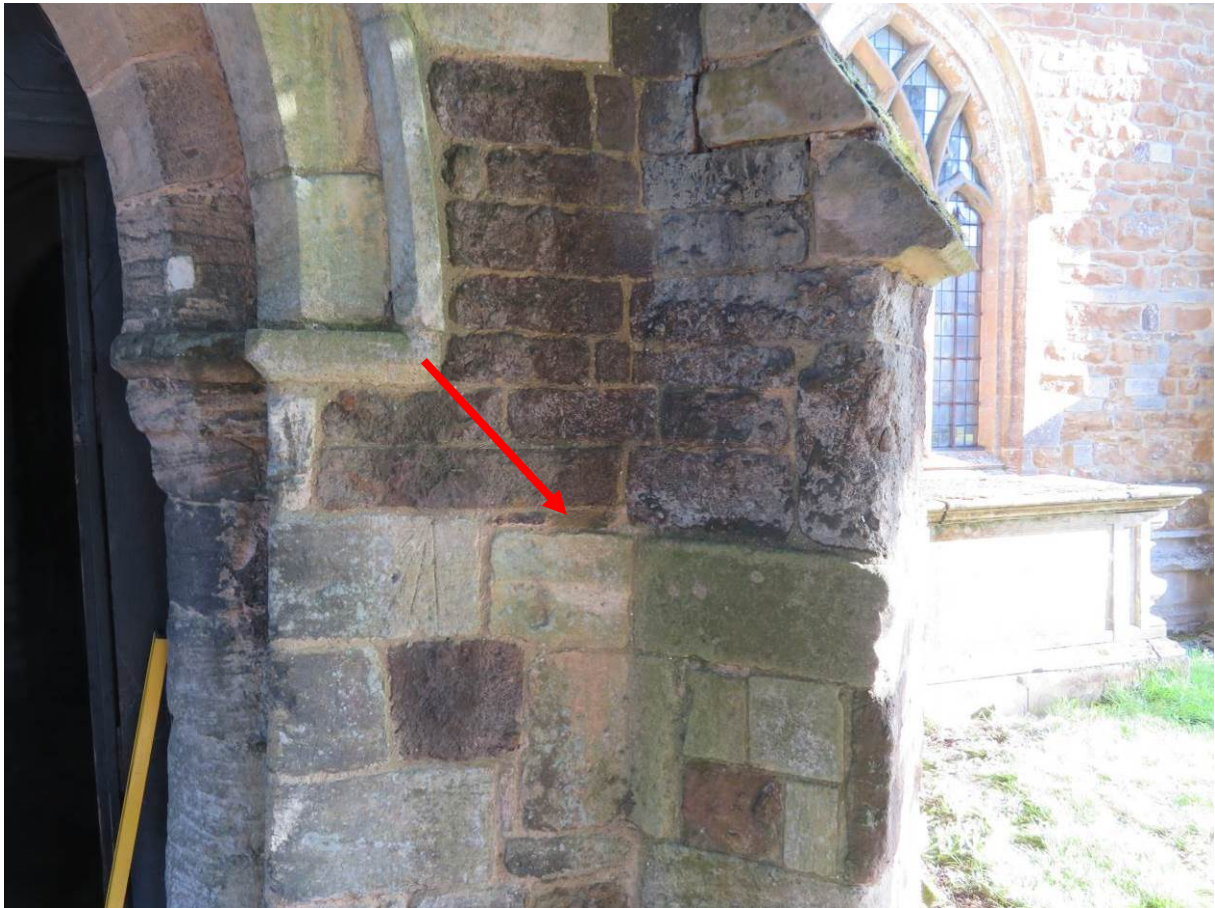
Photograph 15: Ironstone re-building over limestone to porch with levelling course highlighted

- 3.1.5 It was noted to the south-east corner buttress that it is predominately dressed limestone to two thirds of its height and then changes to ironstone. Interestingly, there is an apparent levelling course applied between the two, suggesting some rebuilding at some point to the upper portion (see photograph 15). The levelling stone suggests movement had already taken place by this time.

- 4.3 There are examples around the church of subsequent 'rectification works' to address this. This includes levelling courses, as seen to both the south-east buttress to the porch and also the head of the west gable to the south aisle. These are useful as they clearly identify movement is not recent in nature. Of course, this does not mean that no further movement will take place in the future.

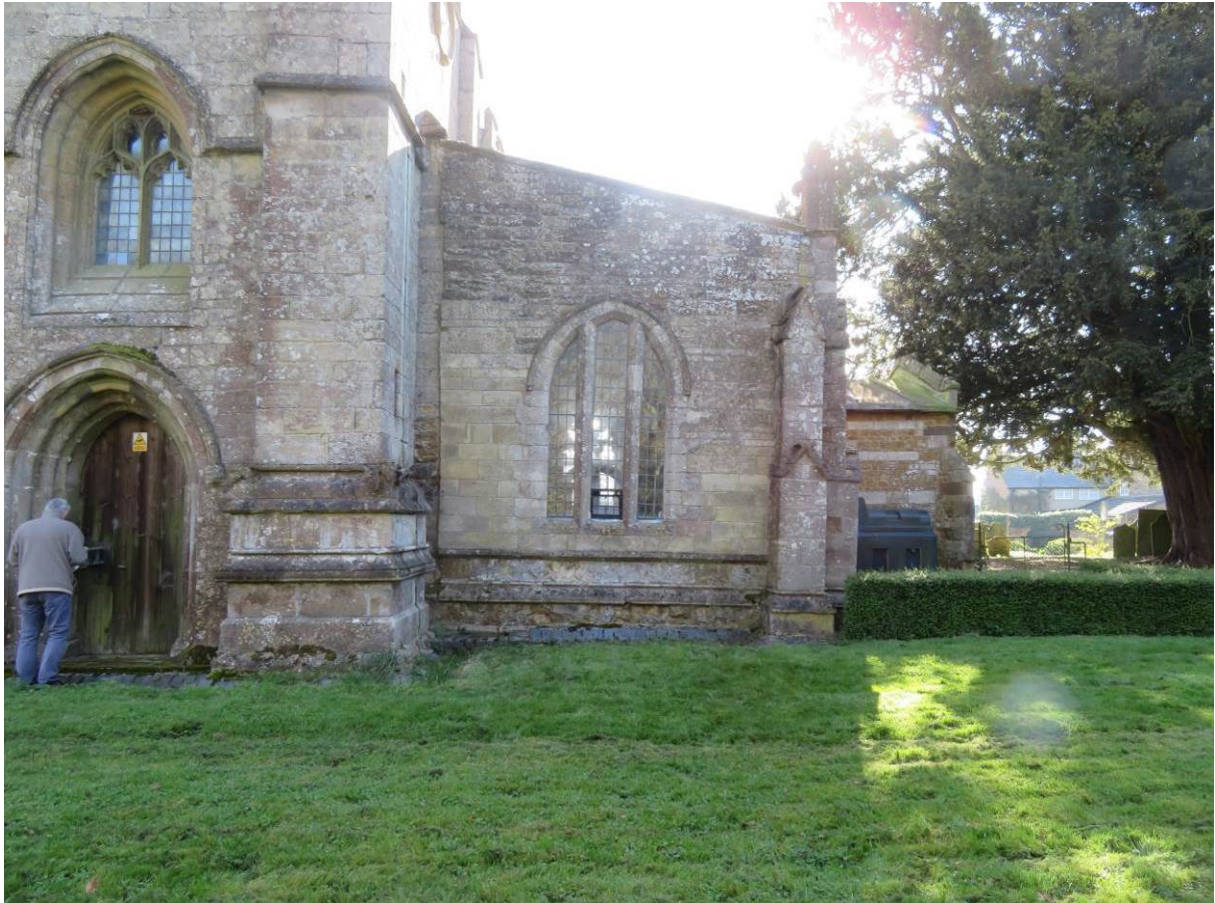
Photograph 16: Settlement of the west wall of the south aisle is obvious

- 3.2.2 It can be seen that the west end of the south aisle has clearly settled towards the south, with this obvious to both the string courses window and also the out of plumb of the south wall (see photograph 16). This was measured on the buttress as approximately 50mm in a 1.2 metre height. The upper portion of the west gable appears to be a rebuild judging by the different masonry and in fact, this is a coursed relatively horizontally (see photograph 17), suggesting that this was undertaken after the majority of the movement had taken place.

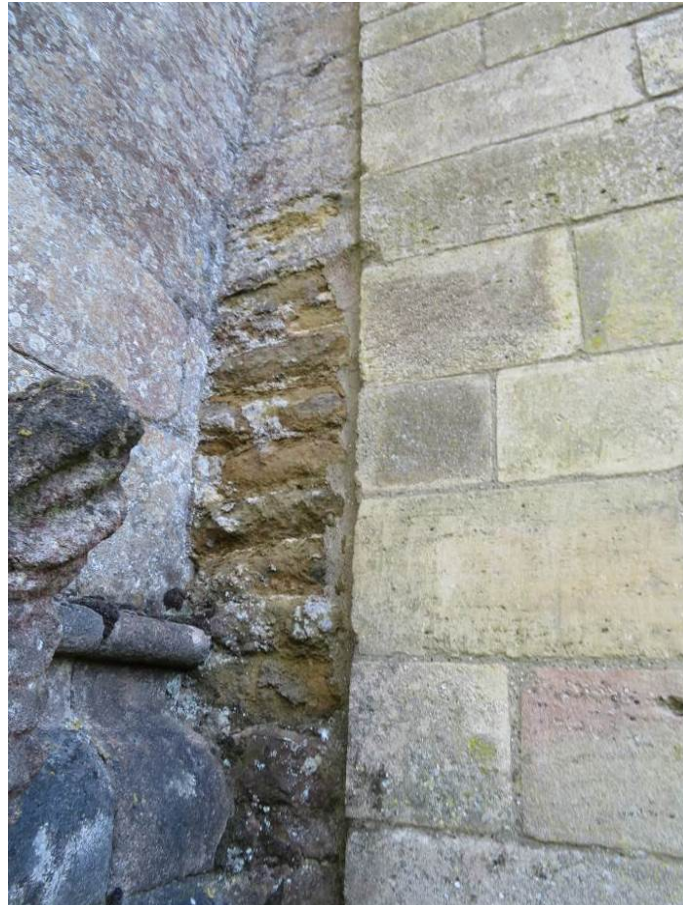
Photograph 18: Set back section of masonry with pointing at joint not re-opened

- 3.2.3 To the north end of the west wall on the south aisle, there is a setback section of masonry where it abuts the tower and this is where the face work is not coursed through with this i.e. suggesting a construction joint (see photograph 18). There is pointing between the two in a more recent mix but no opening up has occurred to indicate recent movement.

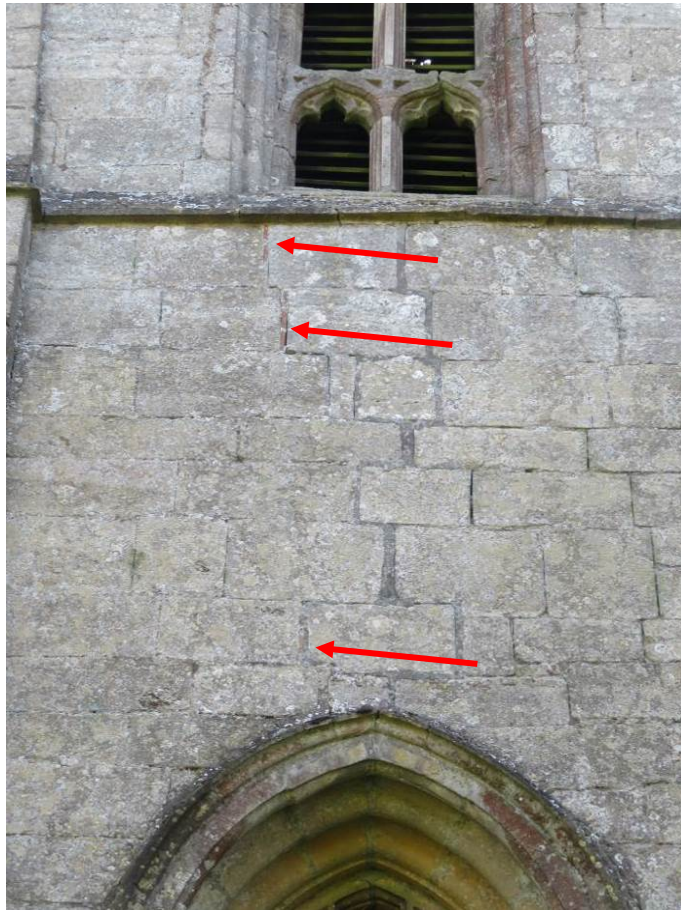
Photograph 19: Crack to west elevation of tower with tiles slips used (highlighted)

- 3.2.4 Looking at the west elevation of the tower, there is quite clearly some settlement of the structure towards the north, as seen in the plinths and string courses etc. There may also be some out of plumb movement to the tower towards the south which has resulted in cracks running up the tower face, particularly between the main west window and the belfry window (see photograph 19), above which have been pointed and in some places with tile slips inserted and with no significant re-opening.

- 3.2.5 At ground level, there is some minor evidence of opening up with these cracks, but not of a significant nature. This movement is more difficult to read above the belfry window and towards the parapet, partly due to the nature of some of the ironstone blocks which have decayed to the face and the height above ground level.

- 4.7 With regards to the tower, there is no evidence of any recent or significant movement. The most predominant crack is to the west elevation and to a lesser extent the east elevation. That to the west has been repaired with tile slips and pointing in the past. The west elevation has openings at three levels, whilst the east has the high tower arch internally and window above, and this these elevations inevitably form weaknesses around which the tower will articulate. I suspect some of this occurred during and soon after construction as the tower settled down on its new foundations.

- 4.10 However, there is nothing to suggest recent movement and the recommendation is simply to repoint and make good these cracks, which will then act as a future tell-tale which should be reviewed as part of quinquennial inspections.

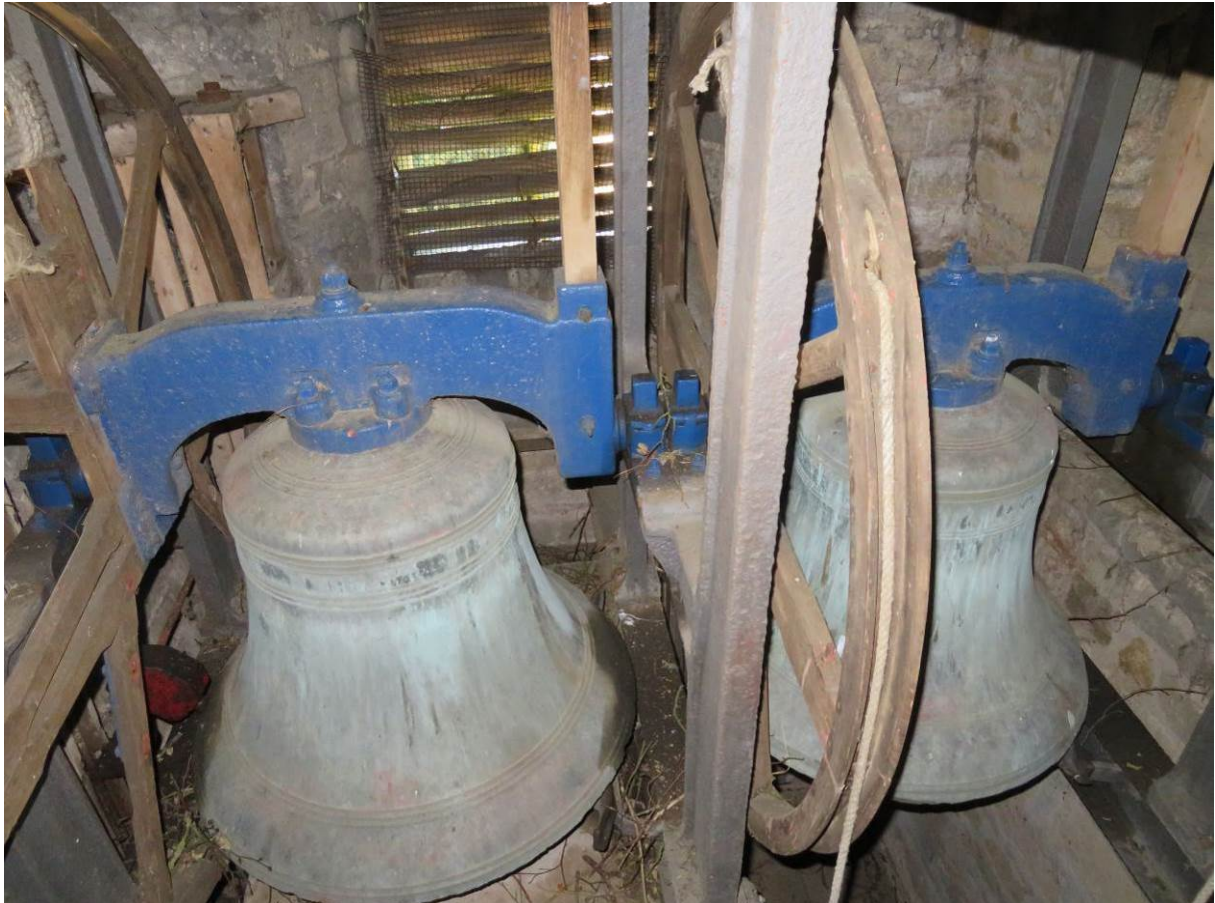
Photograph 20: Part view of bell frame with two larger bells swinging north south

- 3.2.9 Internally, within the tower at belfry level, there is a ring of three bells, with the larger two swinging north south and the upper one east west (see photograph 20).

- 4.8 There are other cracks and I suspect additional open joints will be found as part of the works when high level access is available.
- 4.9 Of course, once cracks have formed they tend to be positions about which future movement occurs. This may have been aggravated by some bell action, with the two larger bells swinging in the north south direction, i.e. imparting a dynamic action to the weaker east and west walls.

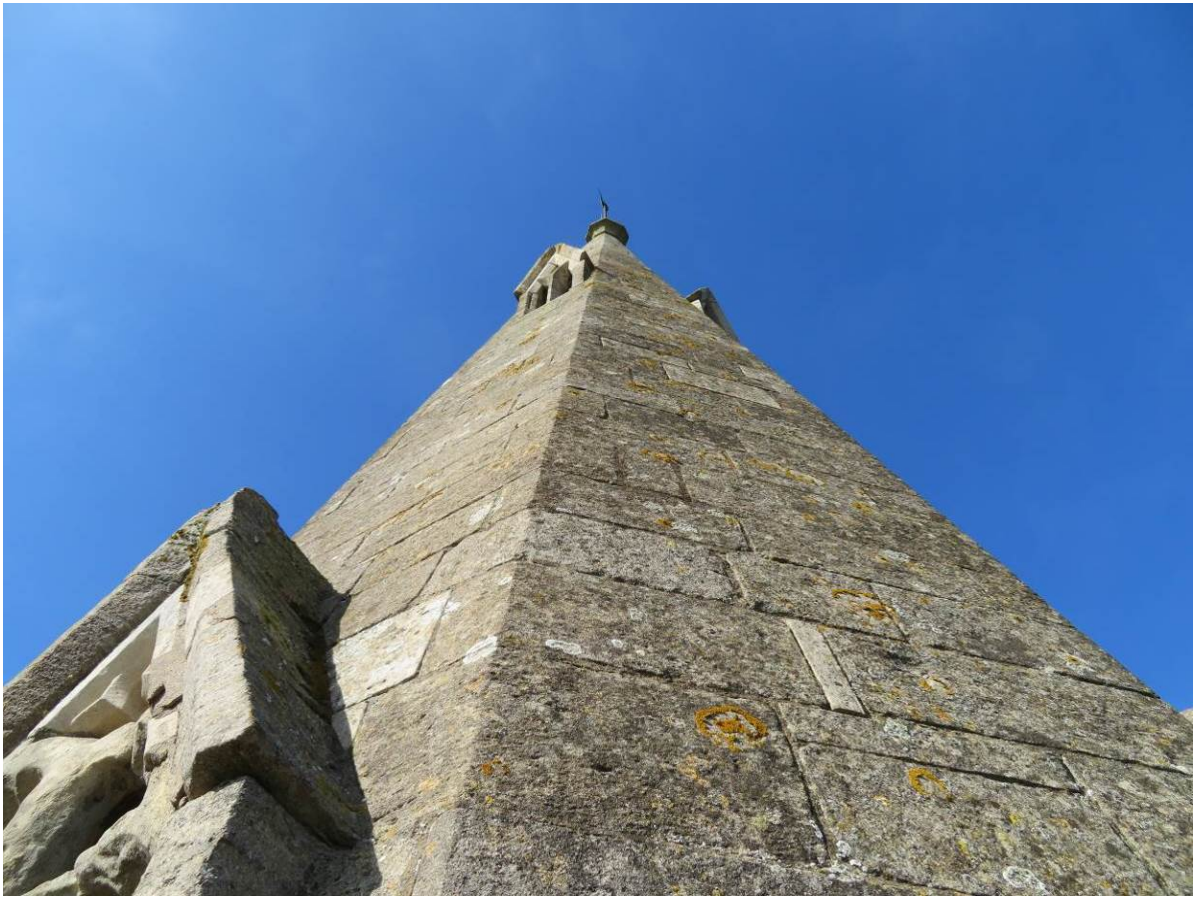
Photograph 21: View looking up spire which appears in reasonable structural condition

- 3.2.10 Access was possible to the small gutters around the spire at the head of the tower, which has been flanché in concrete. It was possible to view up the outside of the spire, with no particular evidence of any significant structural movements noted (see photograph 21).

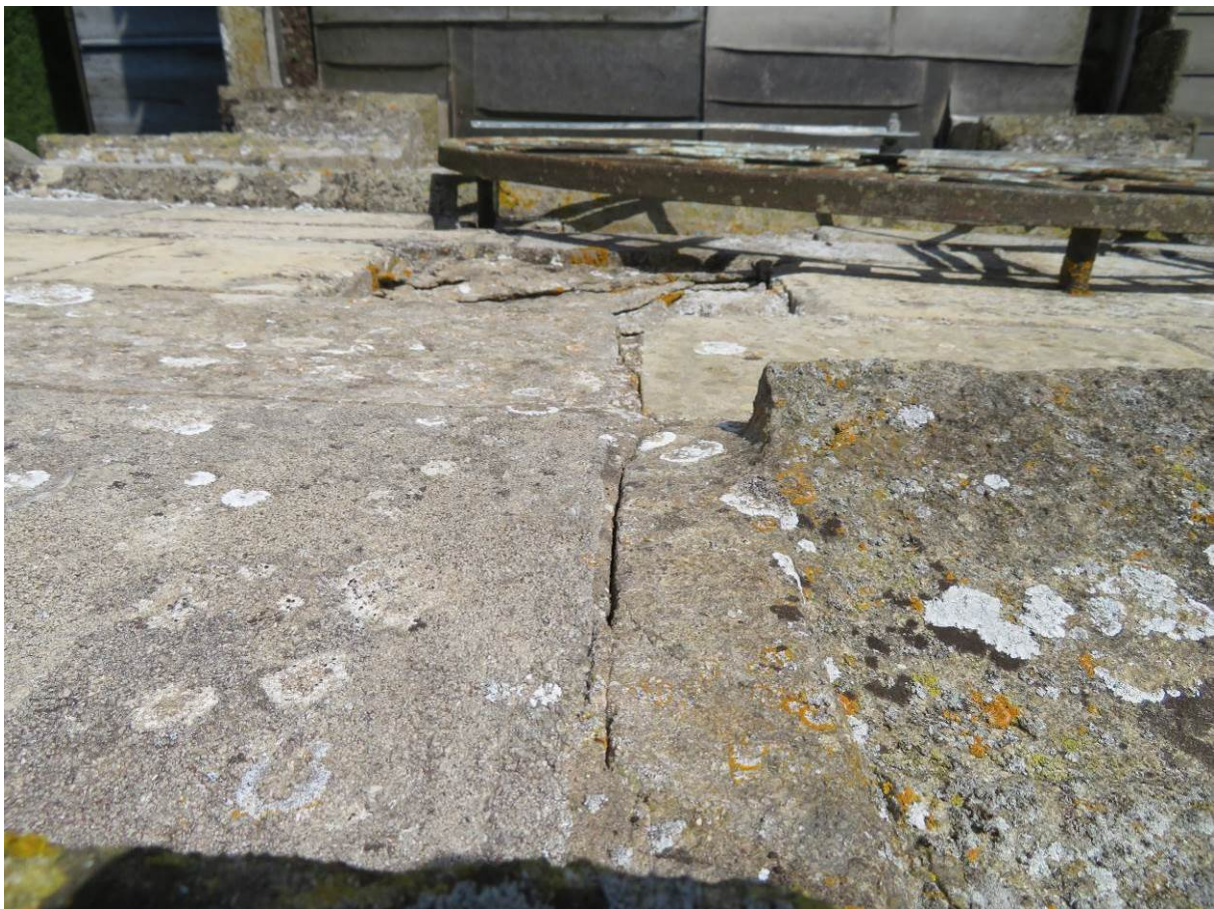
Photograph 22: Open joints parapet as seen from the tower gutters

- 3.2.11 Looking over the parapet wall edges, it was possible to see some open joints to the parapet and below (see photograph 22).
- 3.2.12 Internally, you can view up the spire and see a 'cross-tree' built in at one level (see photograph 23) and perhaps with the plate on the underside of the solid tip, although the latter was not confirmed. There were no significant signs of problems structurally, although there are clear eroded joints with some local decay of stone.

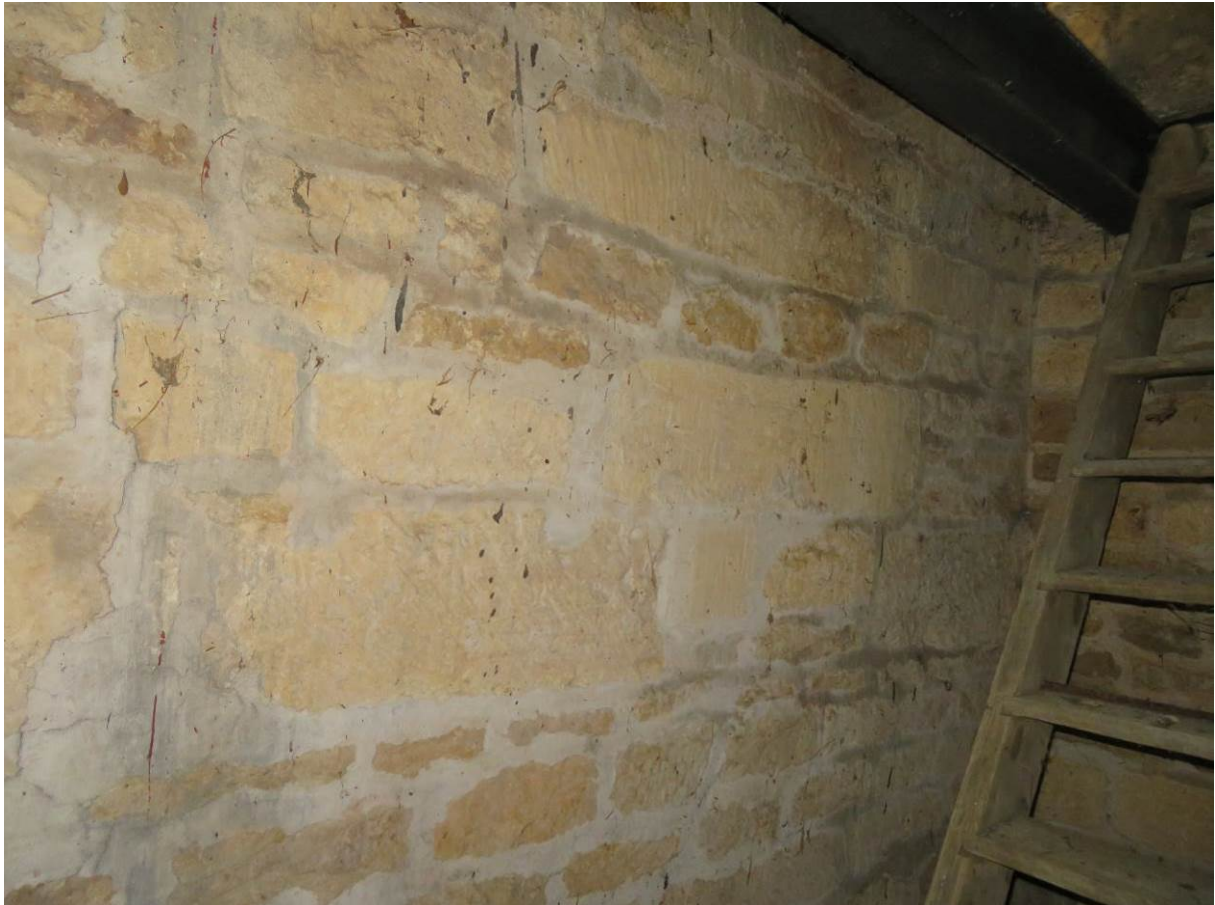
Photograph 24: Pointed walls to head of tower

- 3.2.13 At belfry stage the tops of the towers walls were seen, but which is limited by the clock mechanism. The walls have been repointed and do not show any particular signs of any joints opening (see photograph 24).

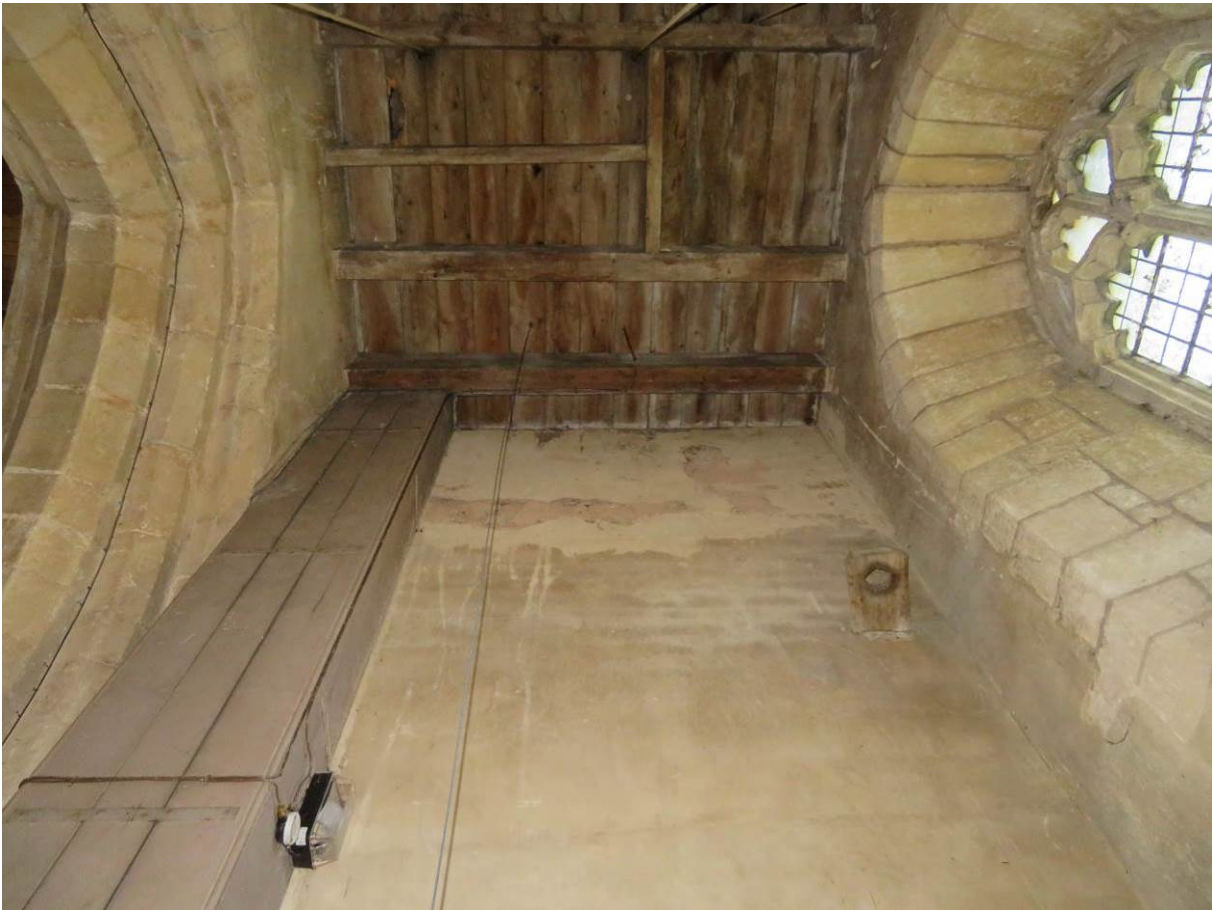
Photograph 25: Plastered walls to lower stage of tower with failure to high level south wall

- 3.2.14 The lower level of the towers internally are largely plastered, although the plaster to the south side is failing towards the head (see photograph 25). There are some minor cracks above the west facing window and door arches, but these are nominal and do not evidence any recent movement.
