05.05.2016

COLD OVERTON • ST JOHN THE BAPTIST

QUINQUENNIAL INSPECTION 2016

Mark Stewart Church Architect

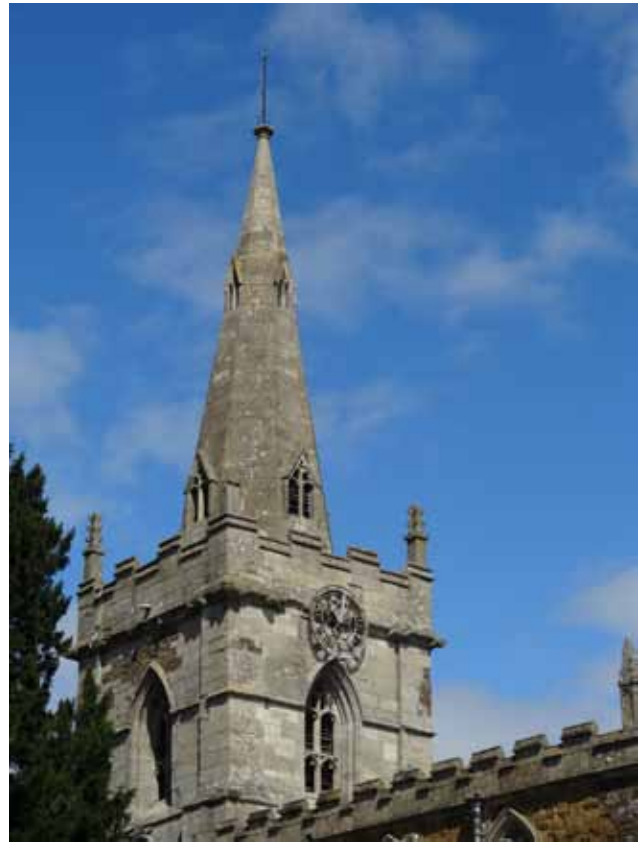
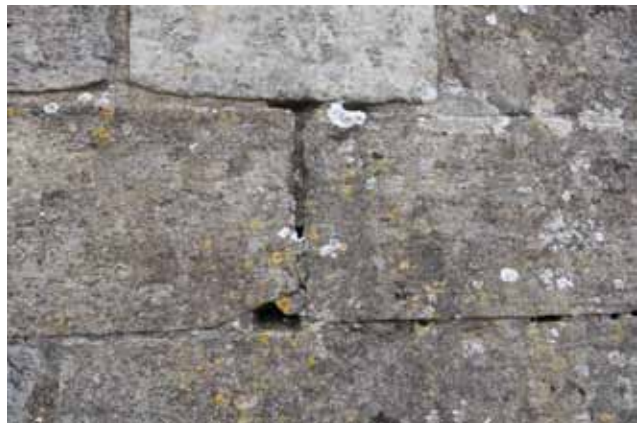
Spire

Inset spire in limestone. The stones forming the spire structure are in reasonable condition despite being repointed in cementitious mortar. However in many places the mortar has eroded creating holes directly through the spire causing water runs within the interior of the spire.

The details to the lucernes have areas of erosion with sections spalled stonework having fallen into the gutter in several locations.

There are areas of eroded stone and poor plastic repairs which are failing.

The timber louvres are in poor condition and at the end of their effective life. Jackdaws are forcing sticks through the damaged and unnetted louvres.

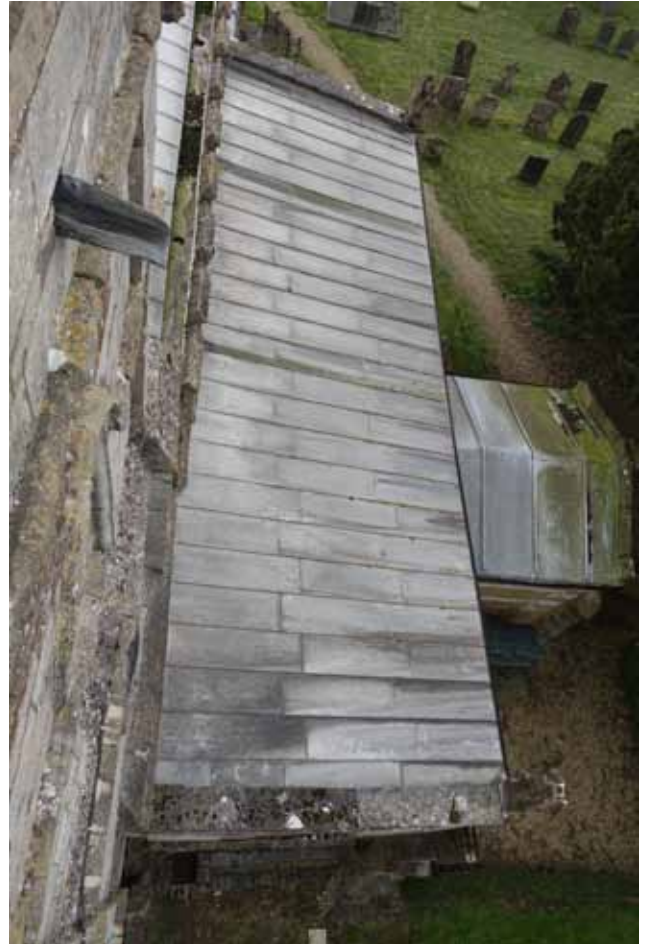
South Aisle

Inadequately small plastic or cast iron gutter in poor condition, not falling to the outlet. Overflowing water is causing harm to the fabric and placing the important internal wall paintings at significant risk.

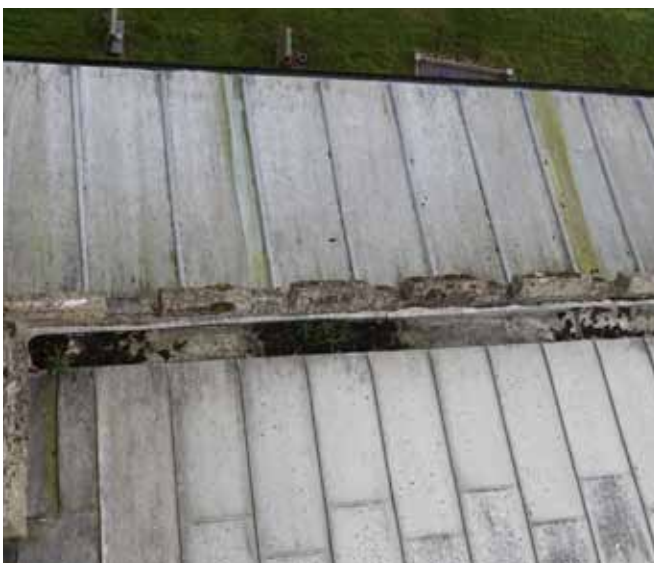
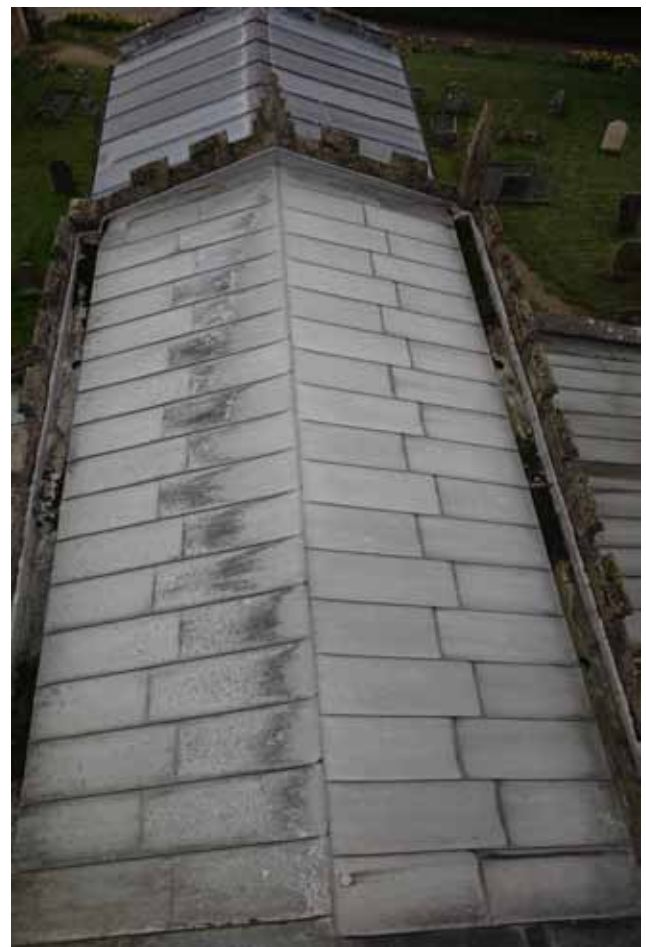
Nave

Aluminium parapet gutters with two outlets. North west outlet is blocked.

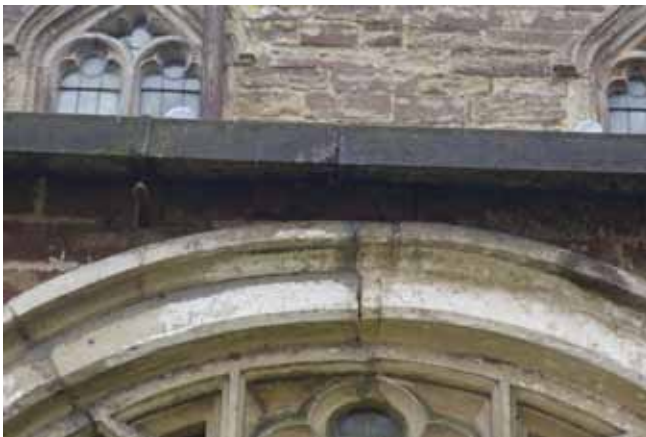
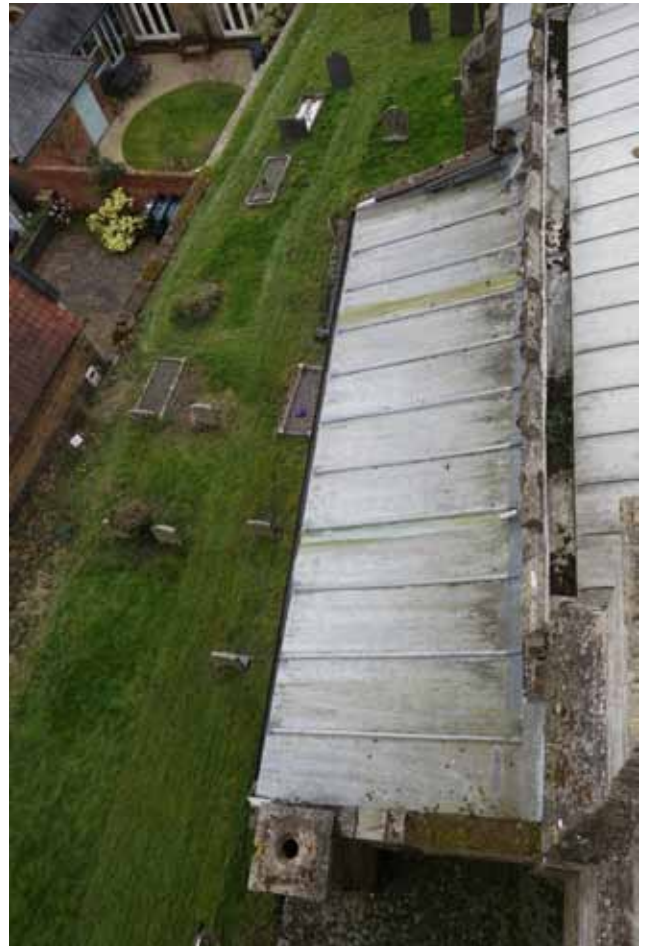
North Aisle

Steel gutter in very poor condition.

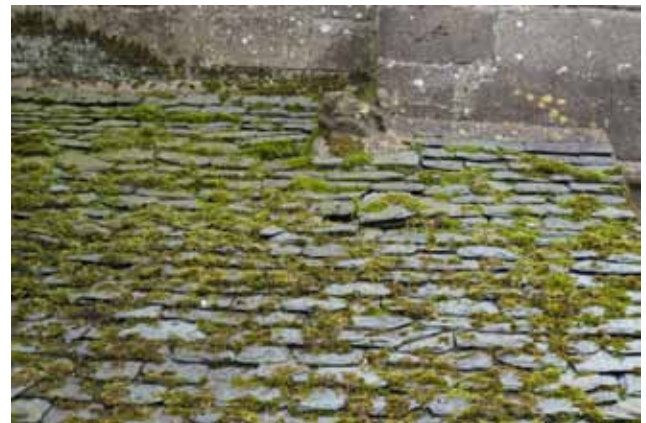
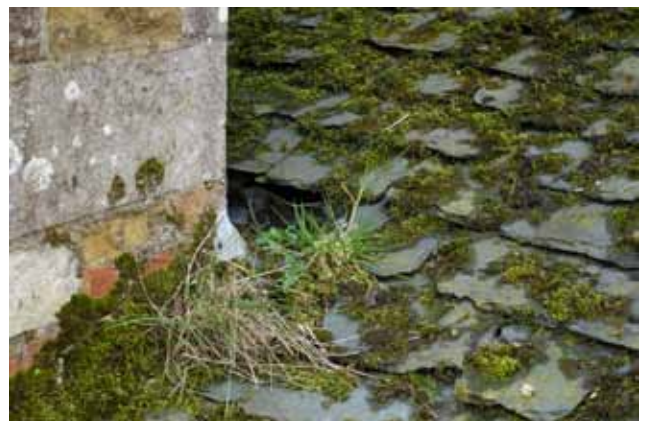
Boiler house

Switherland slate in very poor condition.

Mortar abutment flashings with lead valley to the back of the chimney.

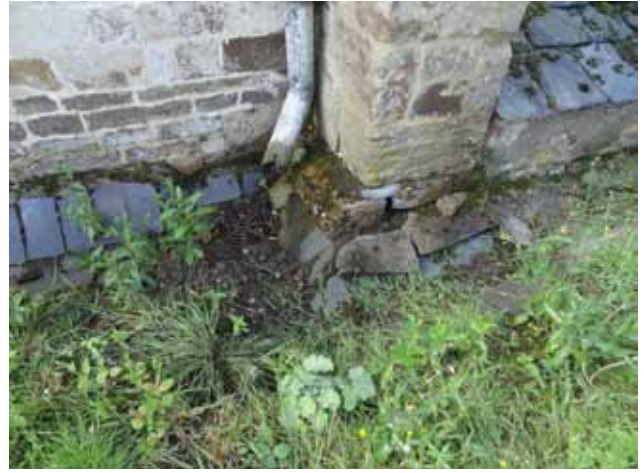
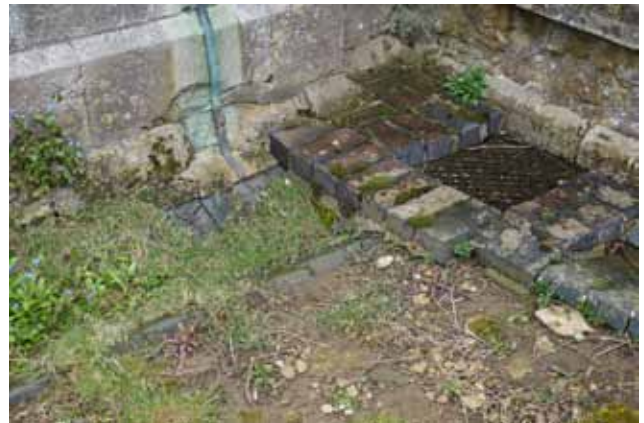
DRAINAGE

The rainwater goods discharge to an open surface water drainage channel which is in very poor condition. These are a few gullies in the channel but these are not always located at the rainwater pipes and in any event do not work.

The channel traps water and reduces the permeability of the lower wall zone.

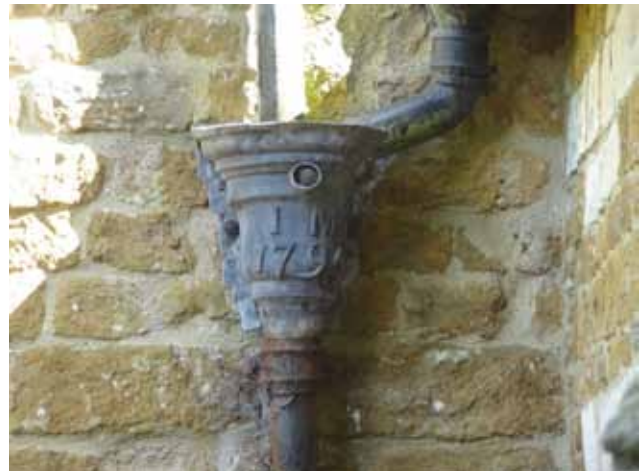
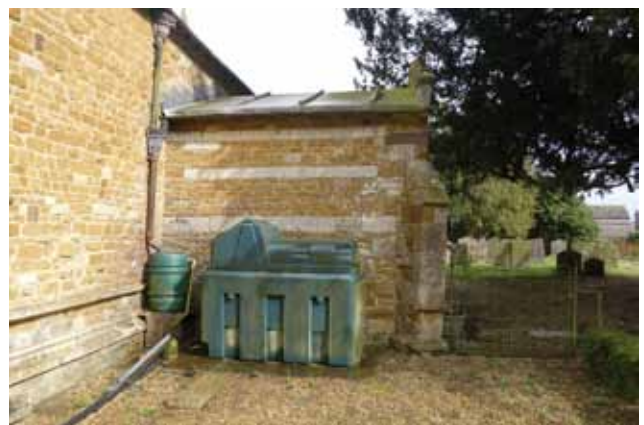
RWP-1 Lead hopper to Aisle with cast iron downpipe. Lead hopper to Porch dated IM 1795. Very corroded cast iron rwp to water but with an in adequate temporary outlet. This is the cause of significant damage to the internal fabric.

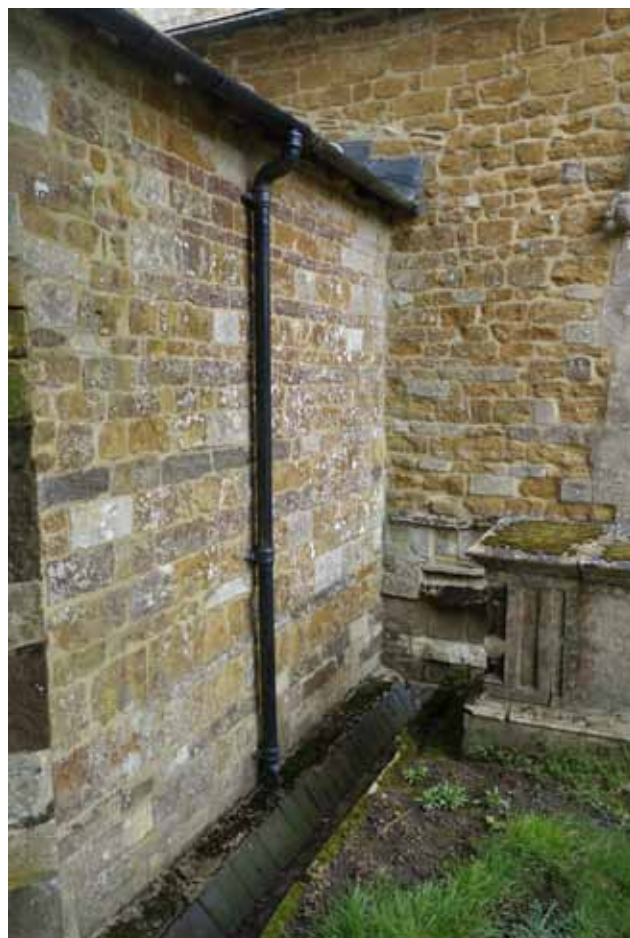
- RWP-2 Cast iron downpipe to open and blocked surface water gulley. This is the cause of significant damage to the internal fabric.

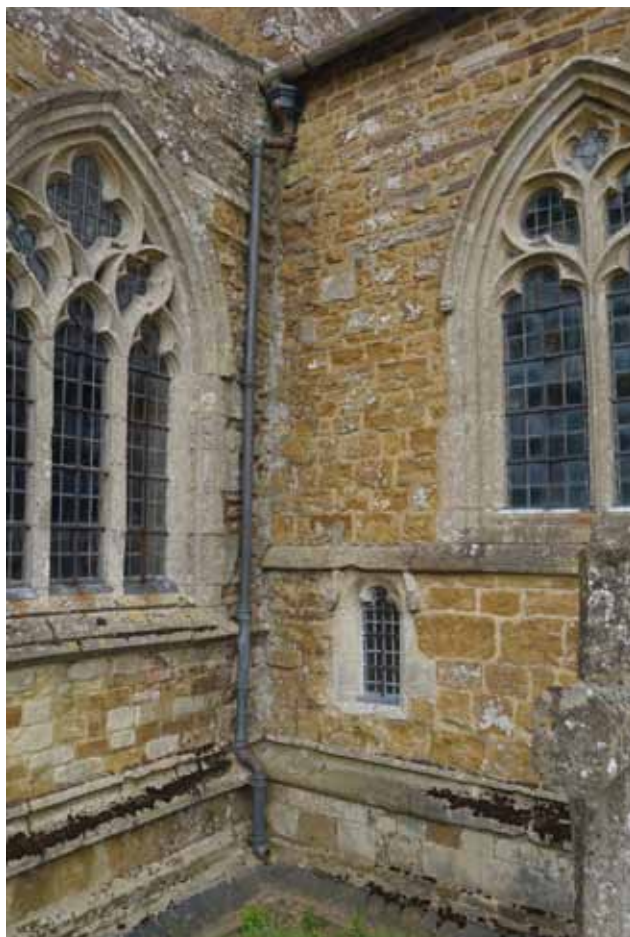
- RWP-3 Lead hopper with corroded cast iron downpipe to open and blocked surface water gulley. This is the cause of significant damage to the external and internal fabric.

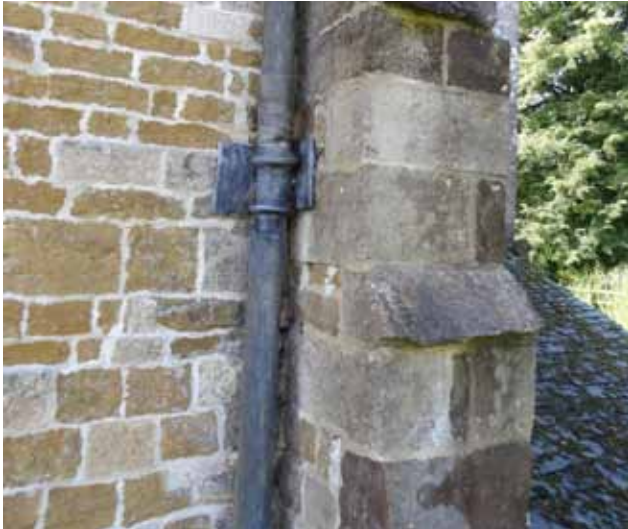
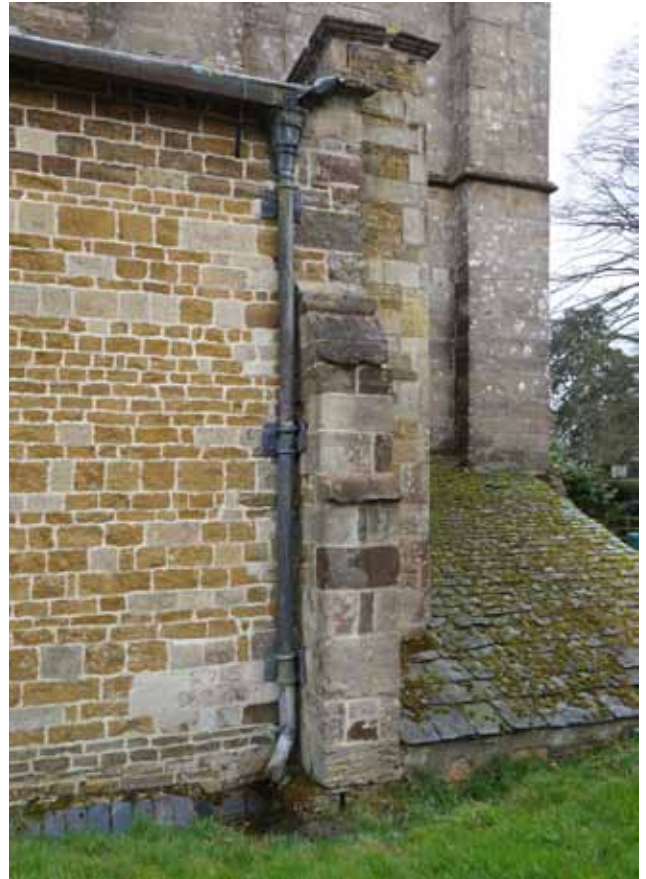
- RWP-4 Small lead hopper dated 1795. Lead downpipe with taped up repairs. The pipe is in poor condition and very distorted. Discharges to an open channel in poor condition with a blocked gulley. Significant damage being caused to the base of the adjacent buttress.

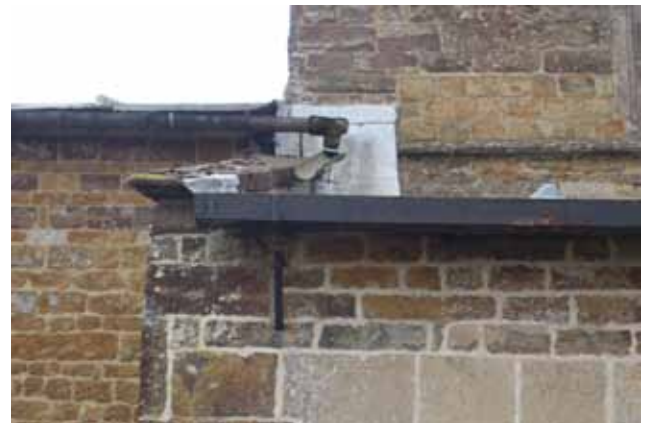
- RWP-5 Short corroded cast iron down pipe and gutter section discharging to Aisle roof.

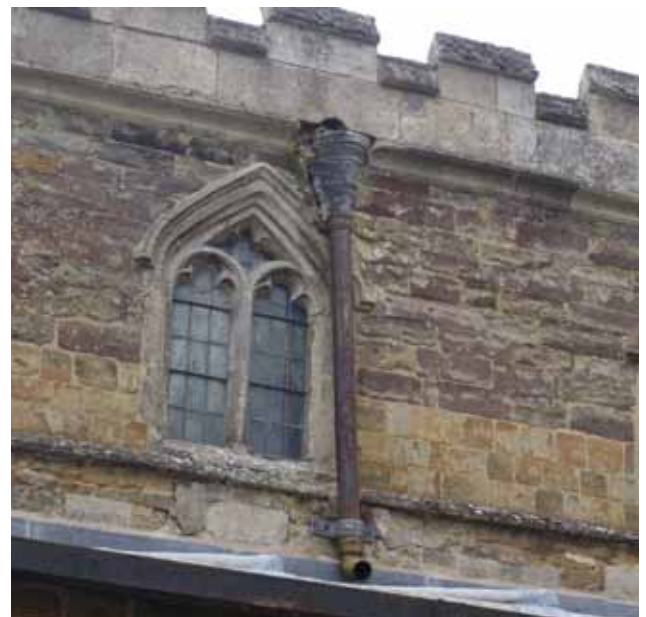
- RWP-6 North clerestorey, east end. 1791 lead hopper [blocked] with poorly fixed corroded cast iron rwp discharging over aisle roof.

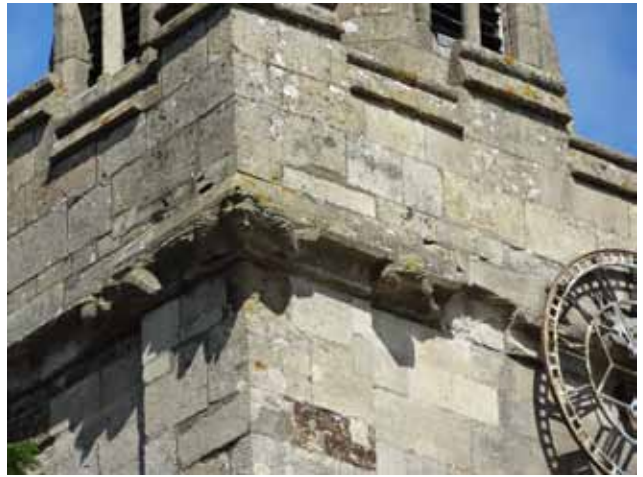
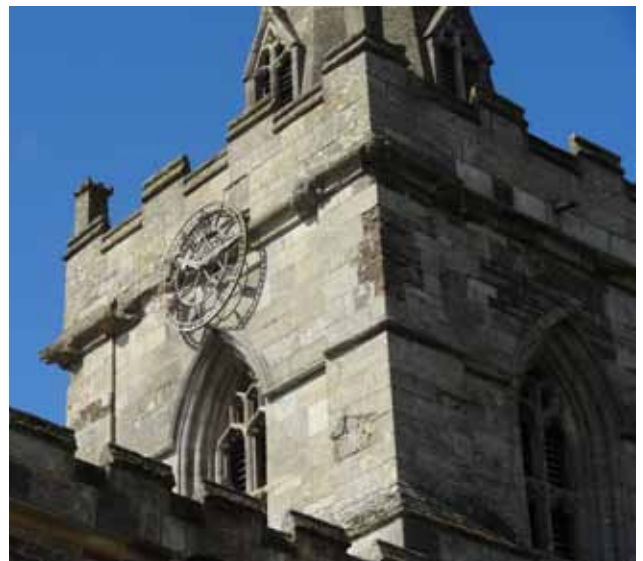
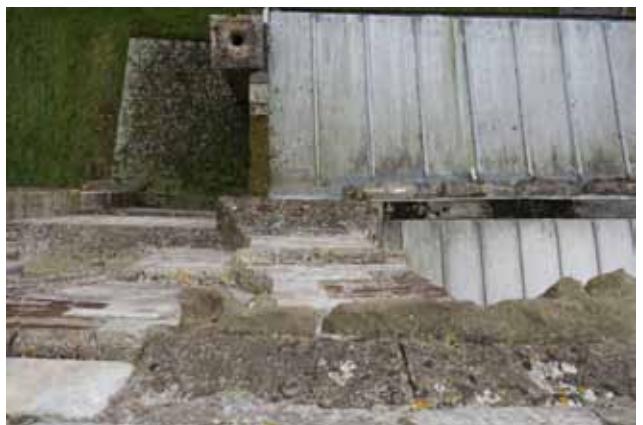
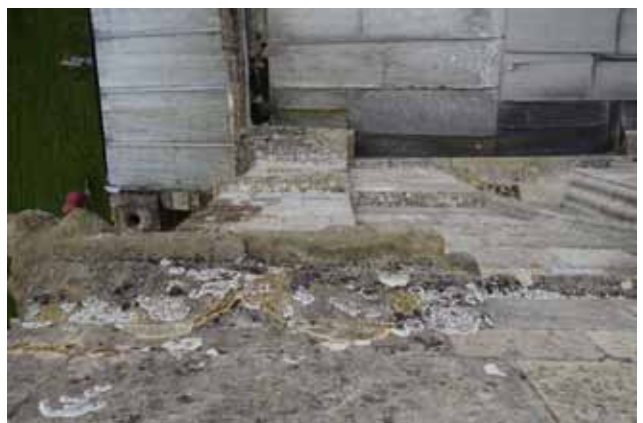
Tower east elevation

Parapet with some displacement, movement cracks and open joints, particularly through the lower left merlin and to the right side of the lower central merlin.

Stringcourse at the base of the parapet. Very eroded head with damage to the carved details to the corbel.

Left buttress with a very eroded stone below the stringcourse at the base of the parapet.

Right buttress with significant movement cracks through the stringcourse at the base of the parapet. Very eroded stone within the lower Bell Chamber section.

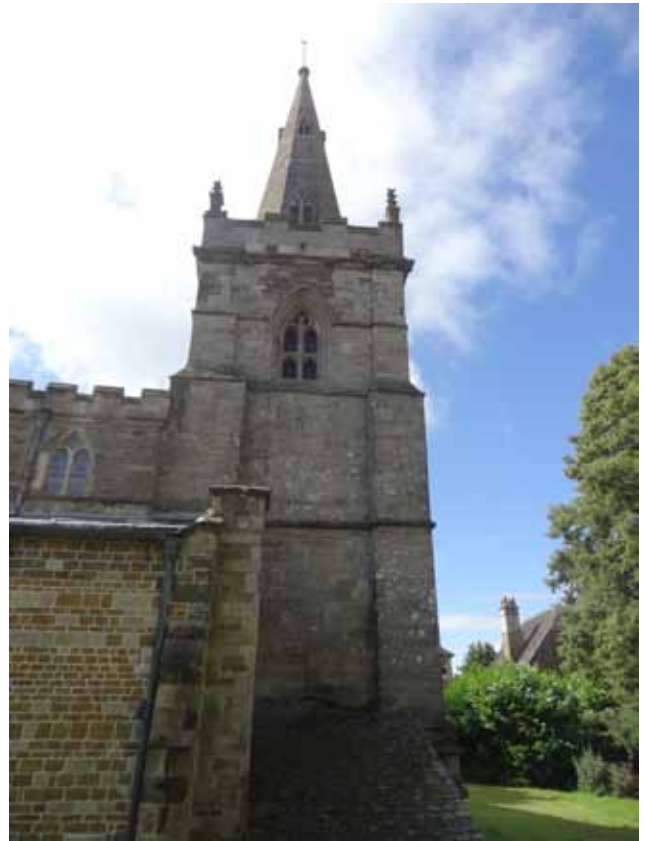
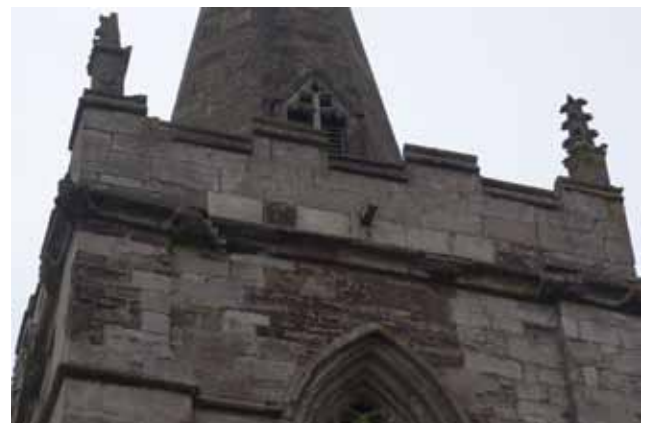
Tower north elevation

Northeast pinnacle, eroded top.

Parapet with some displacement, movement cracks and open joints.

Top of upper bell chamber section with ancient distortion and open vertical movement cracks.

Bell Chamber window, very dilapidated. Erosion to soffit.

Lower bell chamber section with vertical movement cracks.

Left buttress with ancient displacement and some open movement cracks at the top.

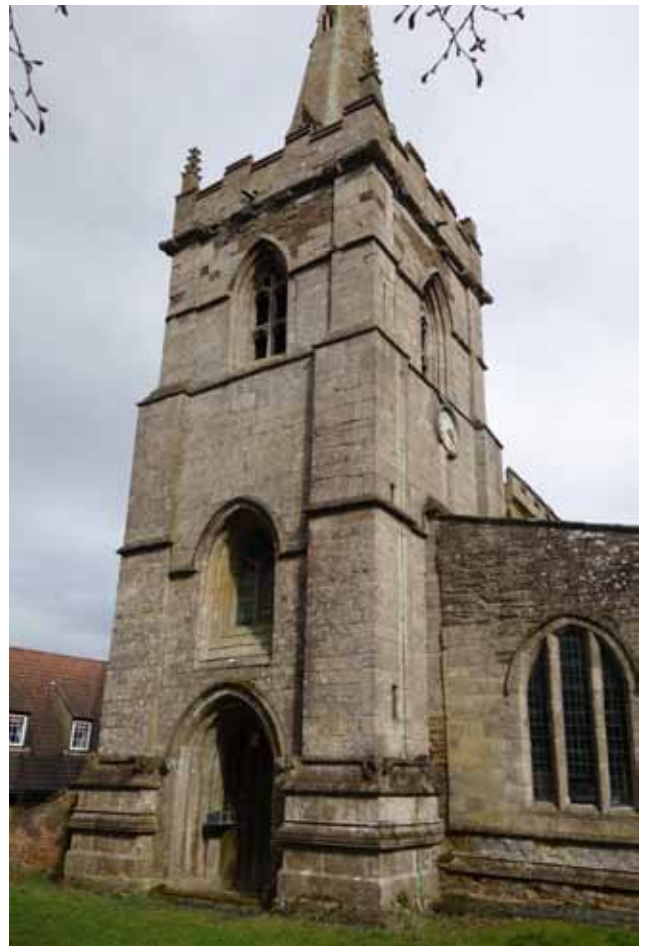
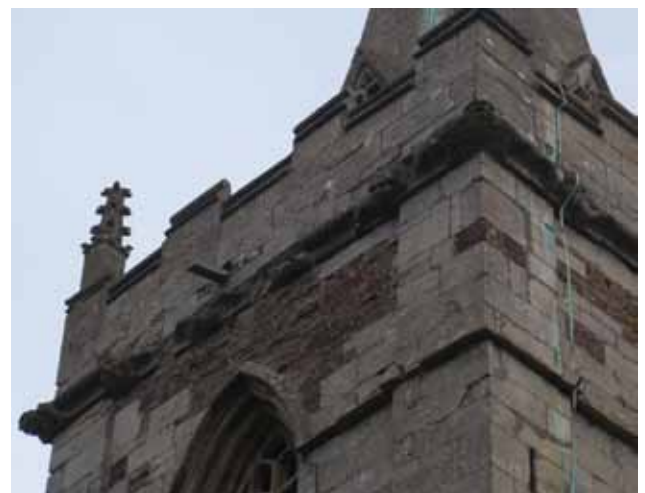
Tower west elevation

Parapet with some displacement, movement cracks and open joints.

Stringcourse at the base of the parapet.
Very eroded head with damage to the carved details to the corbel.

Lower bell chamber section with vertical movement cracks.

Lower wall. West window with movement cracks to hoodmould, head and cill.

Right buttress with good carvings to the upper plinth. Open joints to ground level.
Failed mortar repair under the off set stringcourse to the Bell Chamber section.

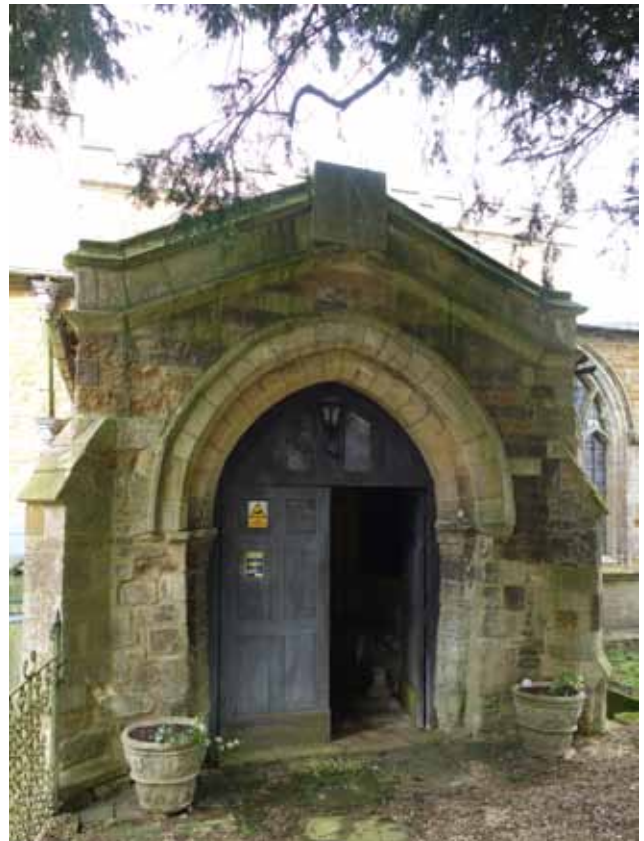
Porch south elevation

Doorway with movement crack to head and corresponding ancient displacement of the jambs. Secure timber doors with a surface facing repair to the bottom rail. Nice simple fanlight.

Right clasping buttress with open joints/ movement crack behind the upper offset.

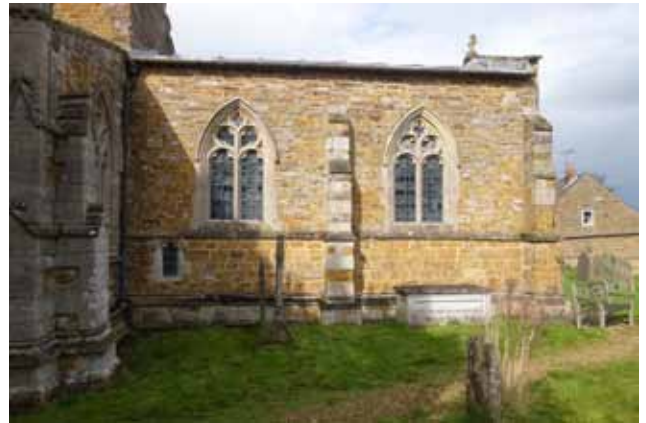
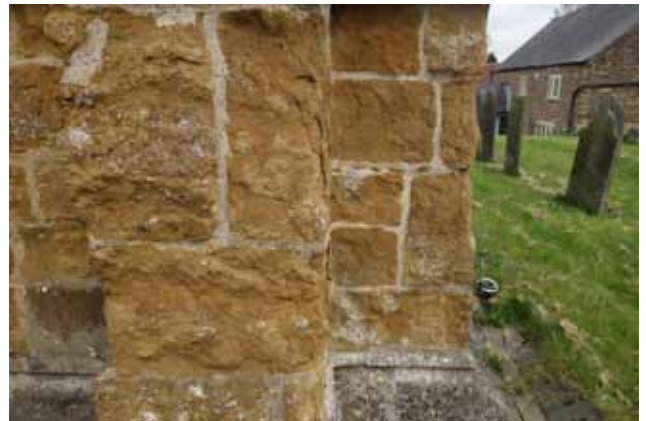
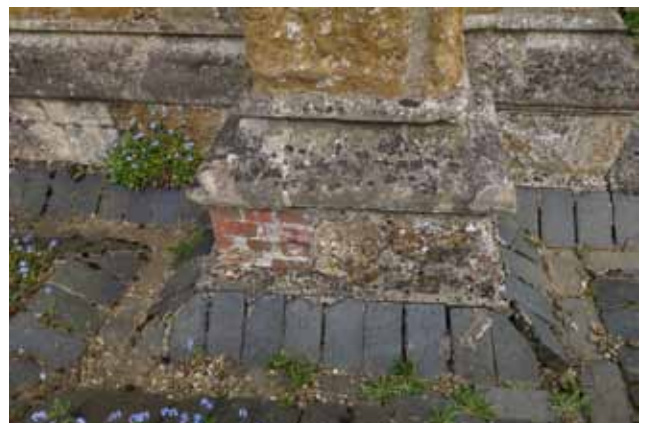
Chancel south elevation

Right buttress with very friable ironstone.

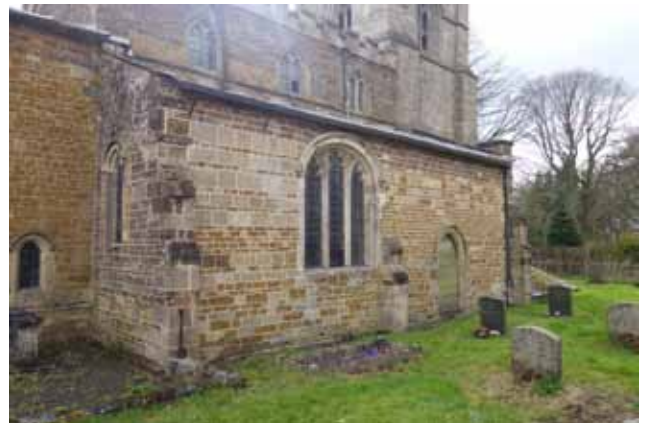
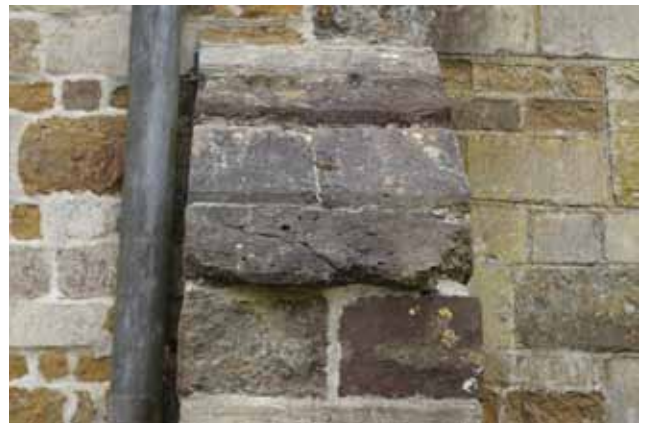
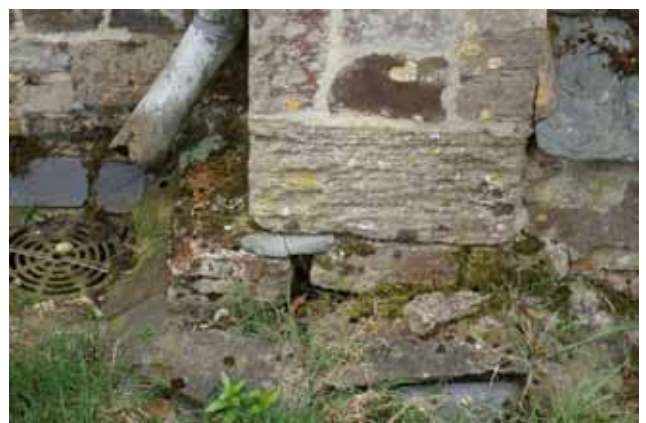
North doorway. Blocked with timber boarding.

Right buttress. Top off set fractured. Open joints at ground level where it is very displaced.

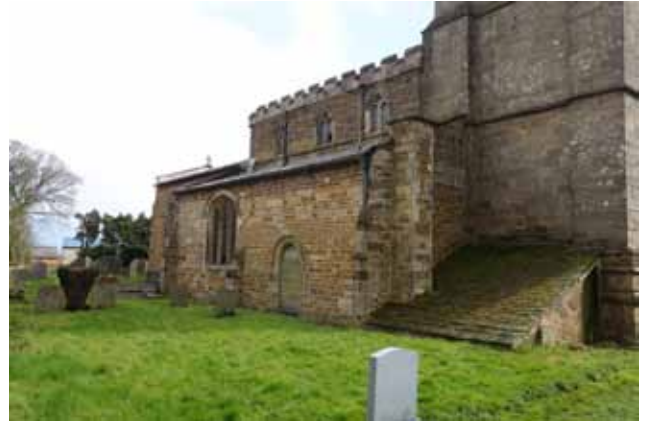
North aisle west elevation

Ironstone walling which is very eroded at low level.

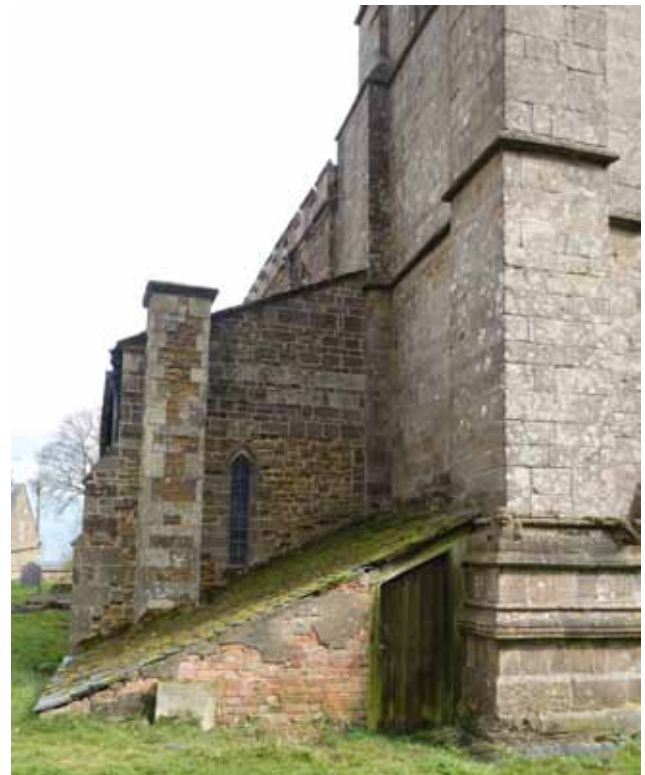
Rendered brick in very poor condition.

Timber frame and door in poor condition.

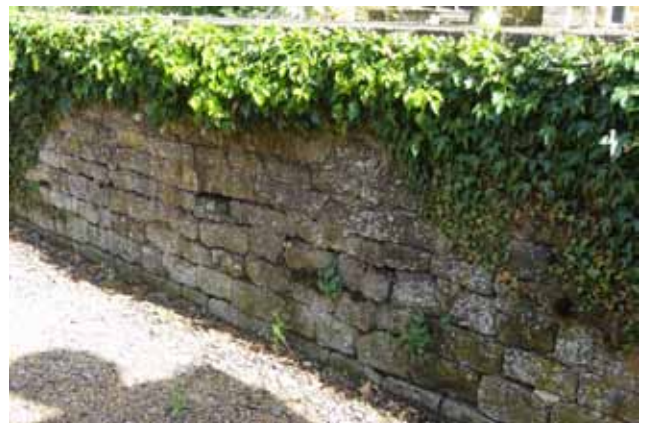
Stone retaining wall with open joints but in satisfactory condition. Vehicle damage by gate.

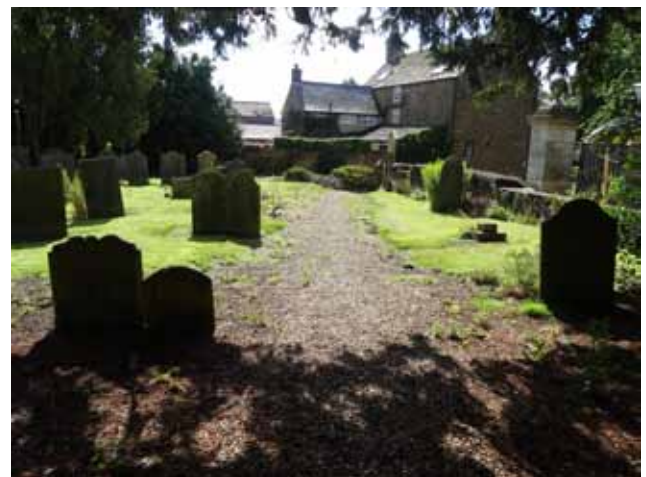
Paving from south gate becoming displaced and a trip hazard.

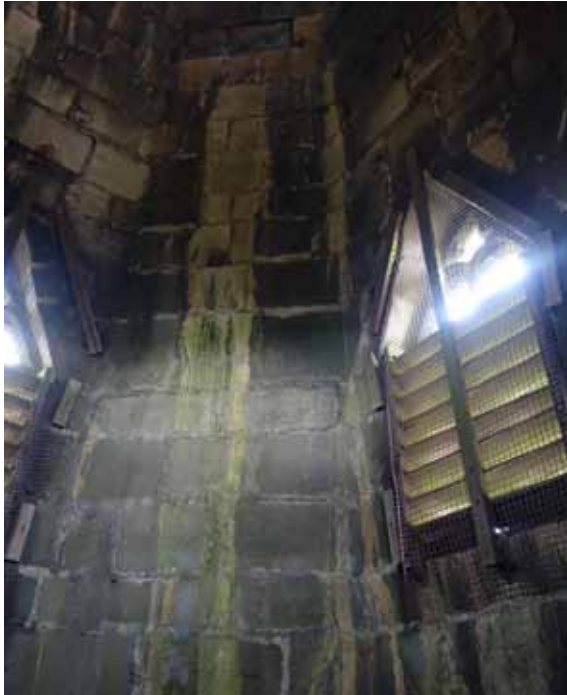
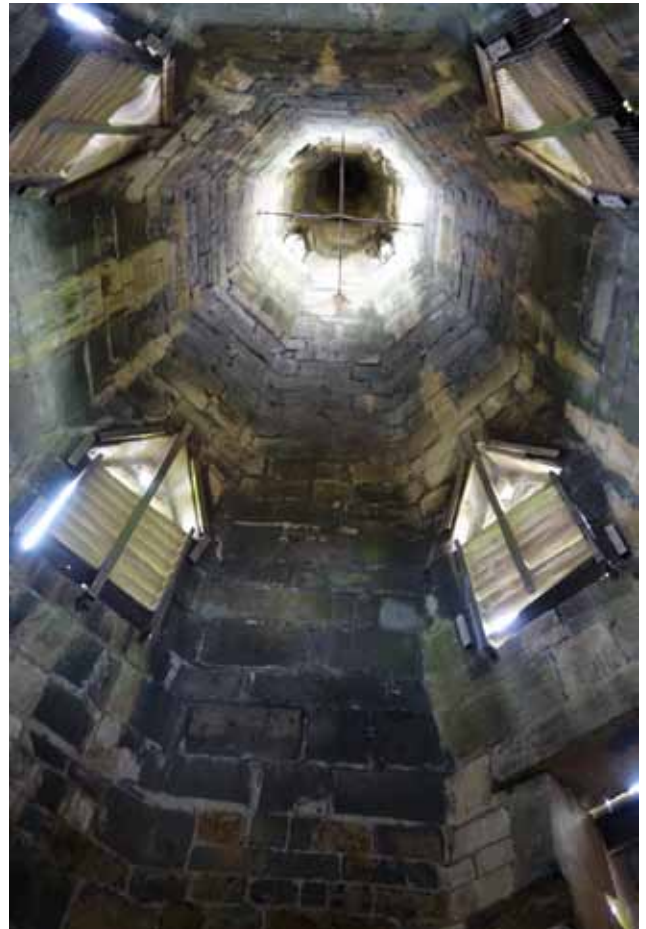
Whilst the stonework is in satisfactory condition there are significant water runs down from open joints.

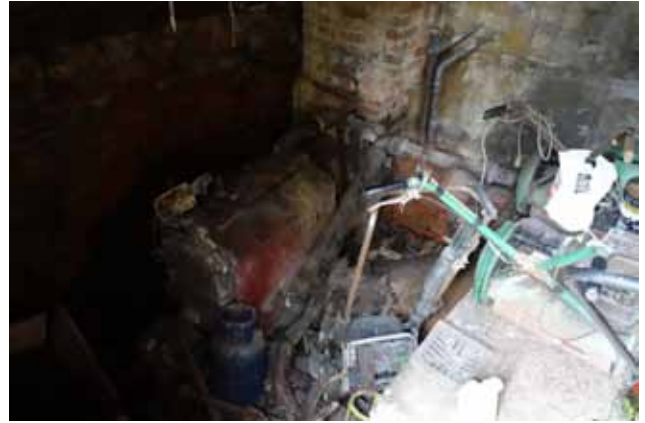
Boiler house

In very poor condition and not fully inspected due to asbestos to the redundant boiler.
