# ST JOHN THE BAPTIST CHURCH

MAIN STREET - COLD OVERTON - LEICESTERSHIRE

## CONSERVATION TREATMENT REPORT OF THE MIEVEAL WALL PAINTINGS

REPORT NUMBER: CO-MWP-006B-CTR

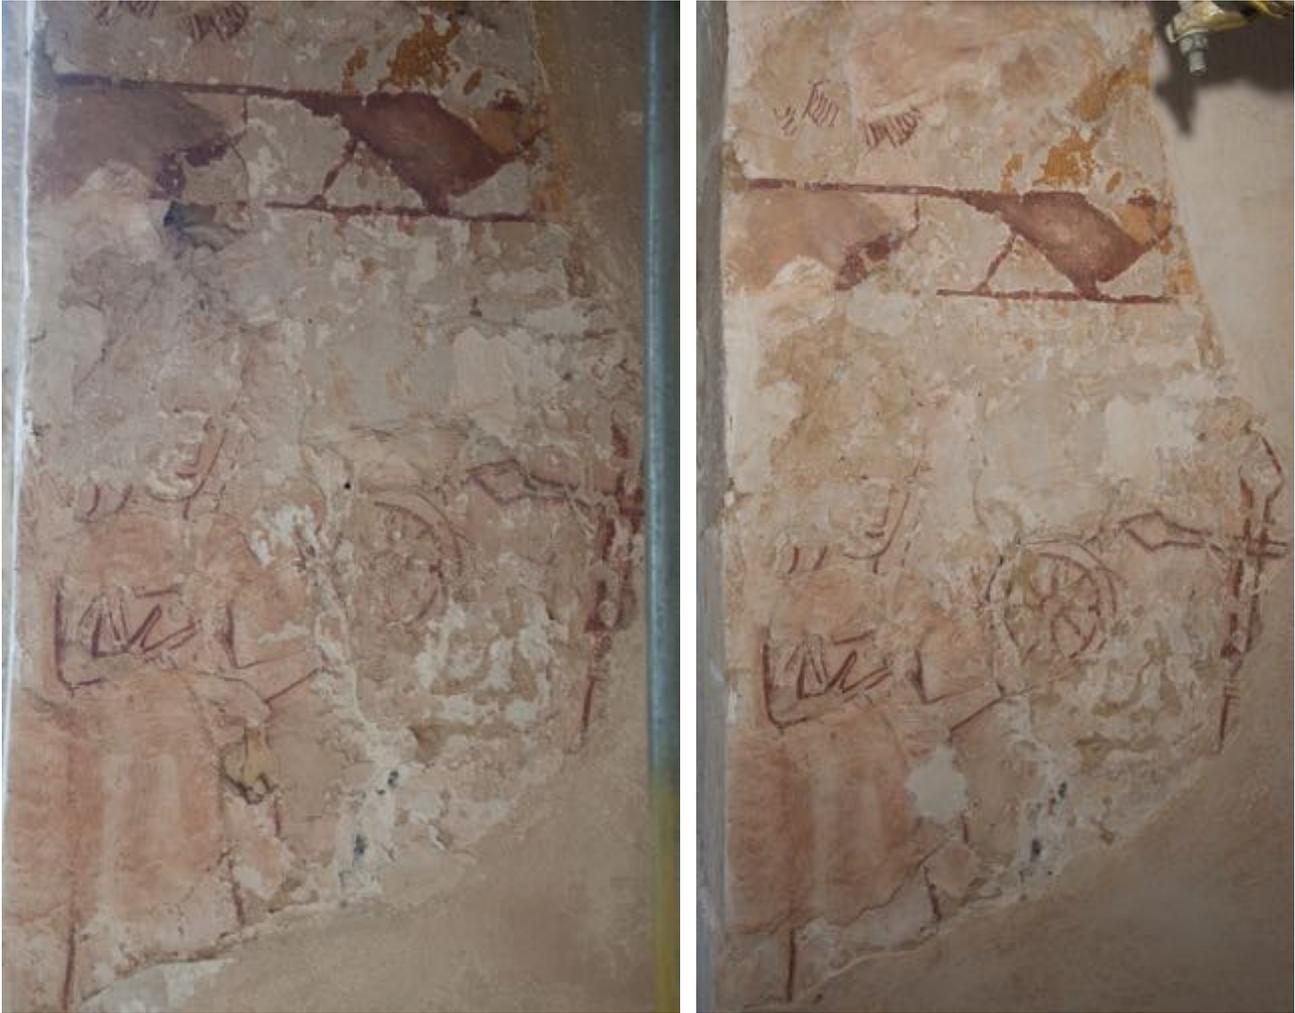
The painted scheme on the East wall represents St Catherine (photo 1) complete with a crown, wheel and processional crucifix on the right hand side, and it is believed to be part of a scheme lower down the wall. It is the only scene that seems to be uncovered from the lime wash almost completely. Only few small remains of lime wash are on the surface and all the scene is wax-free with the exception of the fragmented chevron border design in red and yellow pigments which separates this scene from the one above. The figure is side profiled with one hand raised up to her chest and the other holding the wheel out in front. Above the chevron border design there is two pairs of feet from an unknown character. On the lower edge of the scene there are fragment of a previous decorative scheme (photo 3).

Most of St Catherine figure is constituted by an old repair, probably done by Tristram.

The paint layers of the unnamed characters' feet above were particularly poorly adhered.

Photos 1 & 2: St Catherine scene before and after the conservation treatments. Some more details were uncovered removing lime wash residues (e.g. portion of the wheel)

- Repairs of the plaster substrate within the remain of the decorative scheme: in order to provide stability for the surrounding plaster and to reduce the aesthetic disruption caused by the large number of different surfaces, the areas of loss was repaired using a lime putty and sand mortar of a colour and texture similar to the original in proportion of 1:3. Most of the recent repairs, which were unstable, cracked and smeared on original painted surface, were removed and replaced. However, in some areas this would have put the original material at risk and therefore they have been left in place (St Catherine photos).

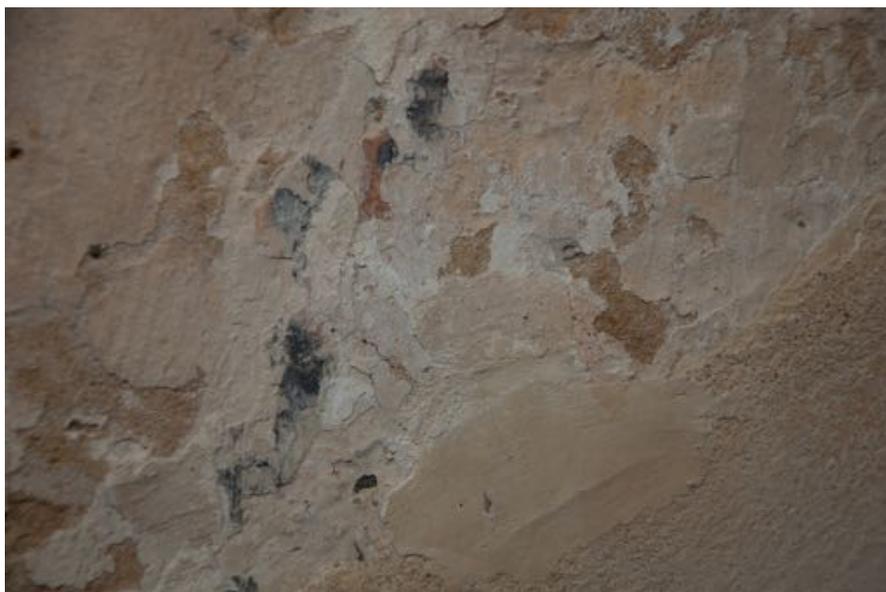
Photo 3: Details of a previous painted scheme.

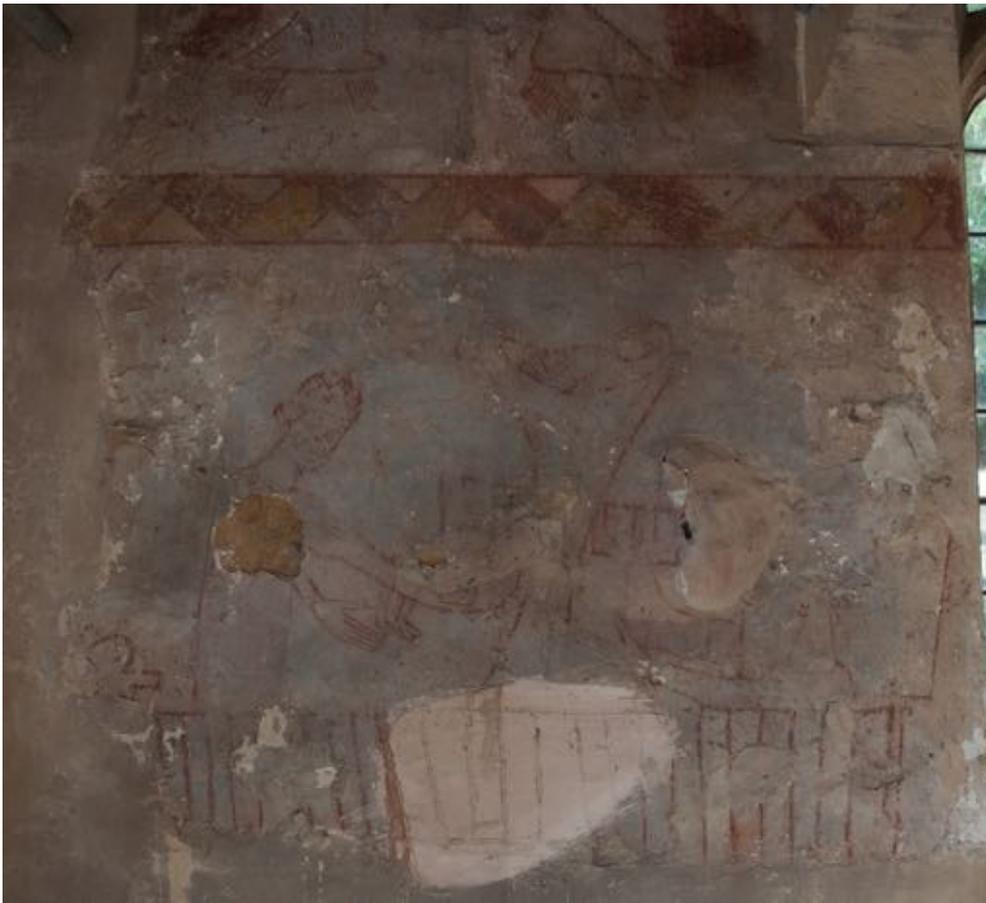
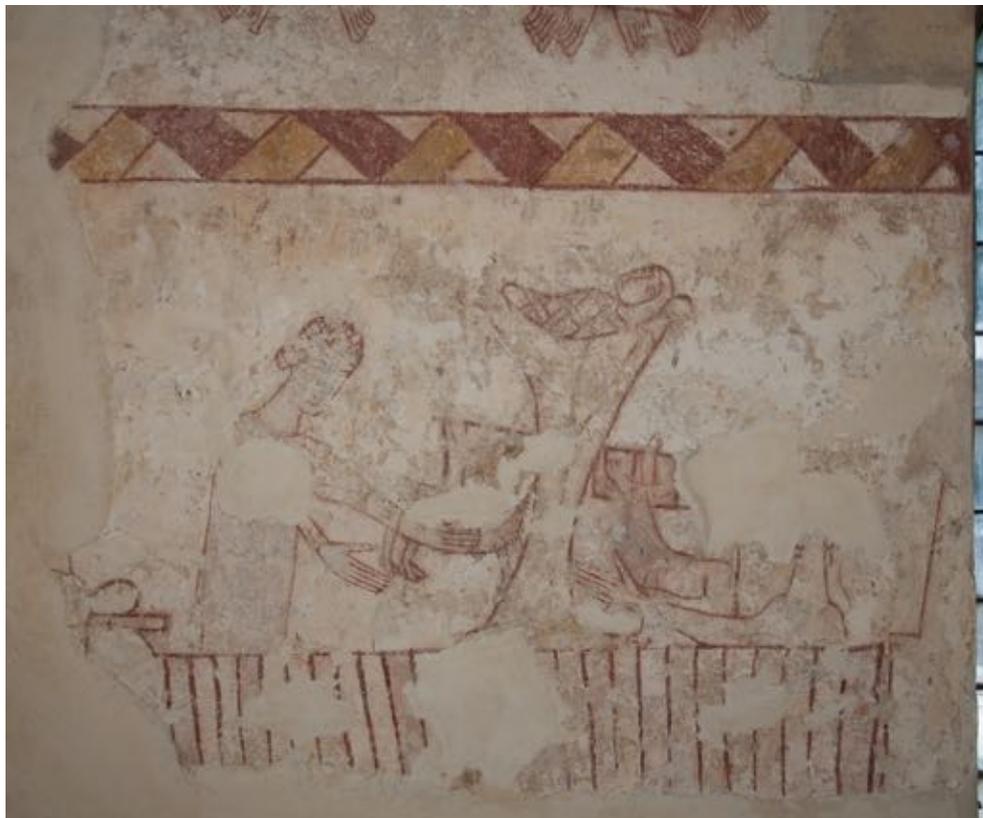
The painted scheme on the South wall depicts the Nativity scene (photo 4) in a traditional mediaeval style. There are two figures surrounding the image of Christ in a manger with animals in the background. It seems that the majority of the surviving painting was favourably uncovered leaving subsequent lime-wash layers over the plain areas. There is a chevron border design above in red and yellow pigments which separates this scene from the one above (Gathering of the Apostles).

It appears that the profiles of the figures and the chevron design was painted in red on a ochre-pink ground.

The main area of lost plaster is on the left side scheme at the centre top of the left side figure and the plaster repairs on the right hand side detached significantly. There were several examples where the plaster delaminated from the substrate and the plaster appeared hollow on the right side of the scheme. All of the deterioration is on-going and directly linked to the poor permeability of the substrate and consequential salts and moisture retention. The historic repairs were not stable as they delaminated from the original plaster or the stone substrate. The plaster repairs were involving already important focal points and the risk of greater loss of decorative information was possible.

The decorative layer was particularly weak around the blown historic repairs.

Photos 4 & 5: Nativity scene before and after the conservation treatments.

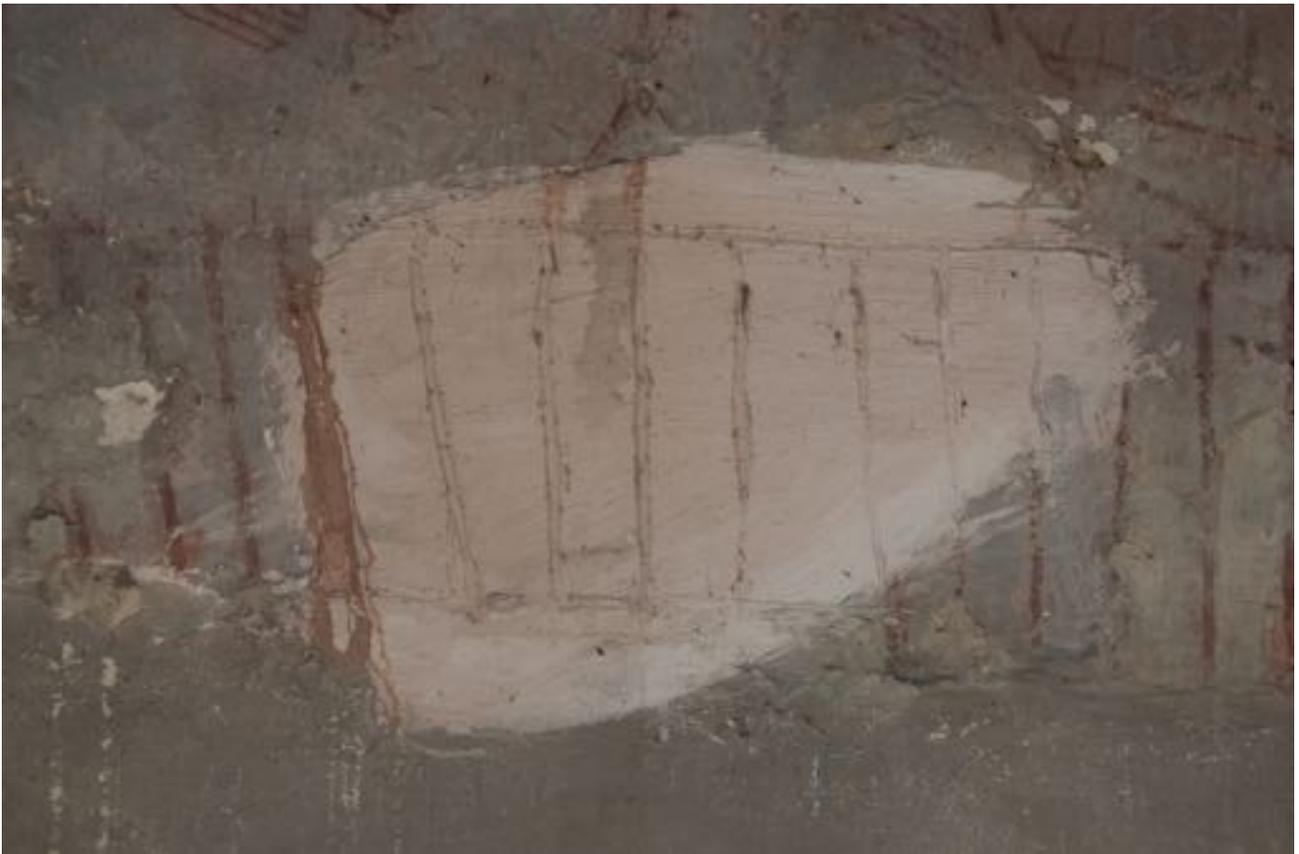
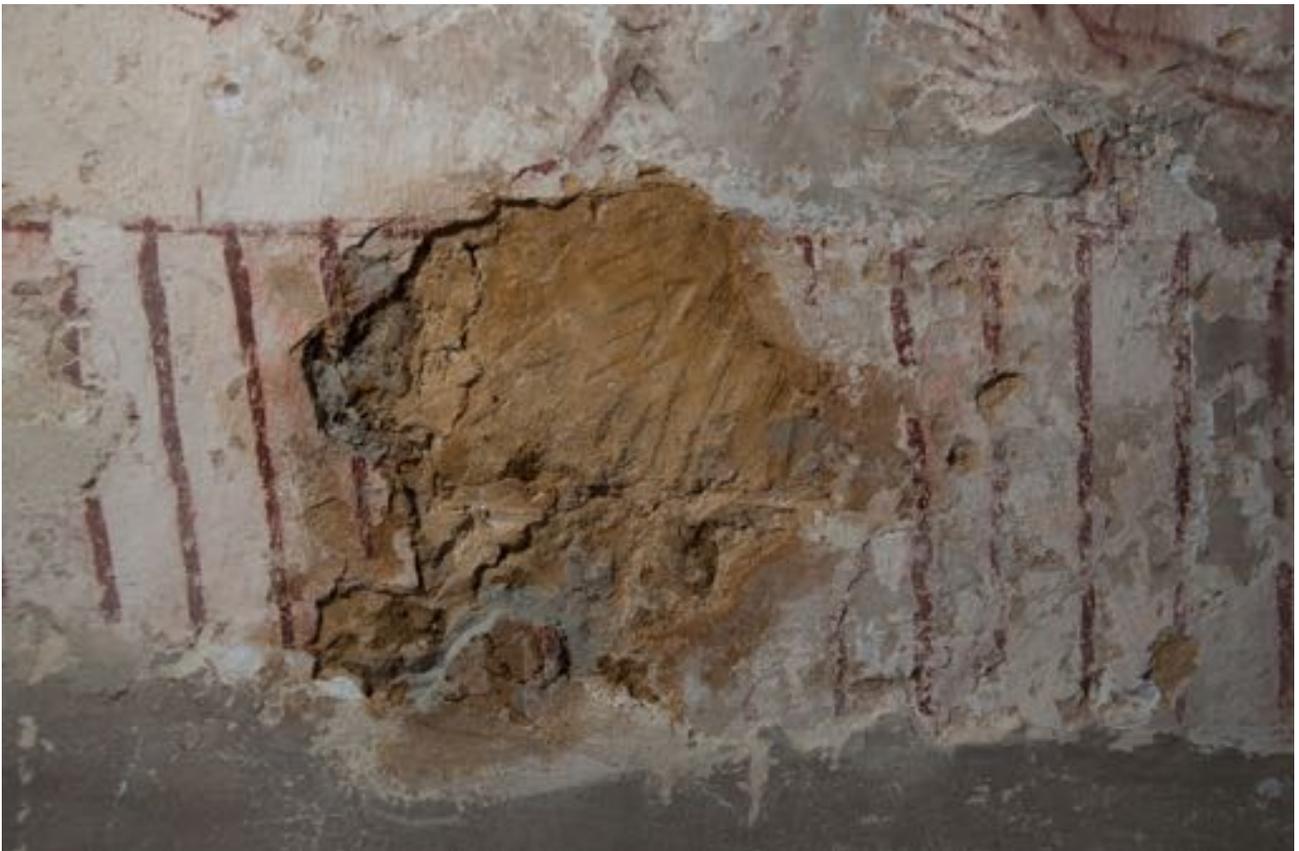
The condition of the wall paintings shows that they underwent significant restoration at least on two occasions in the past. The most recent repairs are made in pink modern filler similar to Polyfilla (photos 4, 6, 10). There are a number of large plaster repairs which cut into the painting, some of which have been retouched and over-painted. These belong to an older intervention, during which a wax treatment was applied over the painting on south wall in order to to stabilise the deteriorating surface.

Photos 6 & 7: Detail of Nativity scene: previous repair before and after removal. A large portion of original painting was uncovered.

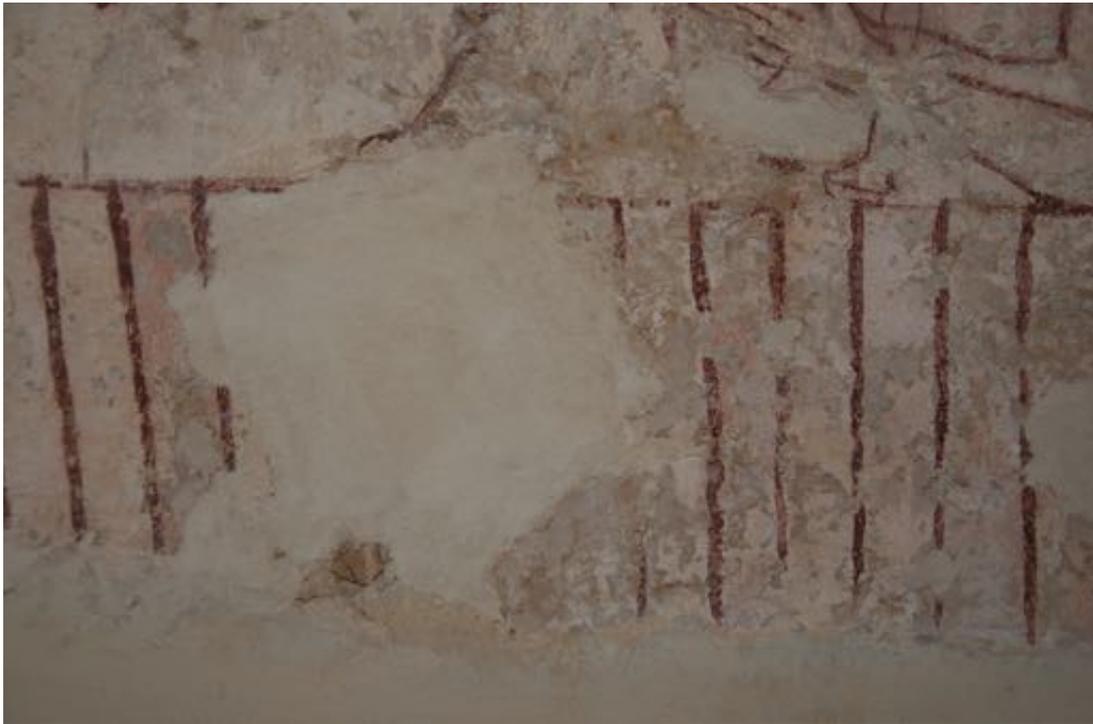
Photo 8: Detail of Nativity scene: new repairs replacing the old one (see photos 6 & 7).

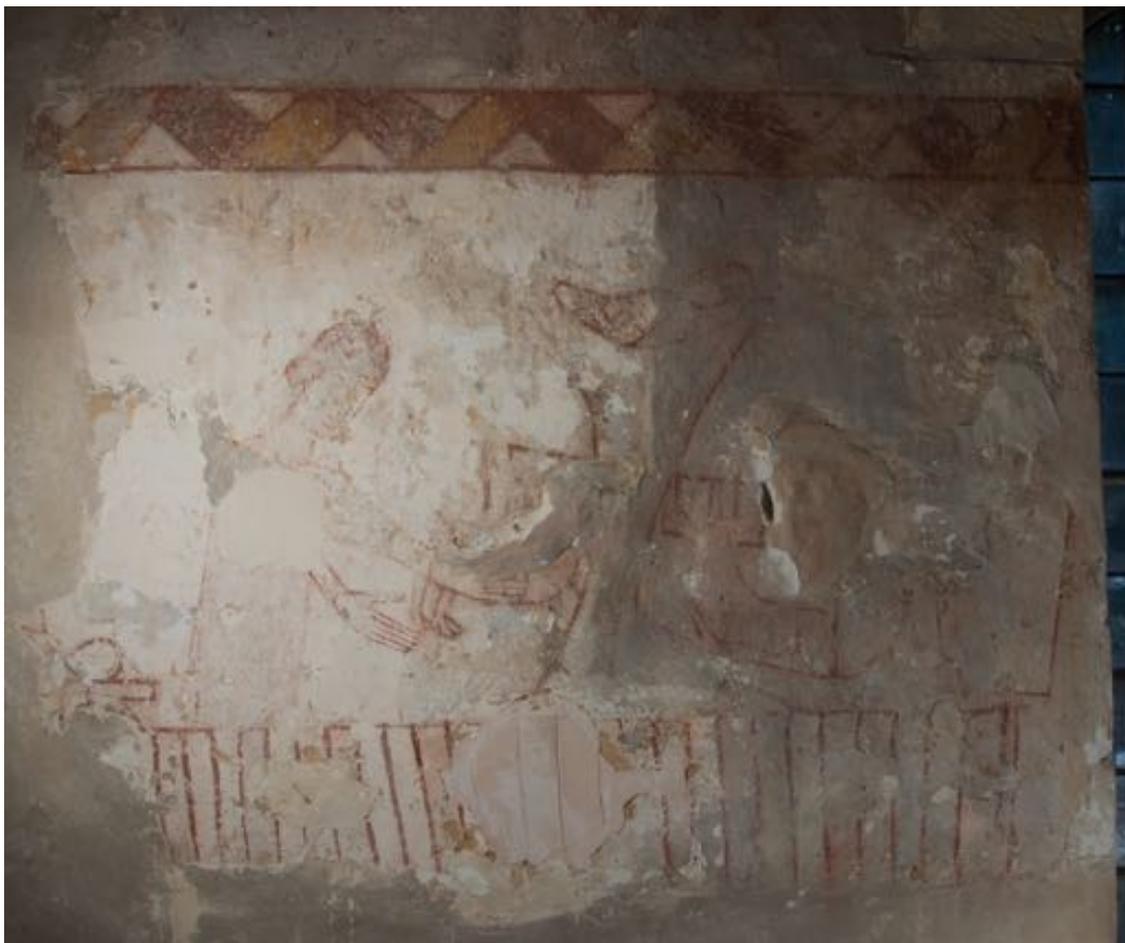
Photo 9: Nativity scene during the cleaning phase (wax and lime wax removal).

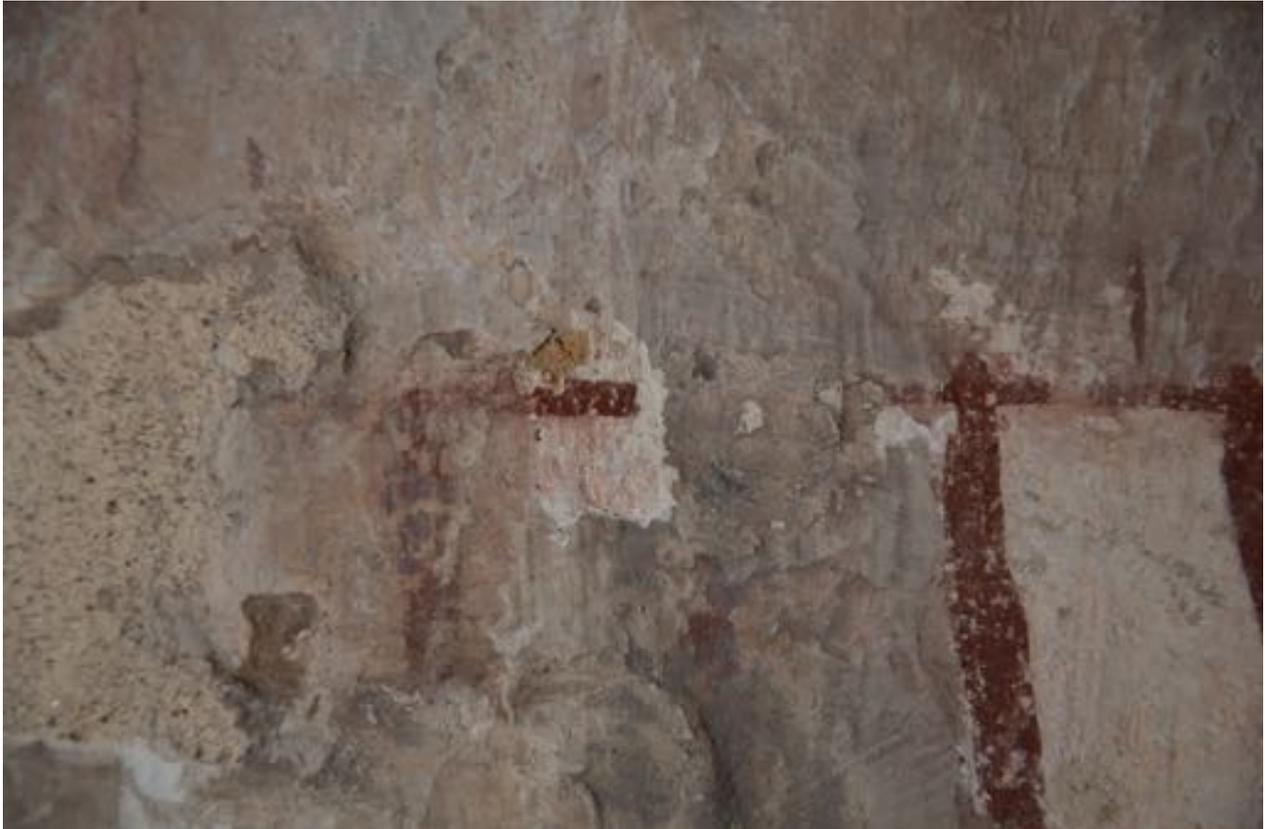
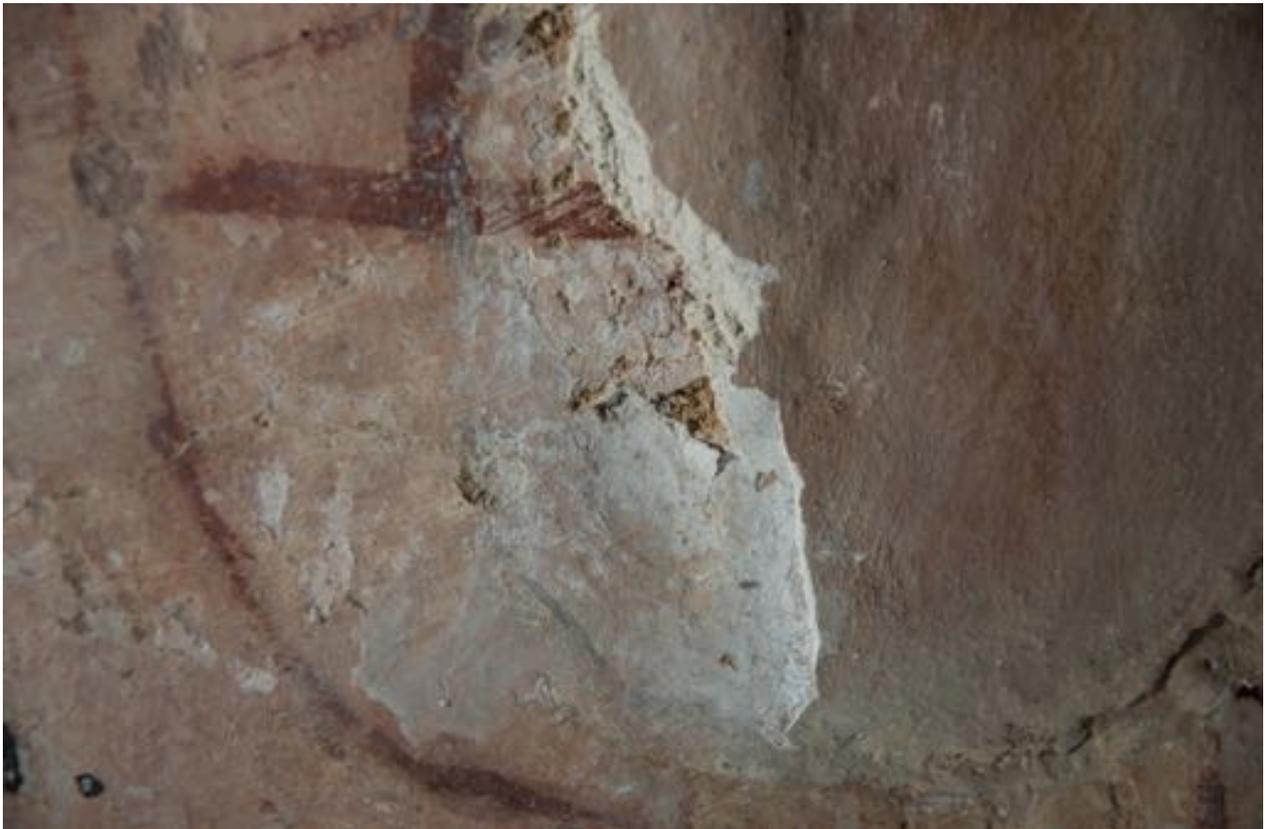
Photos 10 & 11: Details of Nativity scene during the lime wash removal, uncovering original areas of the painted scheme.

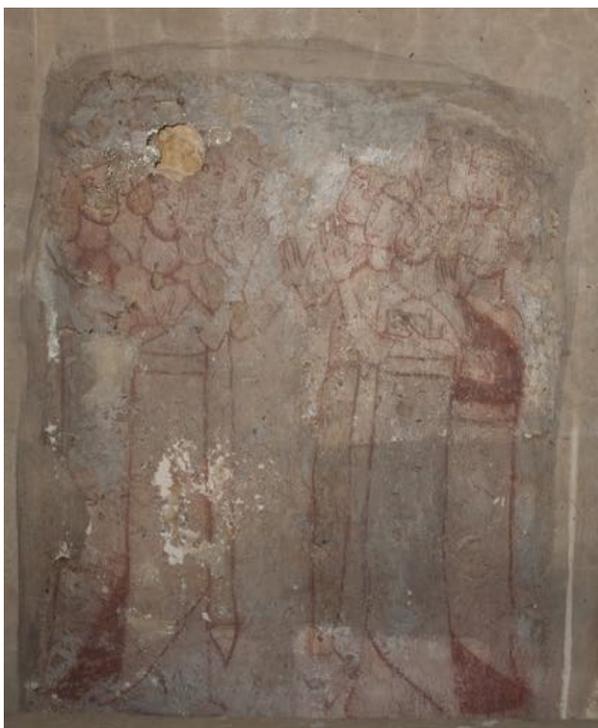
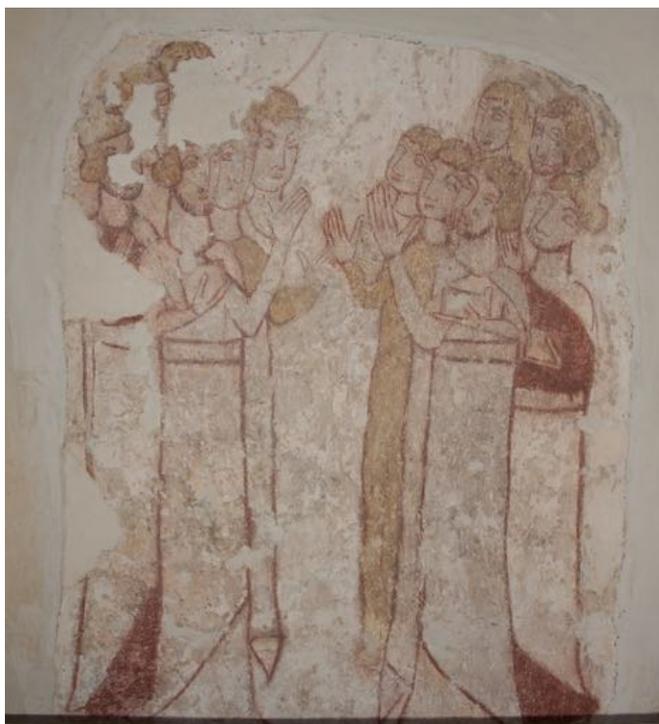
The painted scheme on the South wall is believed to be the Gathering of the Apostles (photo 12). There are six figures on the left and equally reflected with six on the right. The figures at the front hold what appears to be books and are holding their hands up to each opposing group in prayer. It seems that the majority of the surviving painting has been uncovered and there is evidence of later cleaning attempts on the top and bottom right corners of the scheme. There is a chevron border design below in red and yellow pigments which separates this scene from the one below (Nativity). Most figures are outlined only, with only two figures wearing robes which are saturated fill colours.

The main areas of plaster loss is on top left side of the scheme which is severely detached, forming a large void between the detached plaster and stone substrate.

There are two areas of partial cleaning trials which have not worked effectively.

Photos 12 & 13: Gathering of the Apostles scene before and after the conservation treatments.

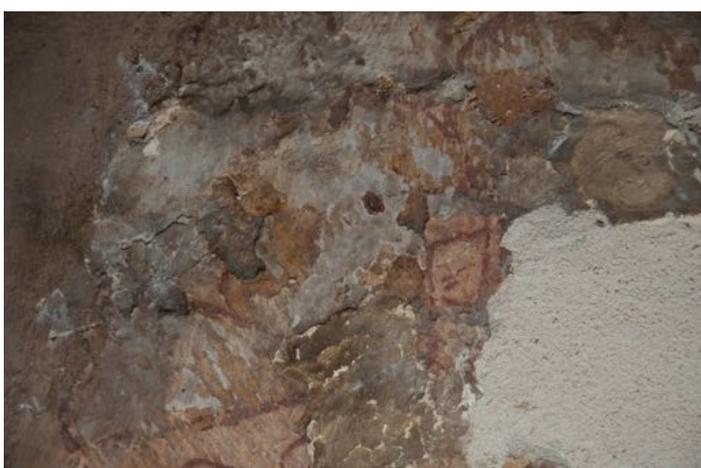
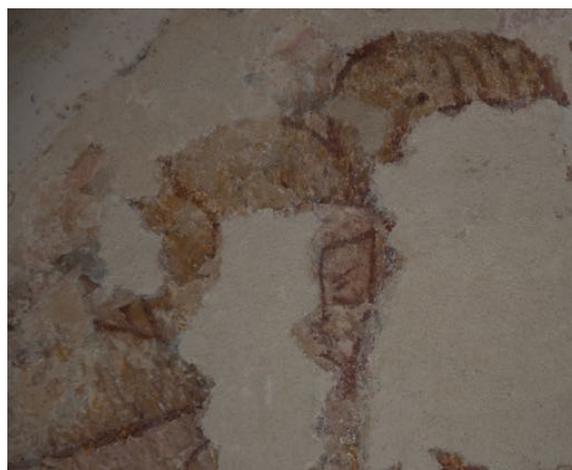
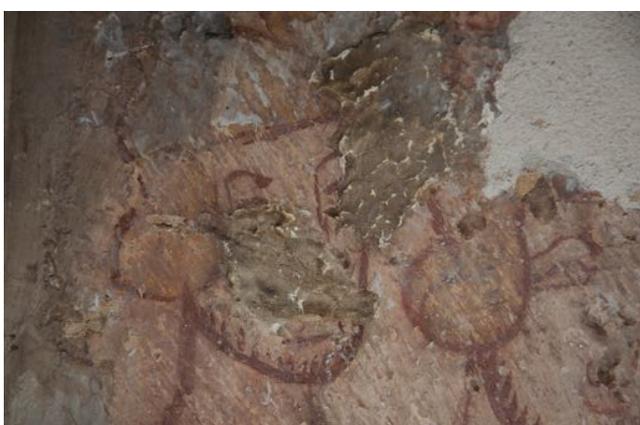
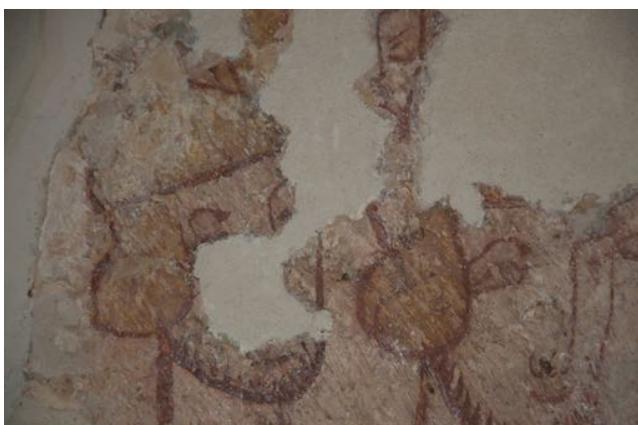
Photos 14-17: Details of Gathering of the Apostles scene: New repairs (photos 15 & 17 on the right) replaced the old ones (photos 14 & 16 on the left).

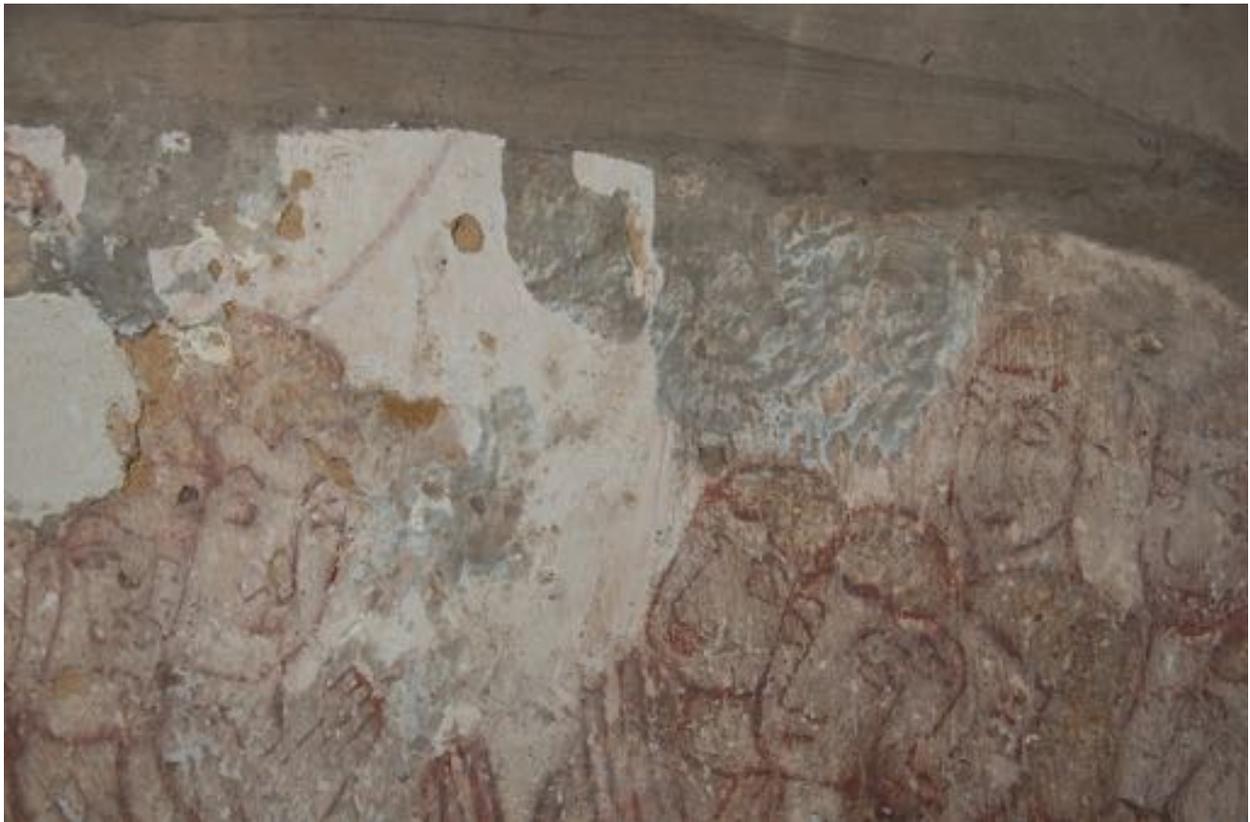
Photo 18: Detail of the Gathering of the Apostles scene during the lime wash removal, uncovering original areas of the painted scheme and old plaster and paint layer losses.

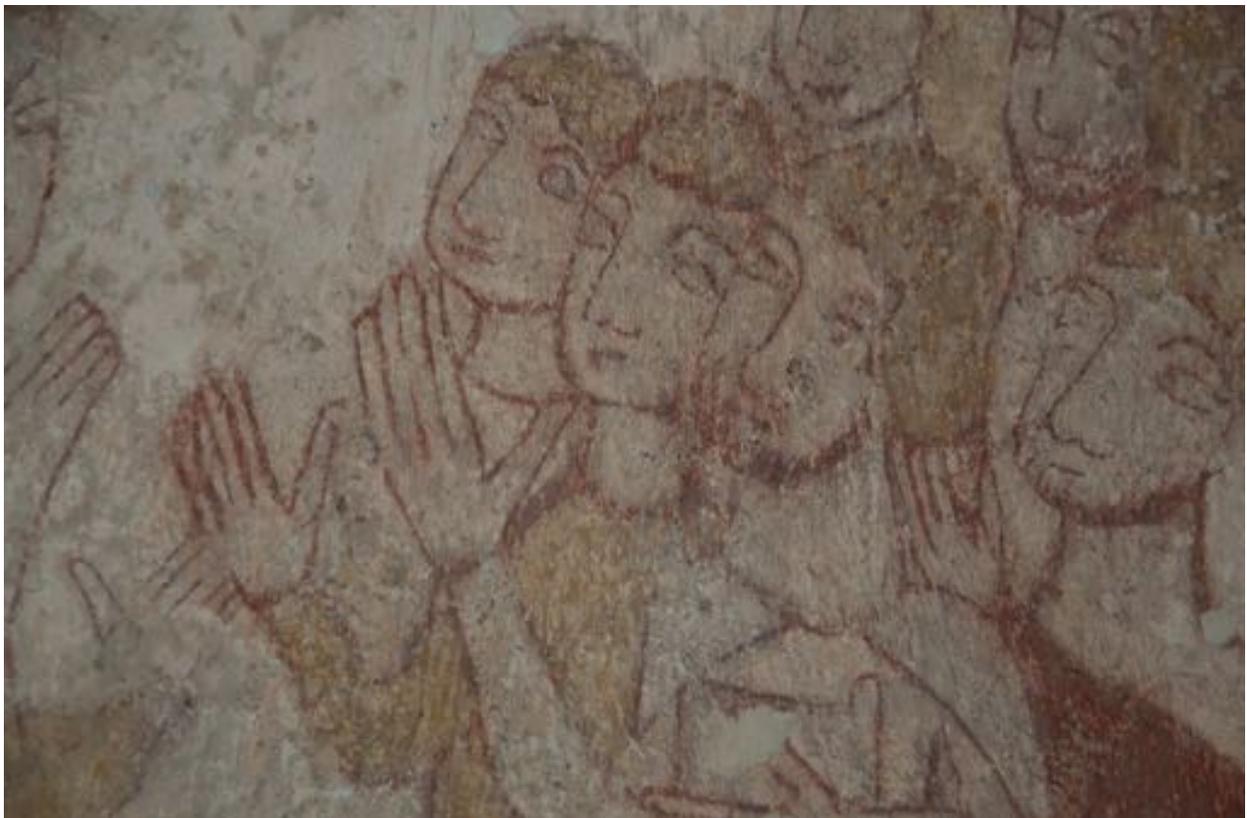
Photo 19: Detail of the Gathering of the Apostles after the conservation treatments.

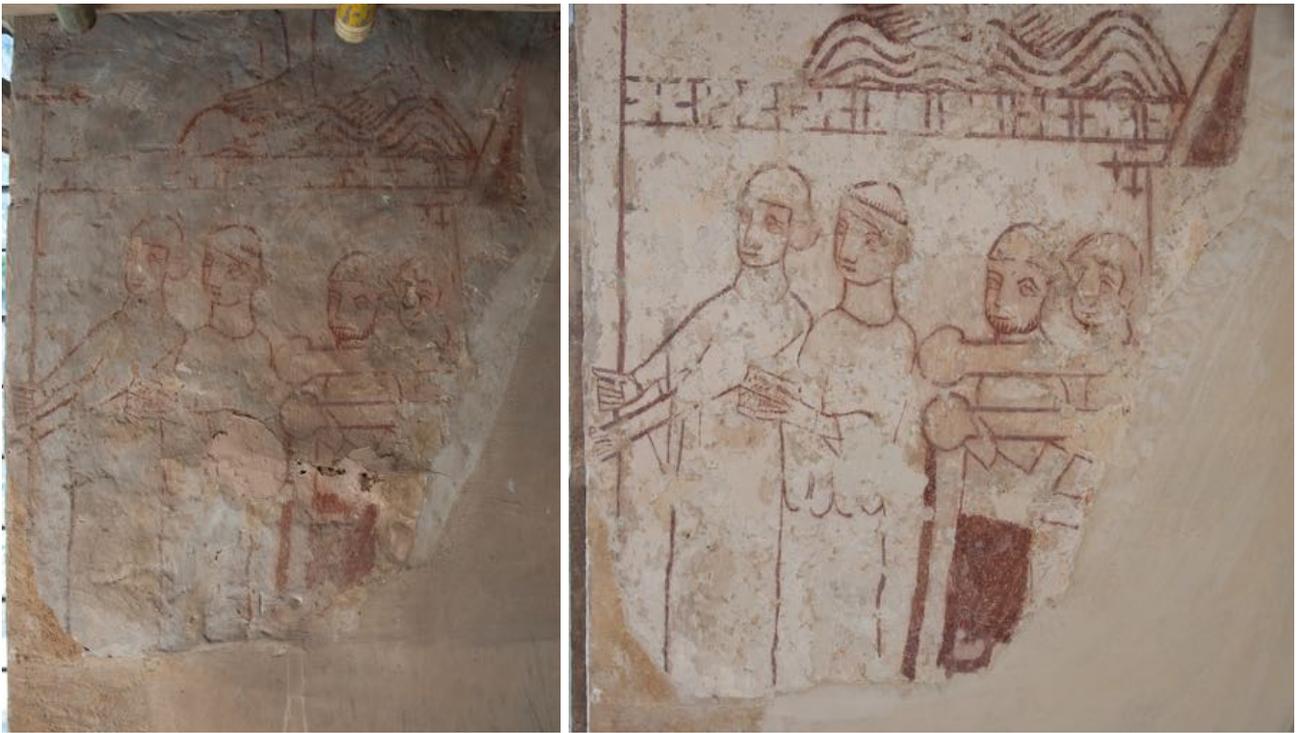
The painted scheme below St John is believed to be the Funeral procession of the Virgin Mary (photo 20). It seems that the majority of the surviving painting has been favourably uncovered along with the profile of the figure, leaving subsequent lime-wash layers over the plain areas. There are four figures with a processional crucifix at the front, two figures walking forwards, one holding out a book/literature and two figures bearing the processional carriage. The carriage extends over to the right but is still covered by lime-wash layers and plaster repairs.

This area had substantial de-lamination of the plaster surface and there were numerous historic plaster repairs. The upper most section of the painting including the figures heads and shoulders was detached and hollow and required stabilisation. The bottom right side of the scheme was in the same condition and included some attempts of repairs. The bottom left side of the scheme was of extreme concern and requires immediate consolidation; comparing the photographic records taken in 2012 with the

ones taken in March 2017 it was evident that further losses had occurred (see report March 2017 and August 2018). The plaster layers detached completely and a substantial section of the painting was likely to be damaged and lost.

Residues of the covering lime-wash are extensive and there are many areas which would benefit from further lime-wash removal to uncover more of the scheme. This was particularly prevalent on the scheme around the heads and the carriage on the right side of the scheme. De-lamination was wide spread and not only concentrated along the edges of the damaged areas of the substrate.

Photos 20 & 21: Funeral procession of the Virgin before and after the conservation treatments.

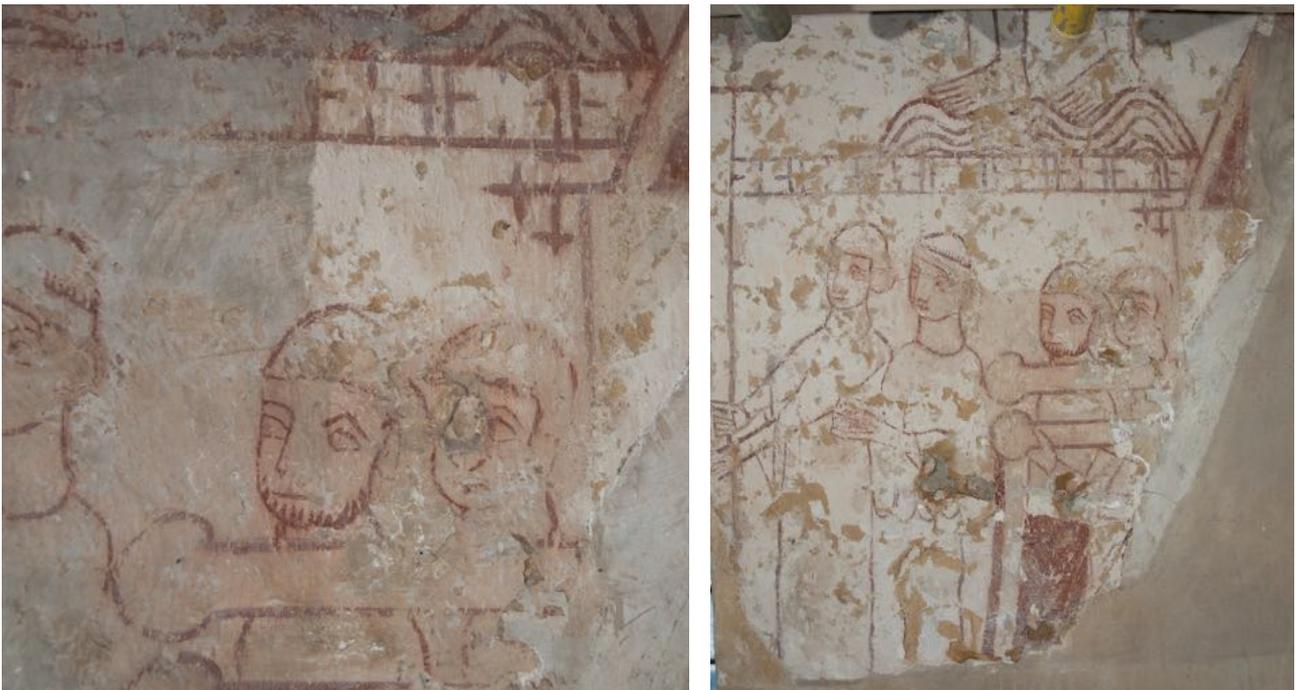
Photos 22 & 23: Detail of the Funeral procession of the Virgin during the lime wash removal, uncovering original areas of the painted scheme and old plaster and paint layer losses.

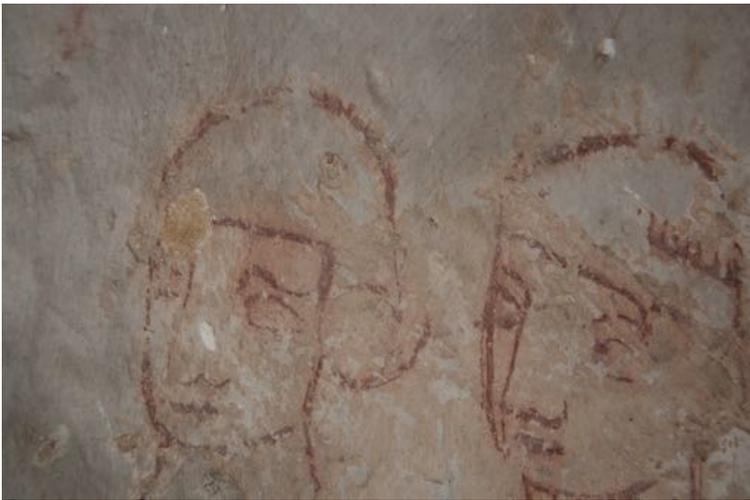
Photos 24-26: Detail of the Funeral procession of the Virgin before, during and after the wax and lime wash removal.

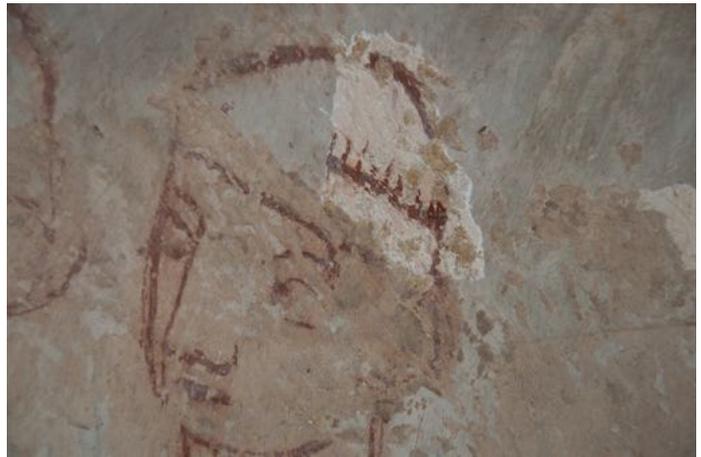
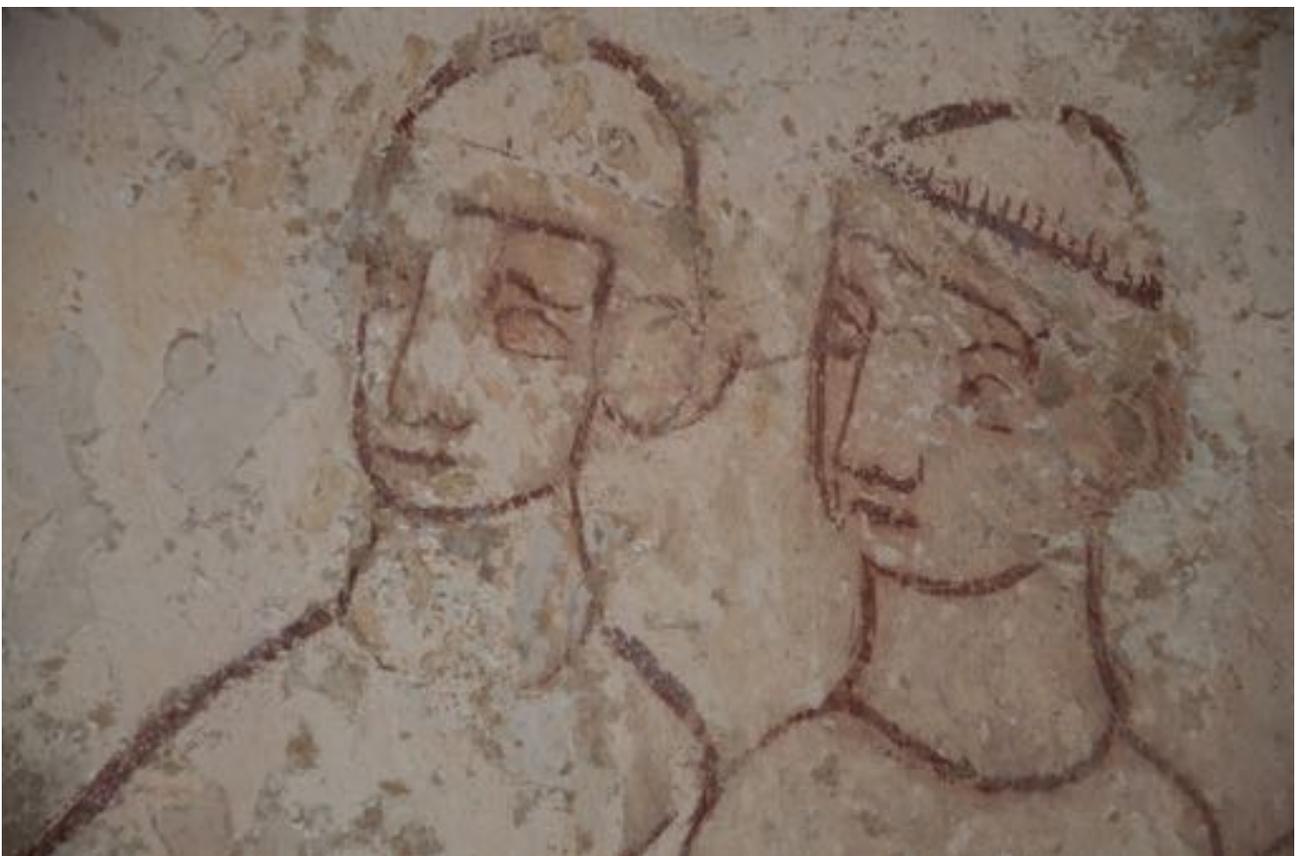
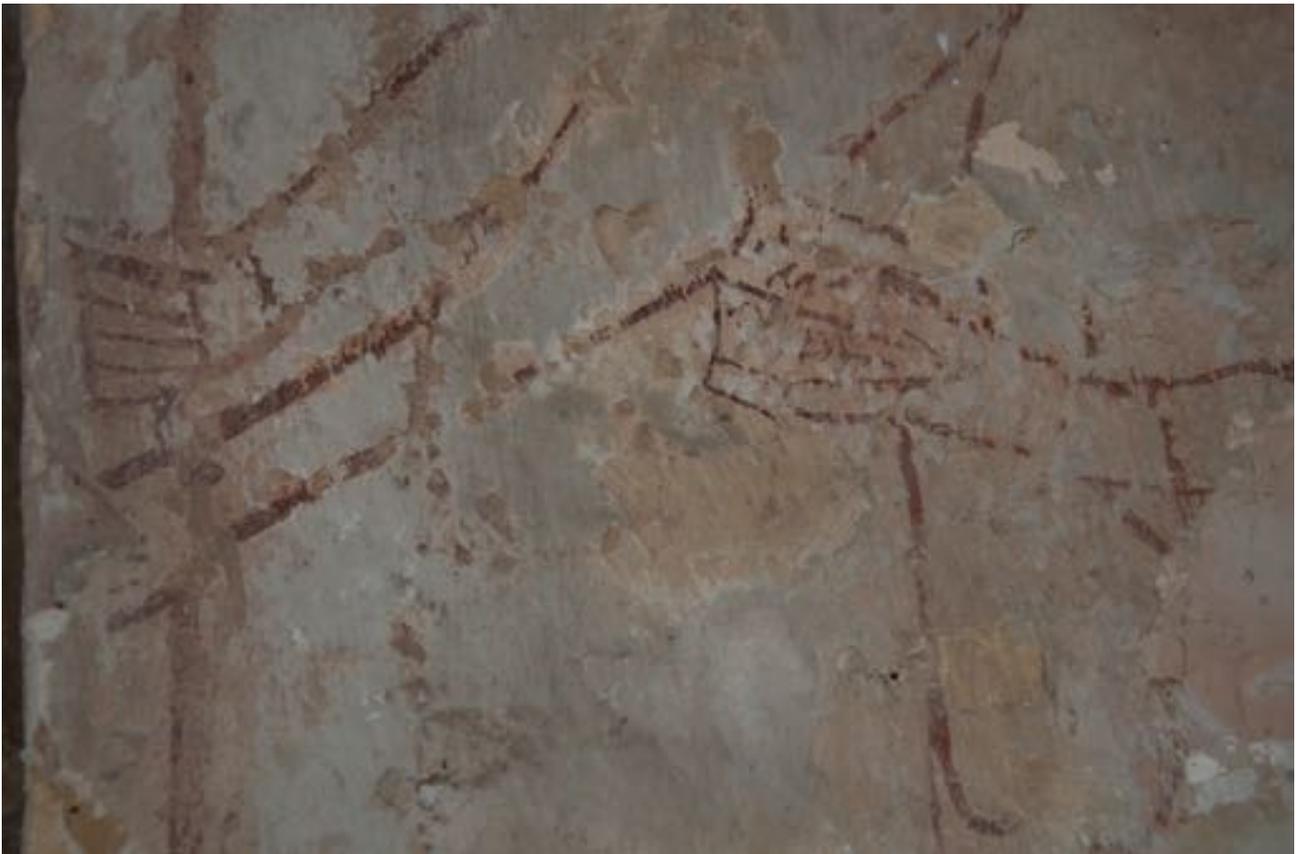
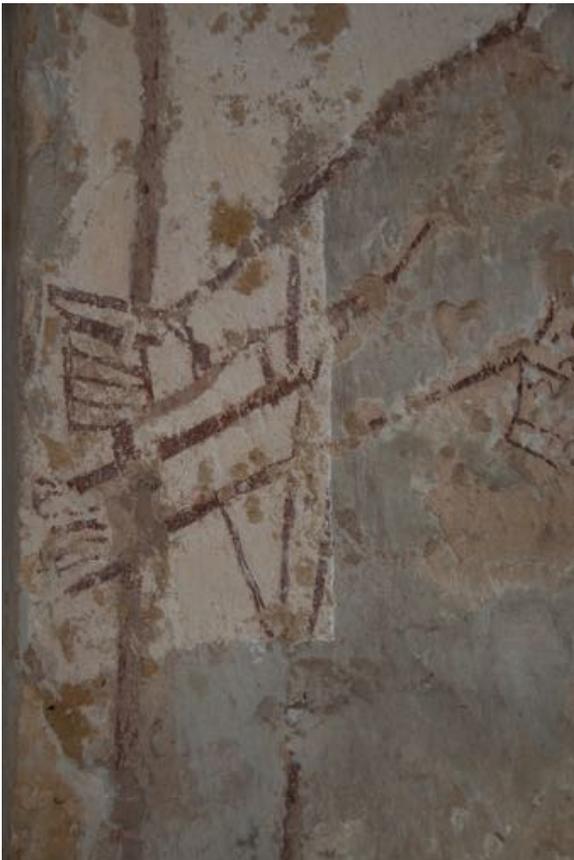
Photos 27-29: Detail of the Funeral procession of the Virgin before, during and after the wax and lime wash removal.

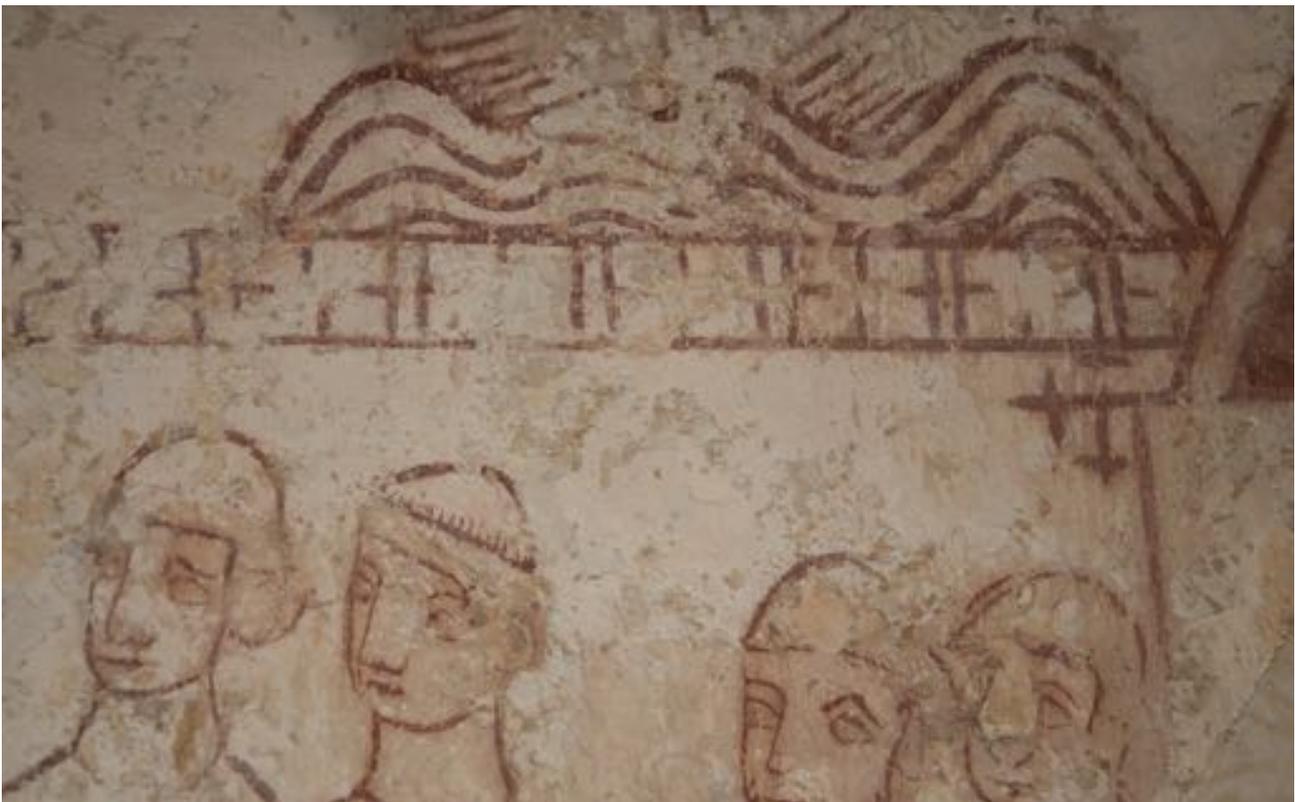
Photo 31: Detail of the Funeral procession of the Virgin after conservation treatments.
