# ST JOHN THE BAPTIST CHURCH

MAIN STREET - COLD OVERTON - LEICESTERSHIRE

## CONSERVATION TREATMENT REPORT OF THE MIEVEAL WALL PAINTINGS

REPORT NUMBER: CO-MWP-006B-CTR

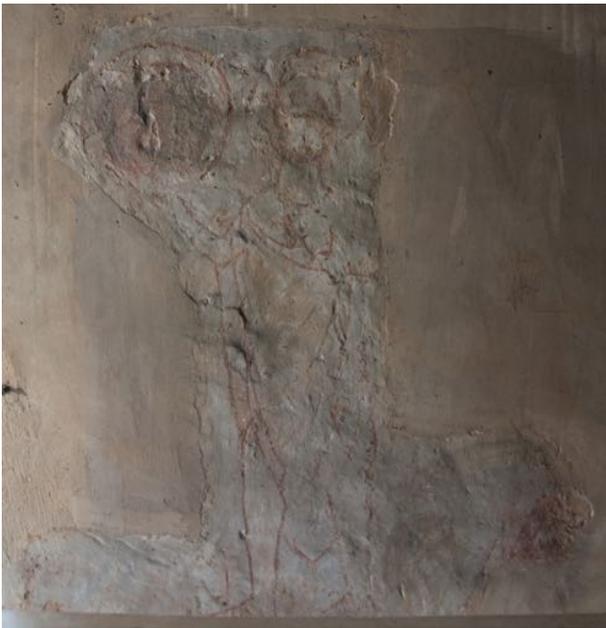
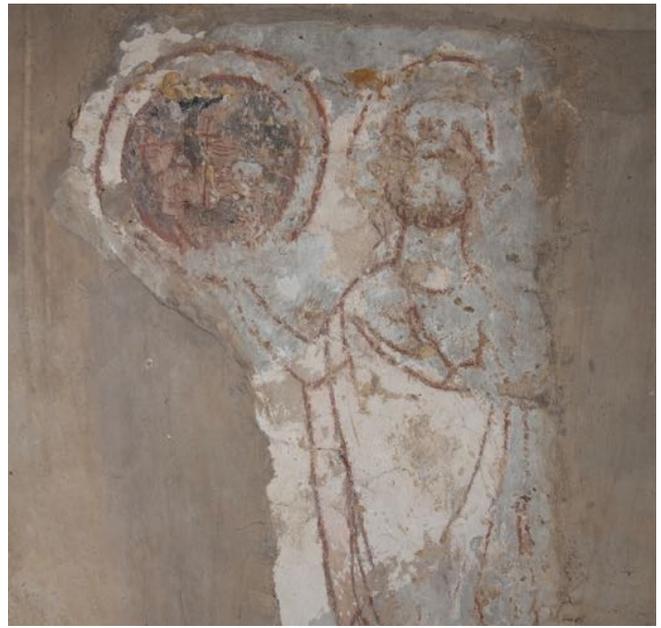
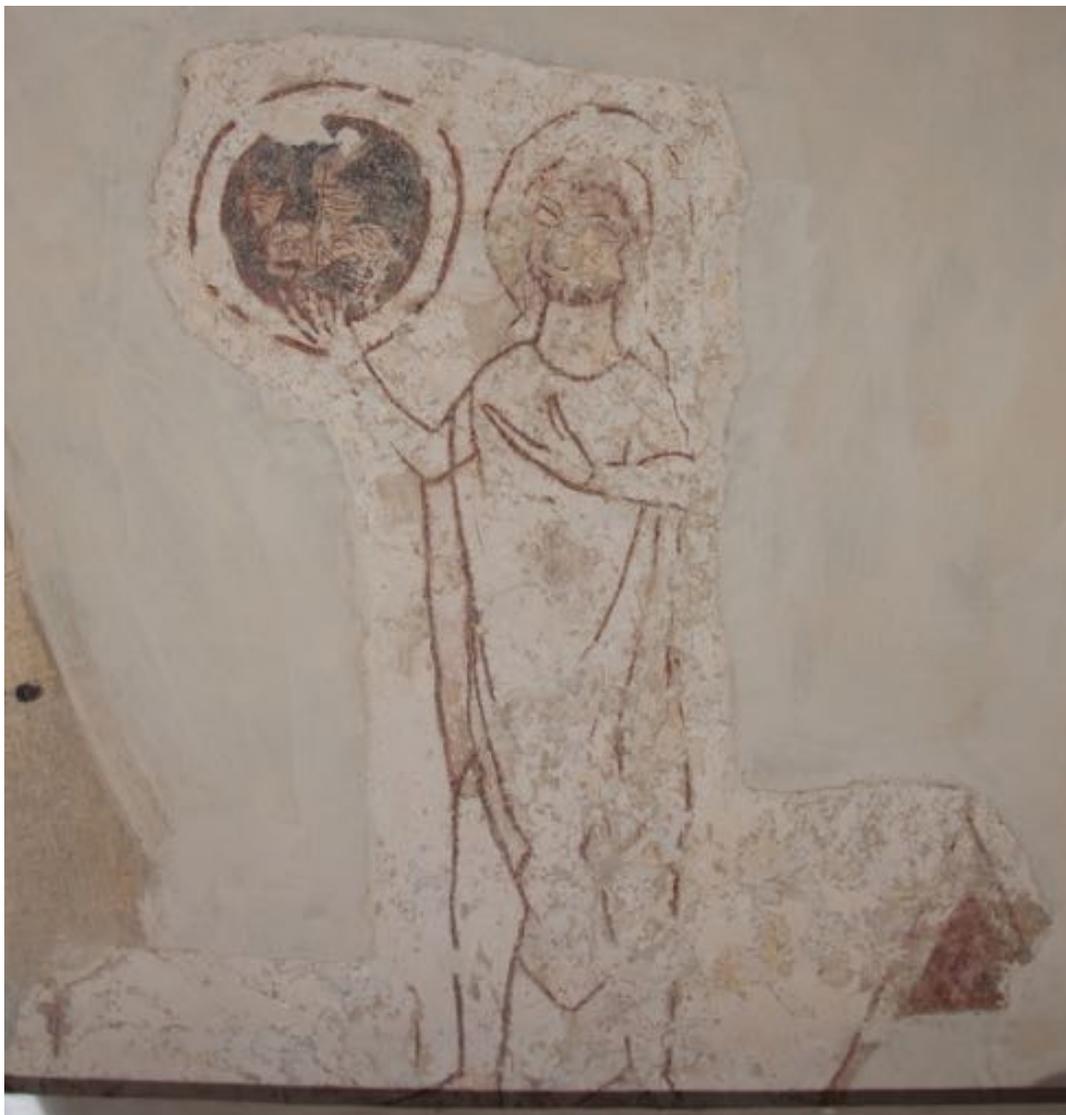
The painted scheme on the right hand side of the window represents St John (photo 37) complete with disk containing the ram emblem and crucifix. It seemed that the majority of the surviving painting was favourably uncovered along with the profile of the figure, leaving subsequent lime-wash layers over the plain areas. St John is stood within the river Jordan with his right hand raised with the disk and the left hand pointing to it. He is robed in the usual fashion.

The plaster and substrate in this area of the South wall was in better condition overall with limited de-laminated areas: the bottom right portion adjacent to the feet of St John and the water. The rest of the substrate was well adhered and in good condition. There are no historic repairs within this area.

It was particularly relevant on this scheme that the residues of the covering lime-wash were obscuring the decorative paint. This scheme would have benefit significantly from further lime-wash residues removal to develop and uncover more of the scheme, particularly the head, disk and water areas, which was carried out in this phase II of the conservation treatments.

Photos 35-37: Detail of St John scene before, during and after the wax and lime wash removal.

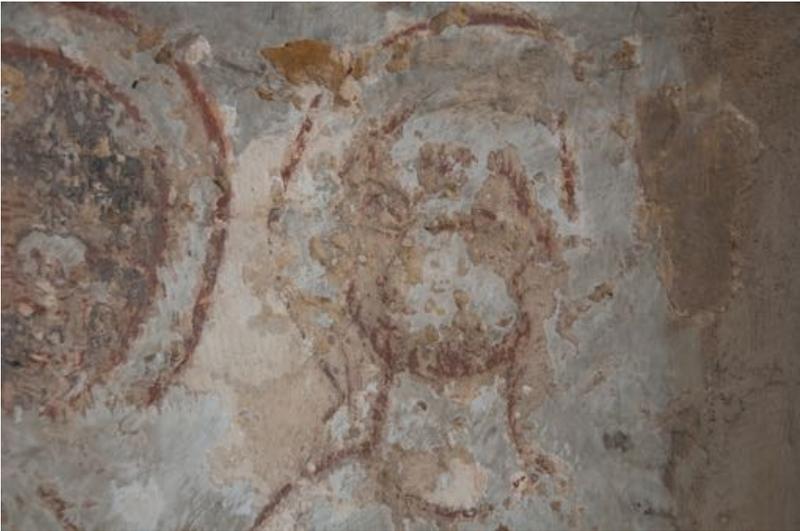
Photos 32-34: St John scene before, during and after the conservation treatments.

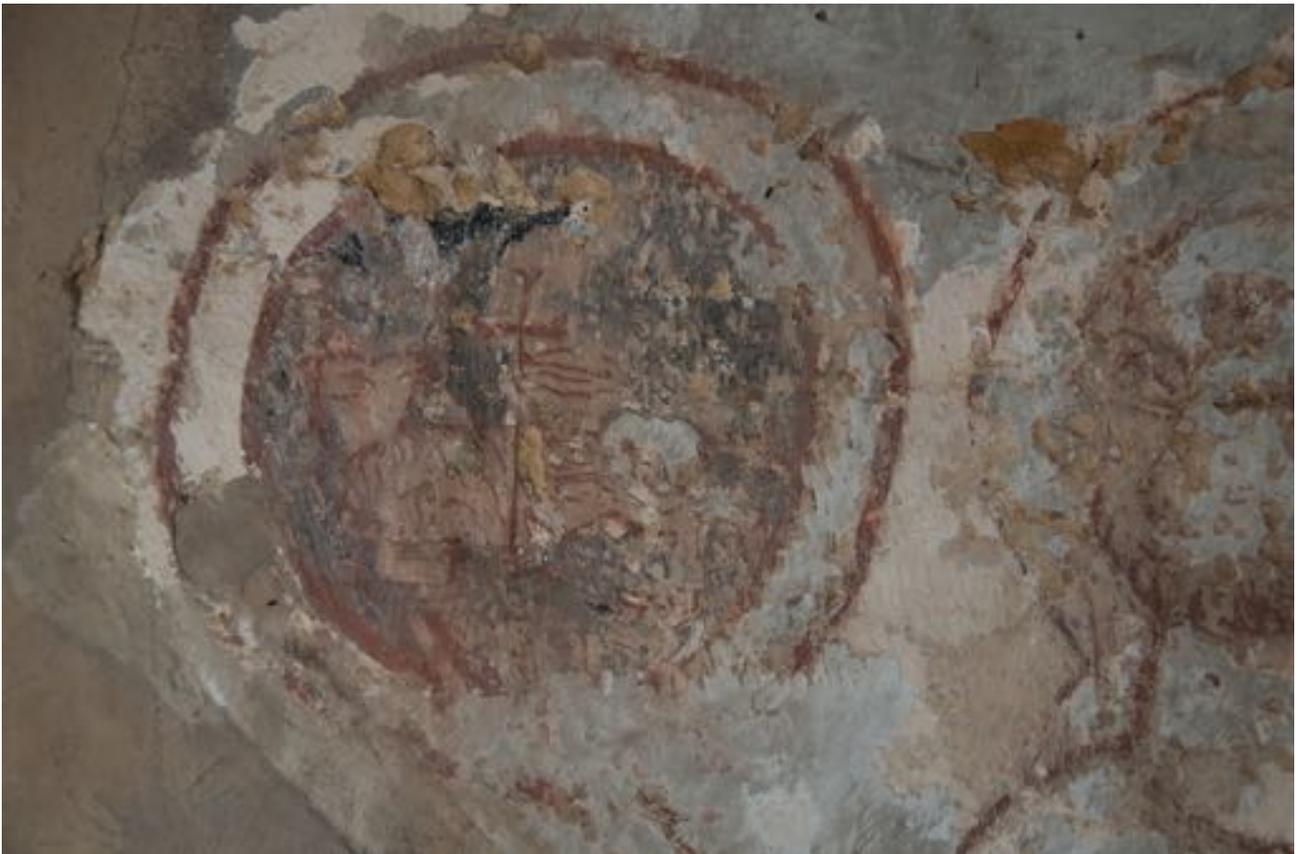
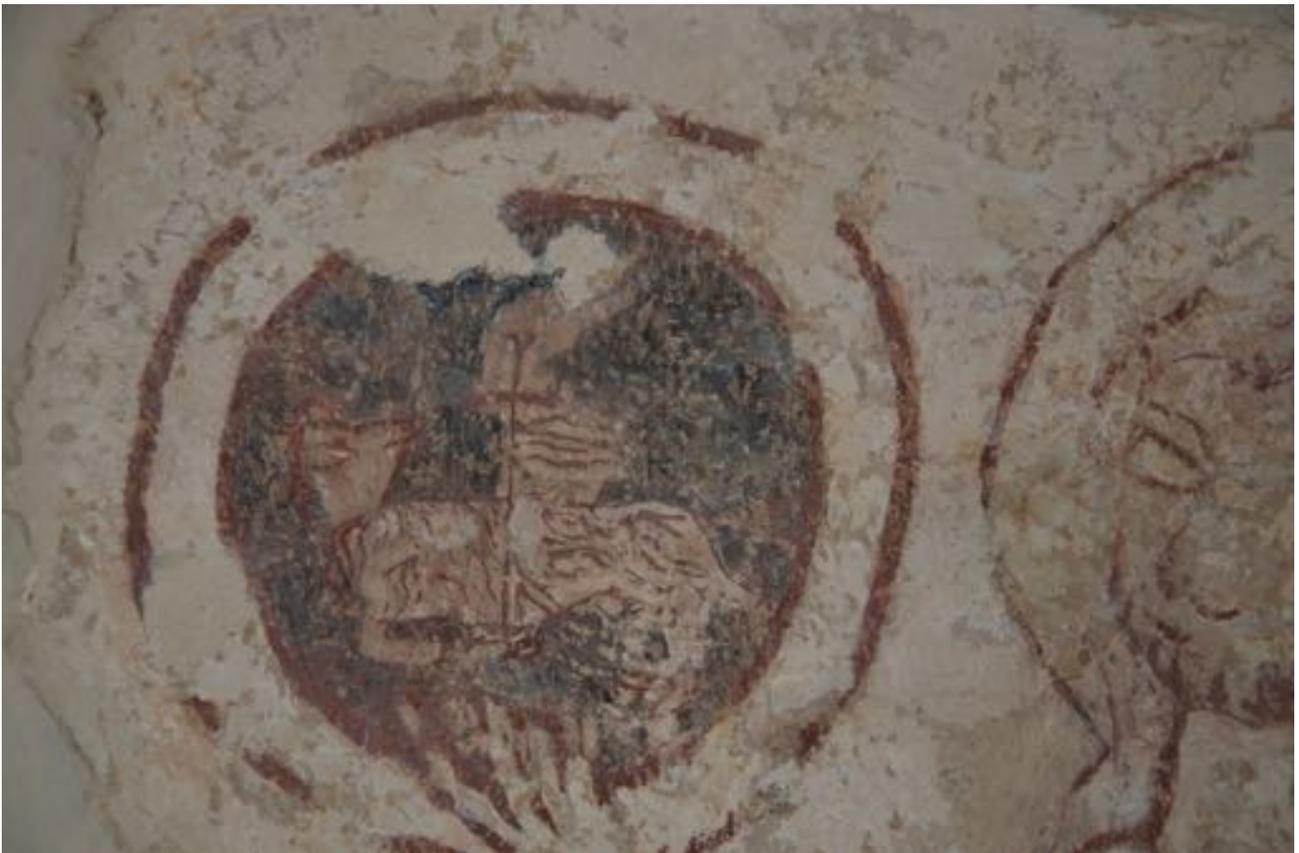
Photos 38-39: Detail of St John scene during and after the conservation treatments.

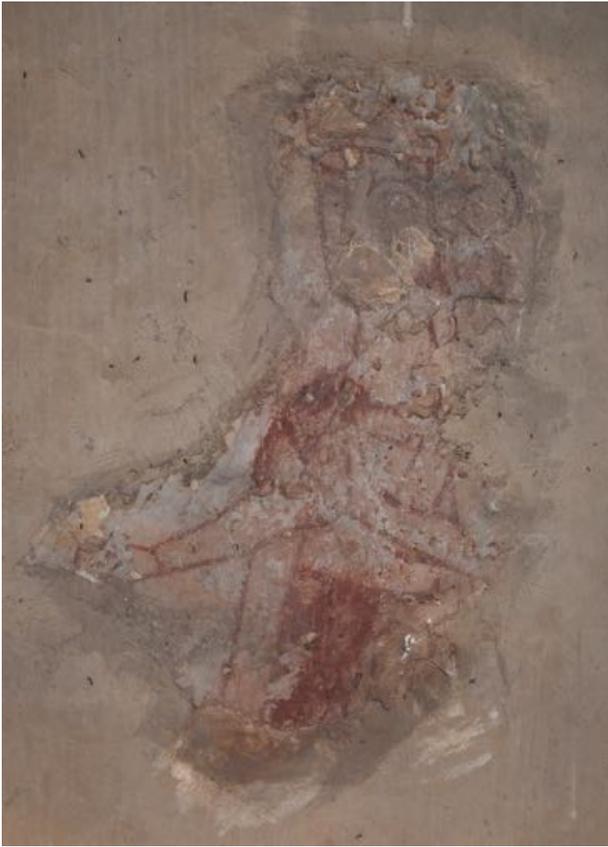
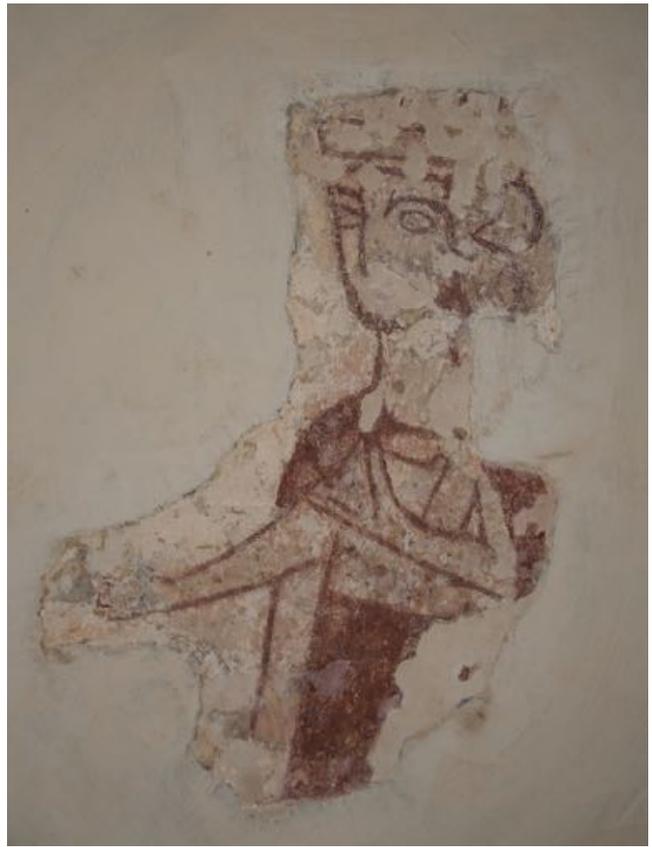
The painted scheme on the south wall was described by Tristram as the representation of *St Margaret* (photo 45) with a crown holding her hand out to the front. Unfortunately, most decorative details were obscured by the level of deterioration. It seems that the majority of the surviving painting has been favourably uncovered along with the profile of the figure, leaving subsequent lime-wash layers over the plain areas.

The plaster is particularly damaged in this area and has many losses and the cohesion was generally very poor. This scheme was in a particularly poor state as the de-lamination of the plaster and the thick wax layer was obscuring the details.

Photos 45-46: Crowned male figure before and after the conservation treatments.

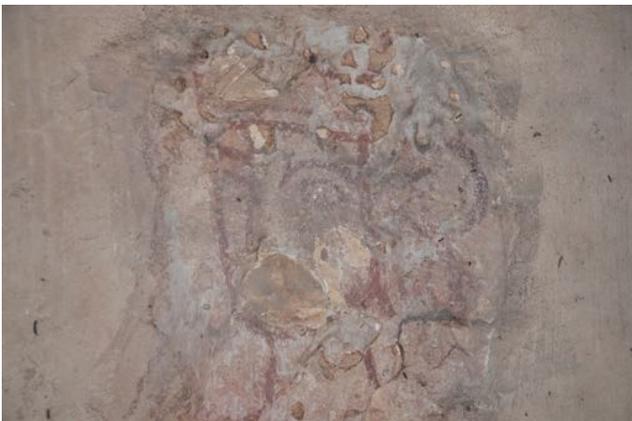
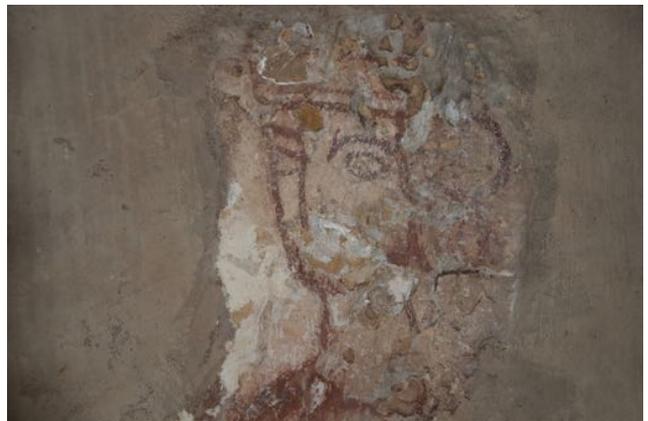
Photos 47-48: Detail of the crowned male figure before and during the conservation treatments.

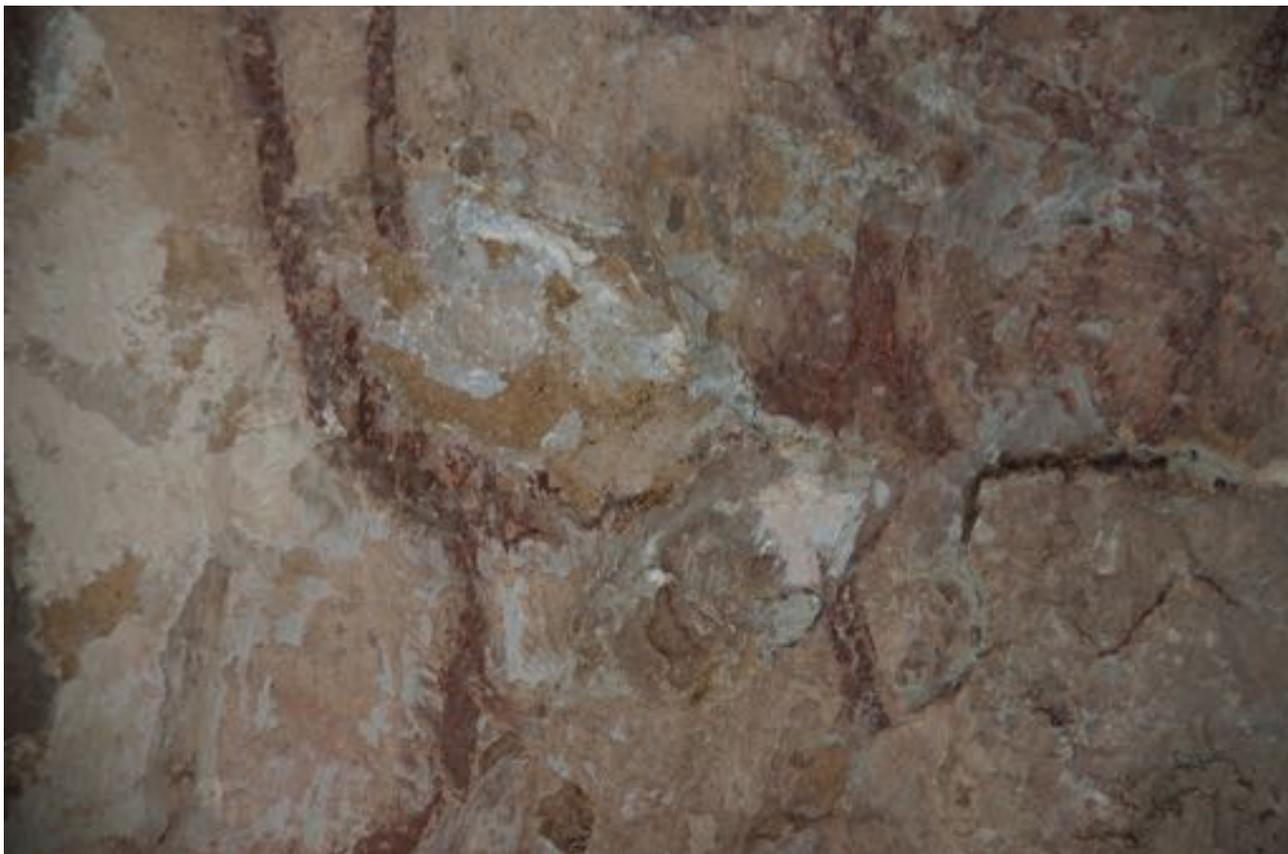
Photo 49: Detail of the beard of the crowned male figure after the wax and lime-wash removal. The new detail reveal that the figure that Tristram believed to be St Margaret, was in fact a male crowned figure.

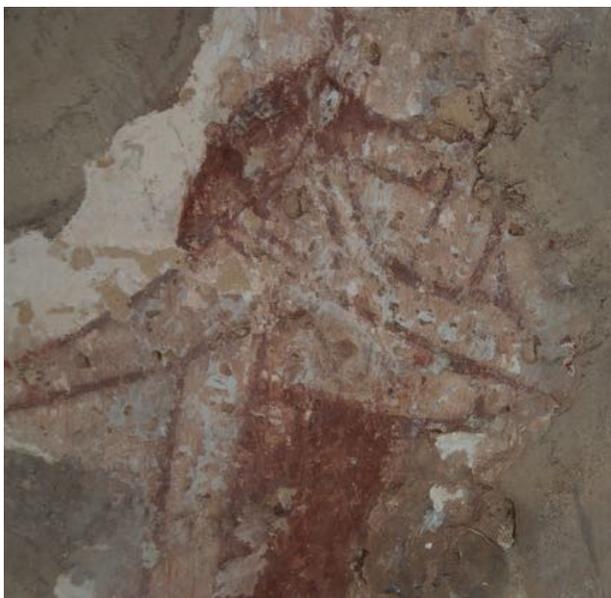
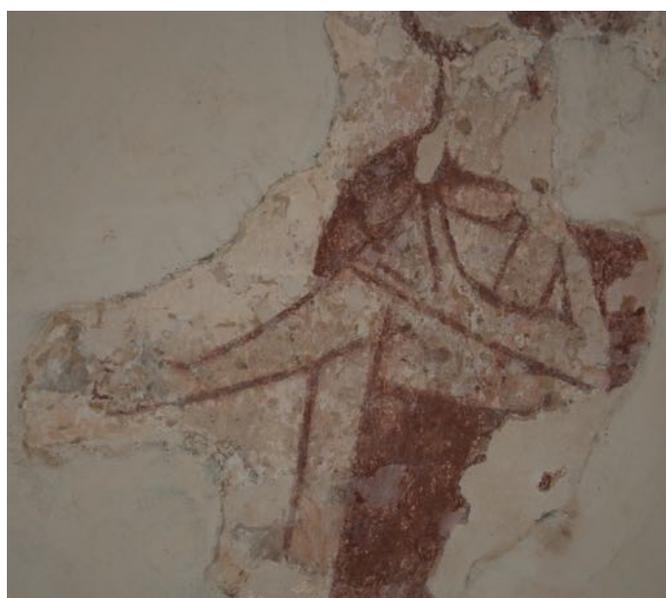
Photos 50-51: Detail of the crowned male figure before and after the conservation treatments.
