05.05.2016

COLD OVERTON • ST JOHN THE BAPTIST

QUINQUENNIAL INSPECTION 2016

Mark Stewart Church Architect

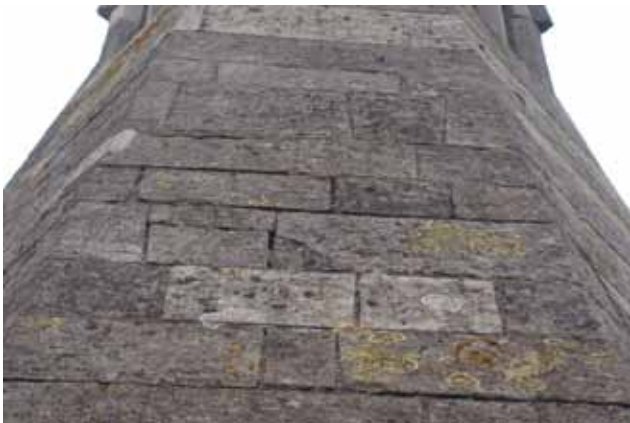
The details to the lucernes have areas of erosion with sections spalled stonework having fallen into the gutter in several locations.

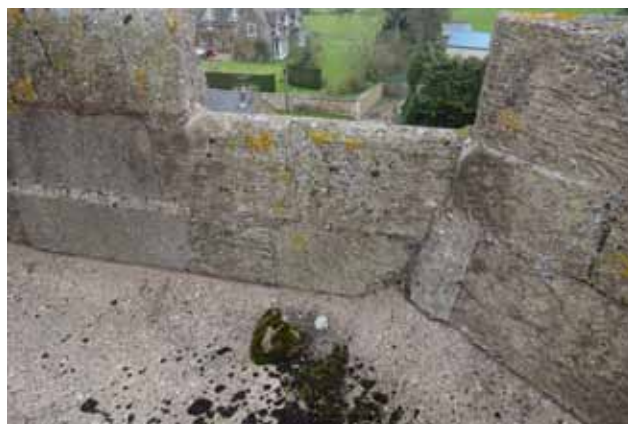
Tower internal face of the parapet wall

Whilst generally the stonework and cementitious pointing are in reasonable condition there are significant vertical cyclical cracks through the depth on the parapet with some significant displacement of the northeast corner.

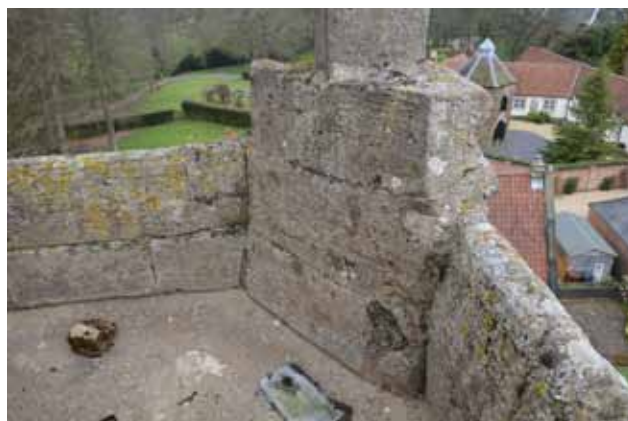
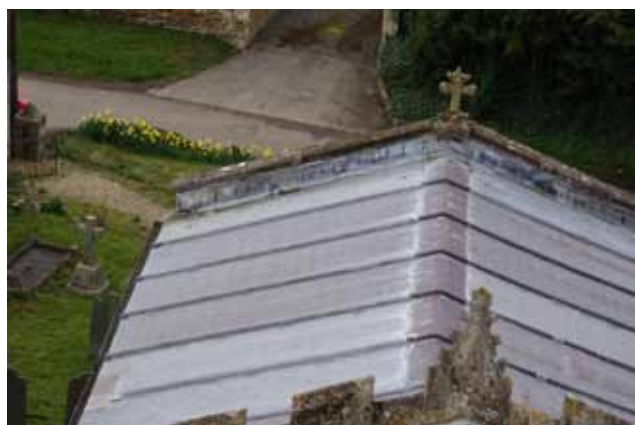
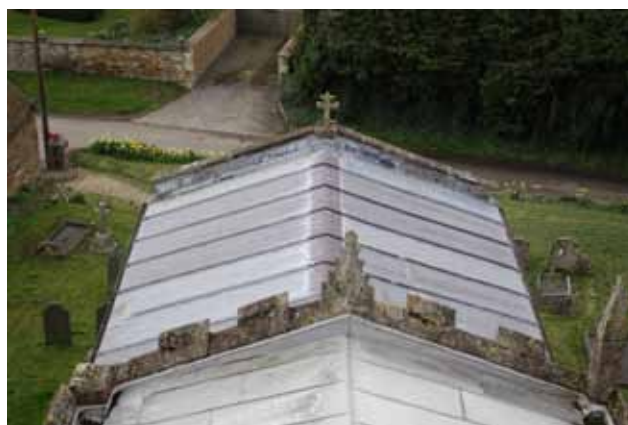
Chancel

Lead in satisfactory condition. Solid roll with small wrap over ridge. Many good repairs. A few older repairs which have joined sheets together and a few old solder repairs.

Lead abutment flashings have become loose.

Fibrous cement gutters in poor condition.

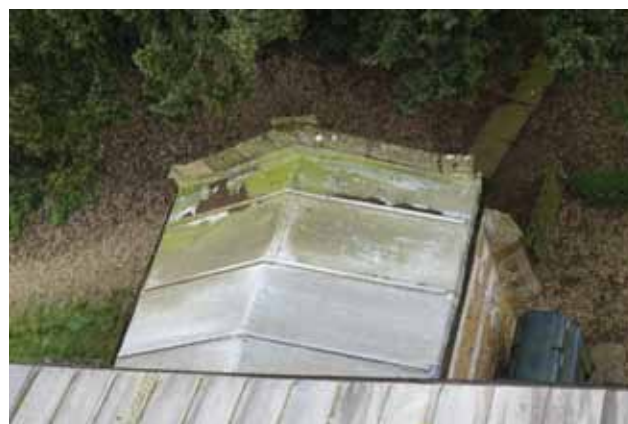
Porch

Lead in satisfactory condition. Solid roll with some repairs. Very small lap at ridge.

Lead abutment flashings.

Cast iron gutters, not falling to the outlets.

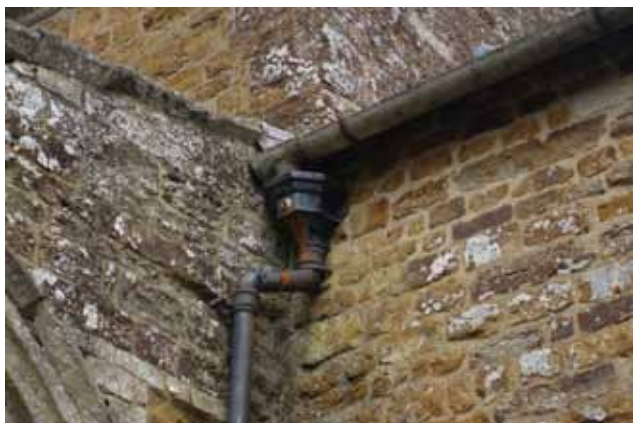
- RWP-3 Lead hopper with corroded cast iron downpipe to open and blocked surface water gulley. This is the cause of significant damage to the external and internal fabric.

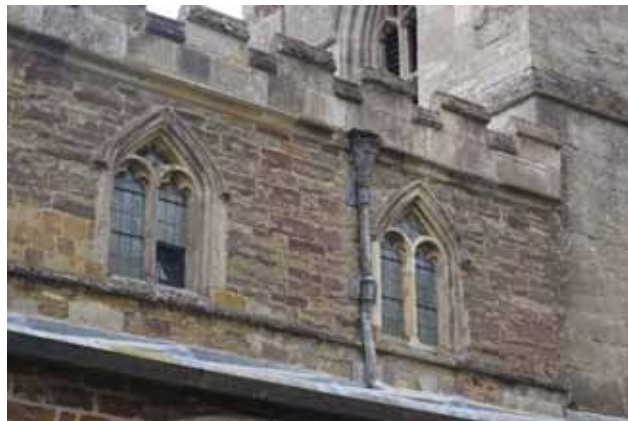
RWP-8 South clerestorey, west end. 1791 lead hopper with lead rwp discharging over aisle roof.

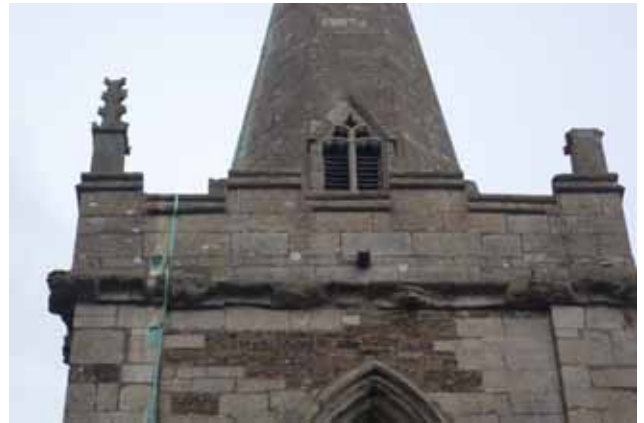
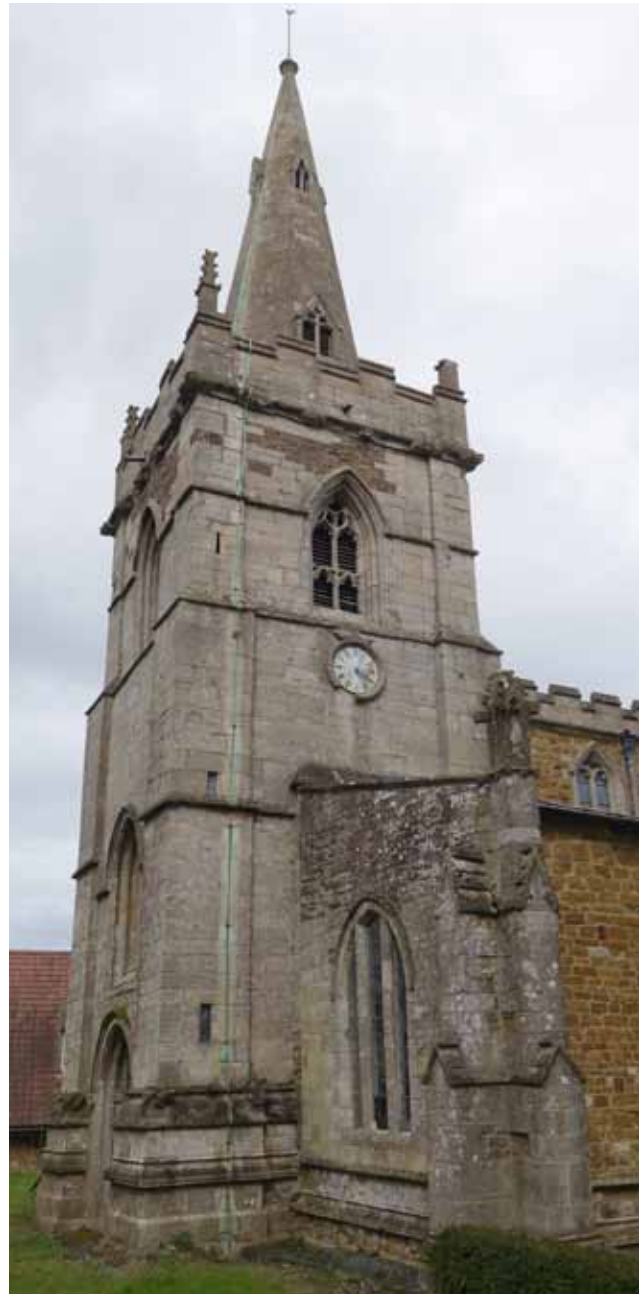
Stringcourse with displacement and open joints to the cill.

Lower bell chamber section. Clock face bottom left quarter of the surround is missing.

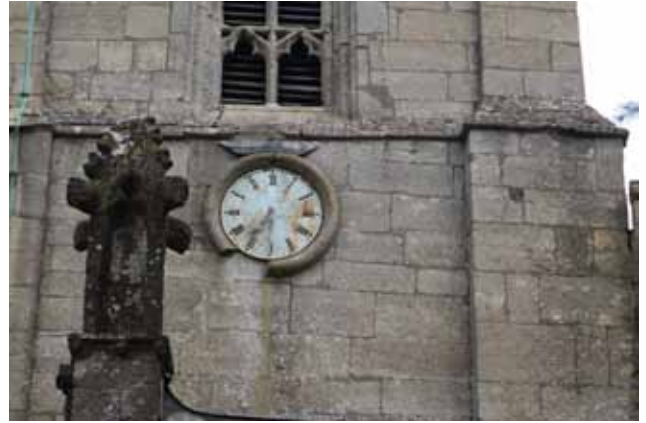
Offset stringcourse with open joints. The line of the stringcourse was amended when the Chapel in the South Aisle was built. There is a significant issue at the junction of the South Aisle parapet gutters abutment to the tower which is causing the internal green mould and this requires urgent attention.

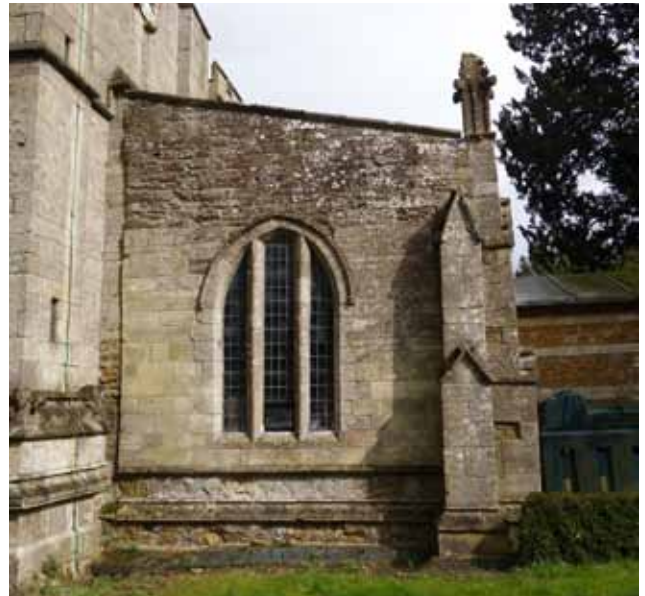
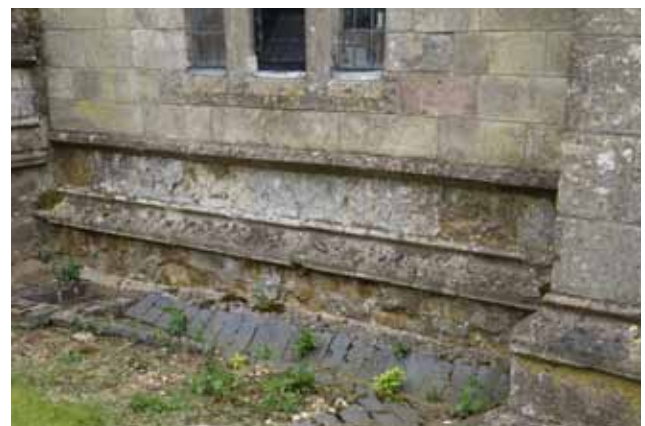
South aisle south elevation west end

Plinth with open joints.

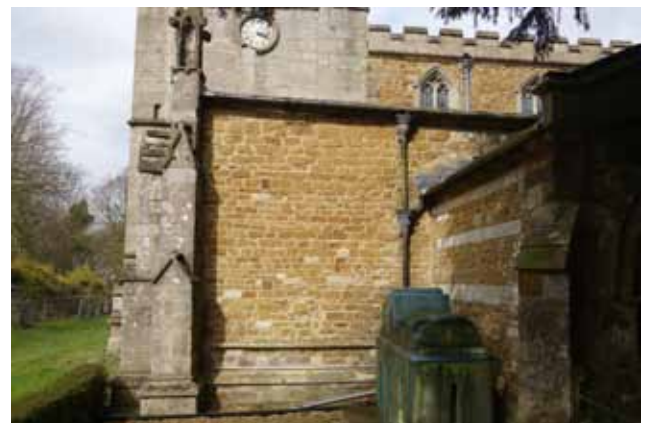
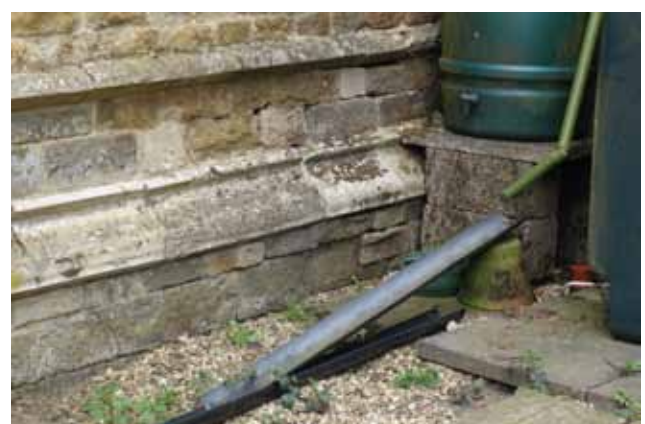
Porch west elevation

Ironstone walling with limestone banding.

Open joints at ground level.

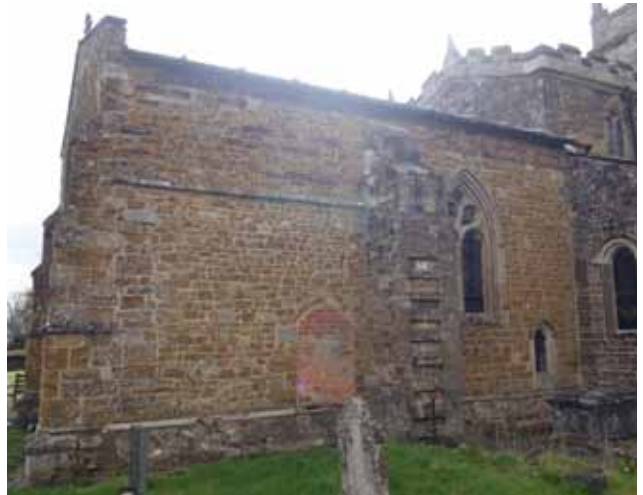
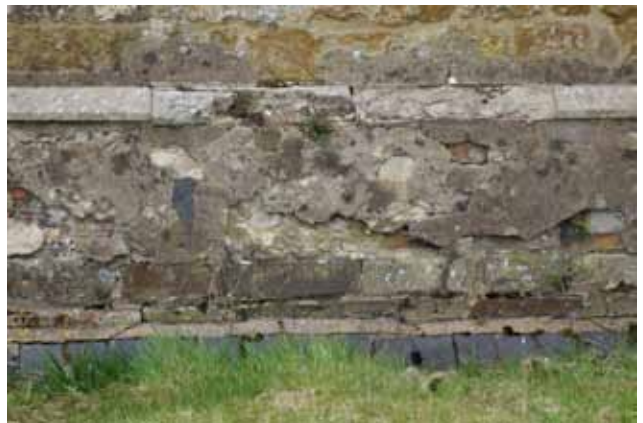
North aisle east elevation

Parapet copings to gable with some displacement of the kneeler.

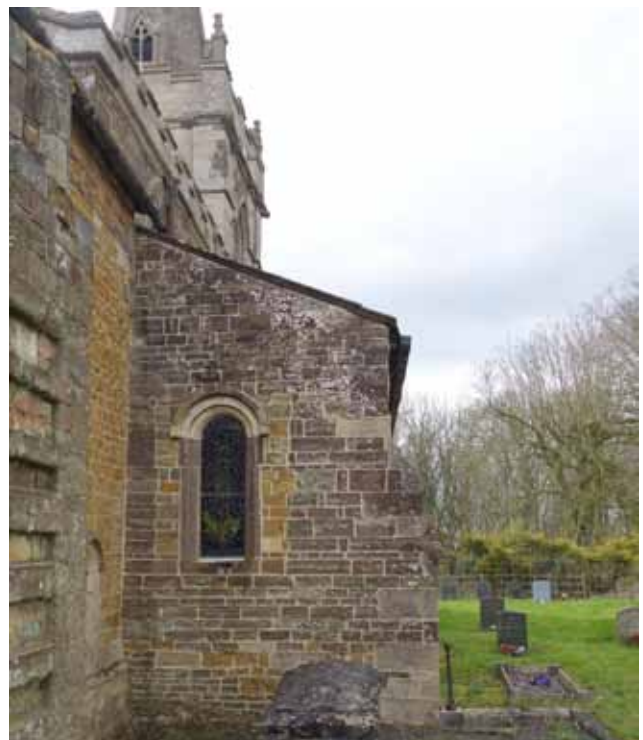
North clerestory

Walling above aisle roof with very eroded joints.

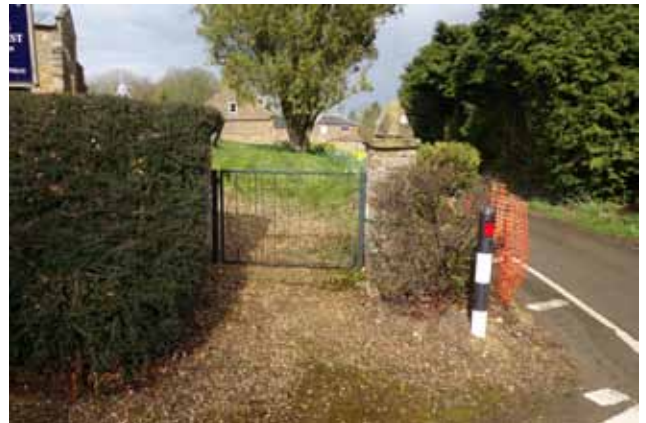
Stone retaining wall with open joints but in satisfactory condition. Vehicle damage by gate.

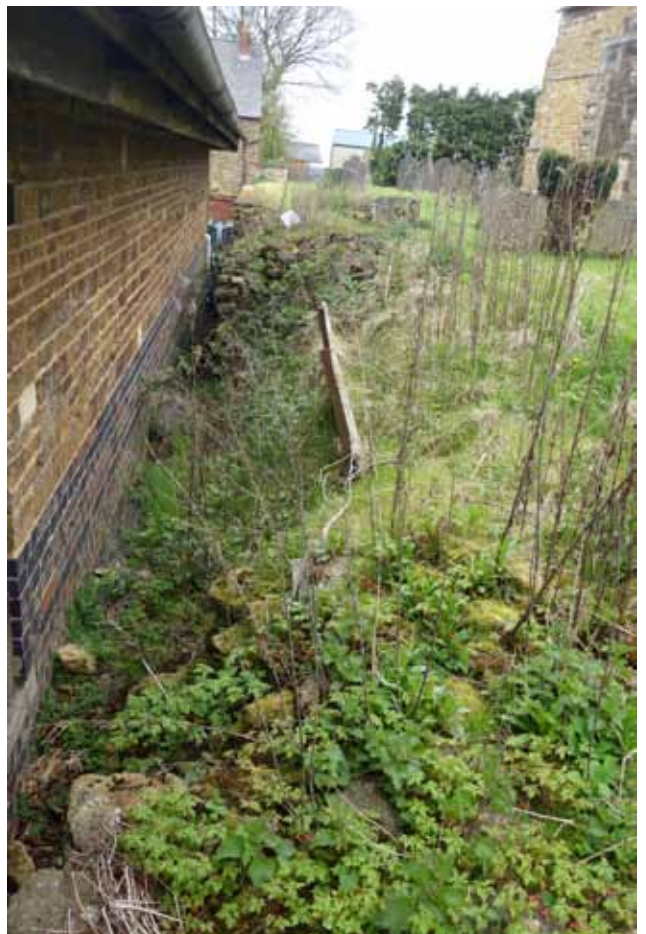
North: Retaining wall partially collapsed at west end.

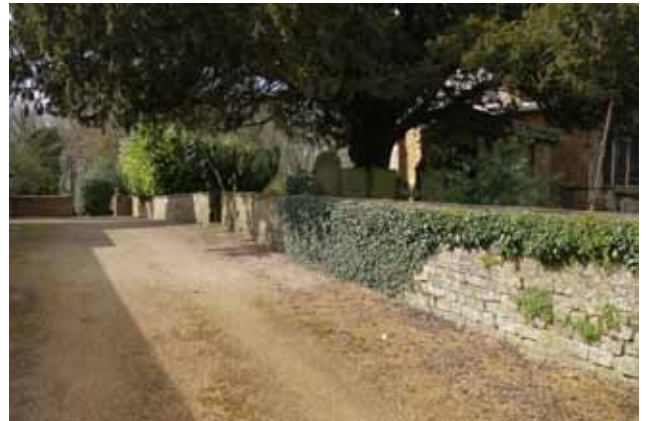
Paths

Paving from south gate becoming displaced and a trip hazard.

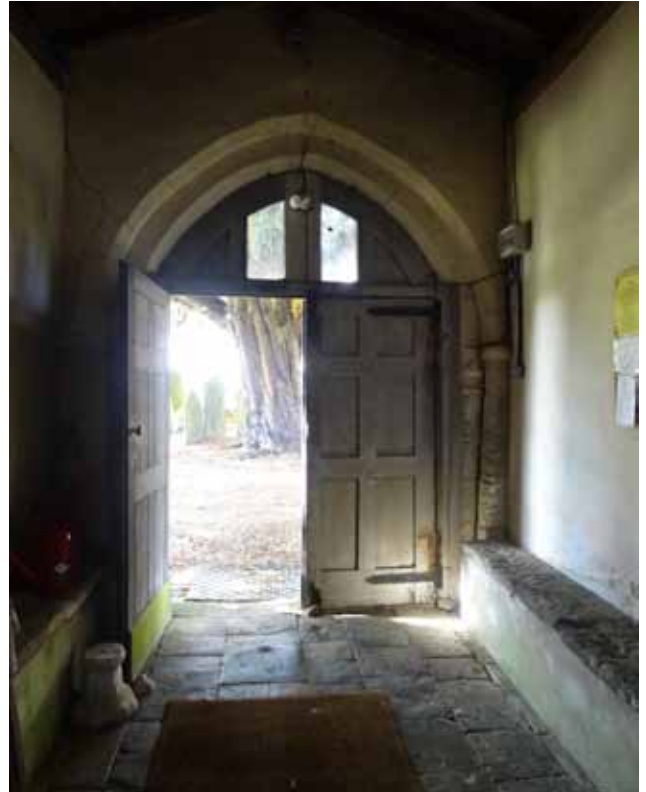
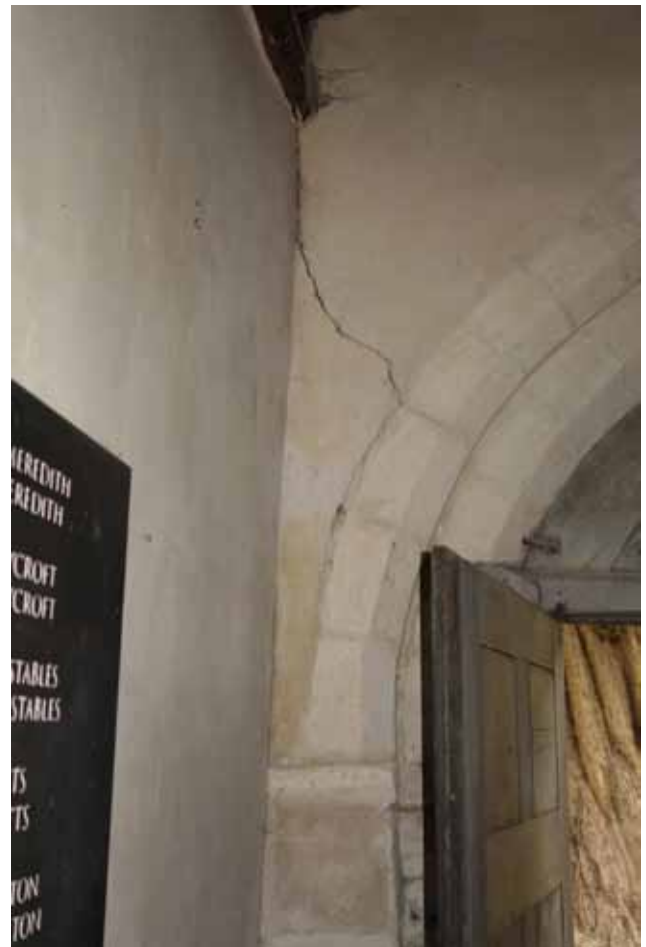
West:
Plaster.
Stone settle.
Plaster under.

North:
Stone corbel to ridge beam.
Plaster.
Green mould and loss of plaster on west side [drainage issue].
Some crumbling plaster on east side.
C12 doorway, limewashed and in a relatively stable condition. Slight displacement to head.
Very good pair of ancient doors.

Demolish Boiler house and chimney and make good original external walls.	RM	£6,000
Make good plaster to Chancel on removal of [asbestos] boarding.	RM	£2,000
Masonry: urgent local masonry repairs.	RM	£5,000
Masonry: Consolidate and limewash C12 south doorway.	RM	£3,000

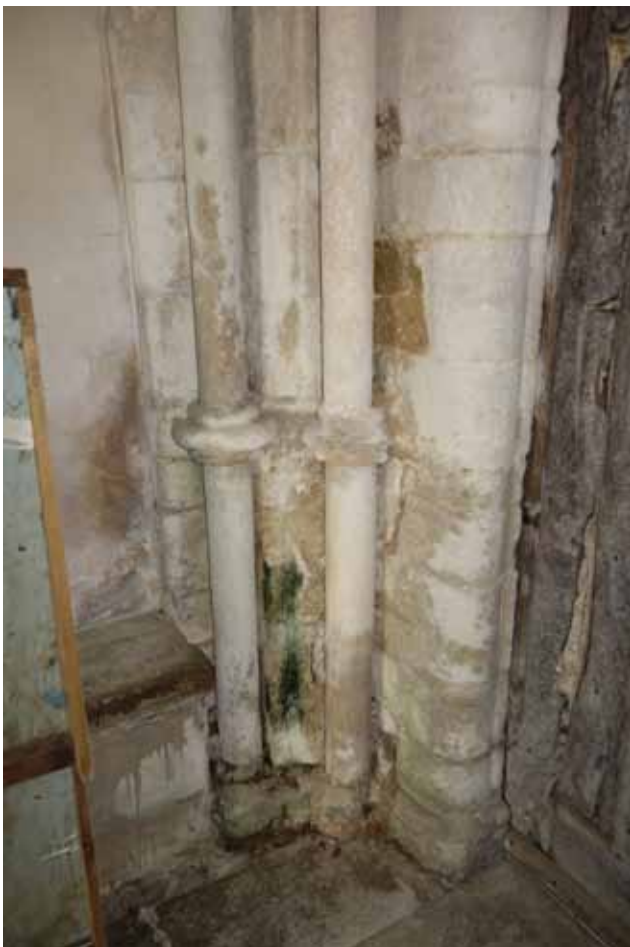
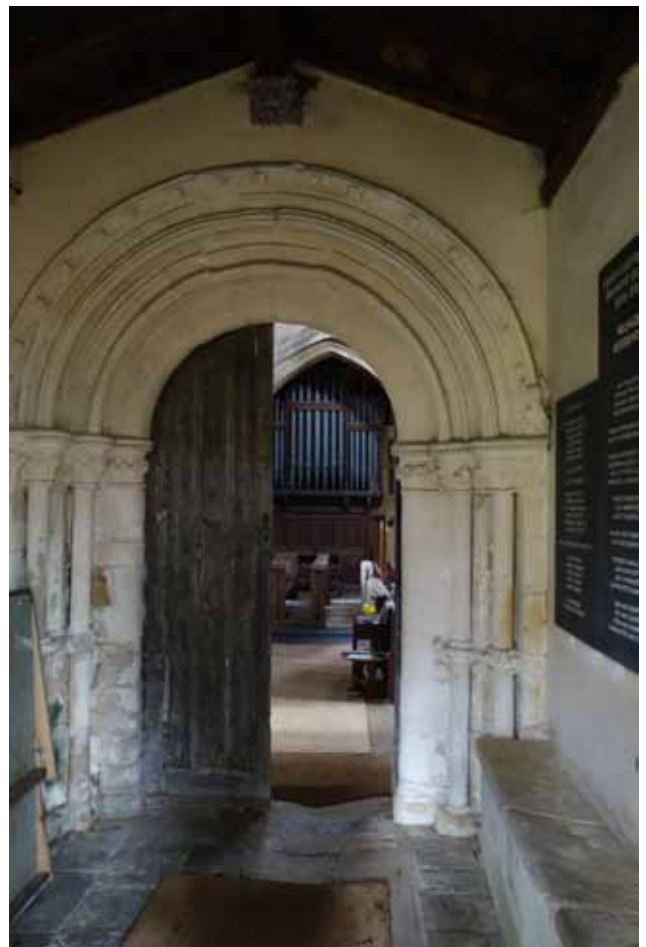
East:
Plaster.
2012 Wall plaque.
Stone settle.
Plaster under with green mould.
Movement crack to the south abutment.

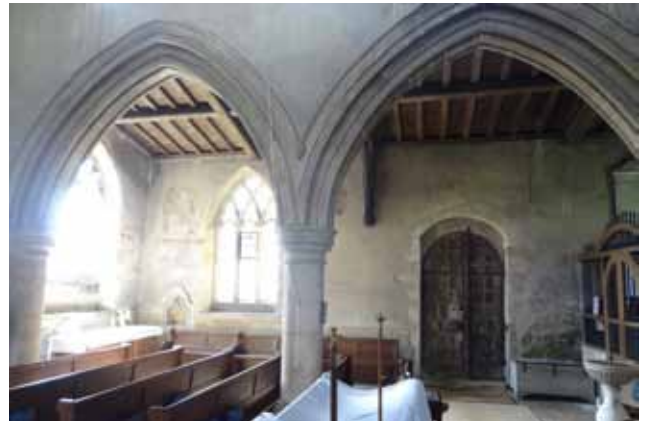
South:
Plaster: with wall paintings.
Piscina
Left window with damaged glass. Movement
cracks to right side and to cill.
Timber roof post.
South doorway with movement crack to
head and to the left of the head up to the
wall plate.
Vertical movement crack to the right of the
doorway.

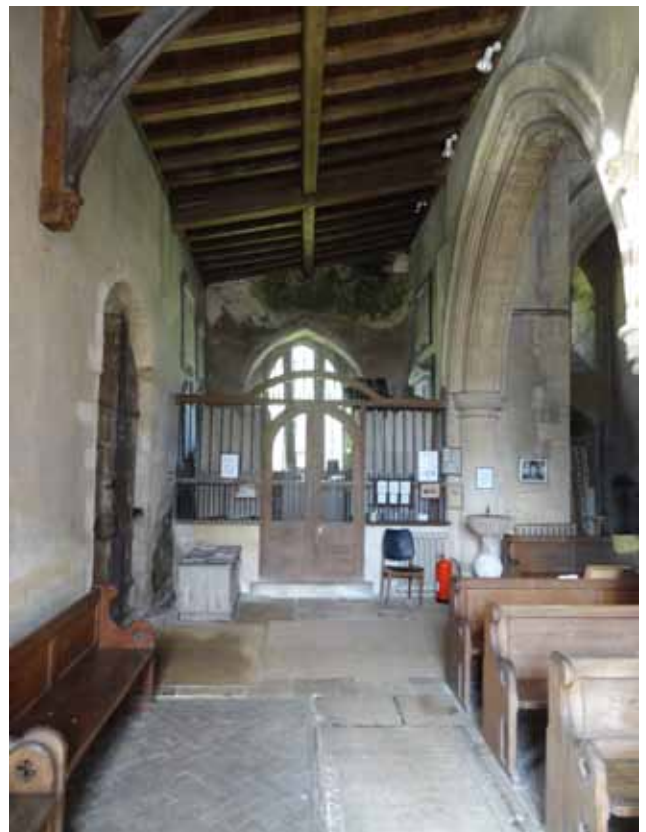
Plaster: Green mould in left corner and at low level [drainage issue].

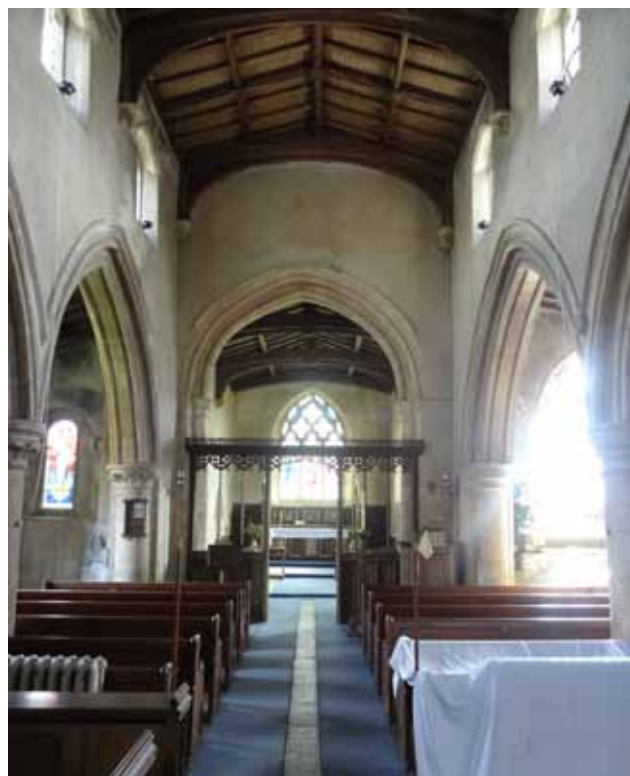
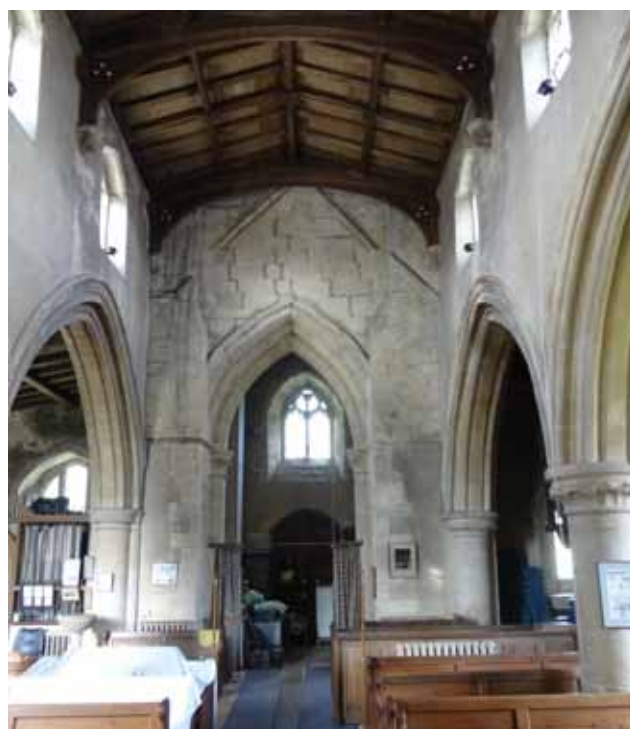
South:
Plaster above stone arcade.
Four roof corbels.
Three clerestorey windows with slight movement cracks to the apex of the soffits.
Some green mould to central pier.

West:
Stone with line of previous Nave roof.
Pointed [stable] movement cracks above the Tower arch.
Tower arch.

North:
Plaster above stone arcade.
Four roof corbels.
Three clerestorey windows with slight movement cracks to the apex of the soffits.

East:
Plaster
Movement cracks above the Chancel arch.
Chancel arch with some ancient displacement of the piers.

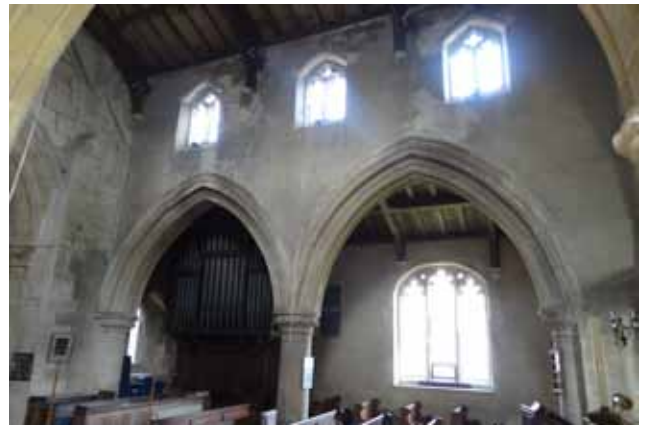
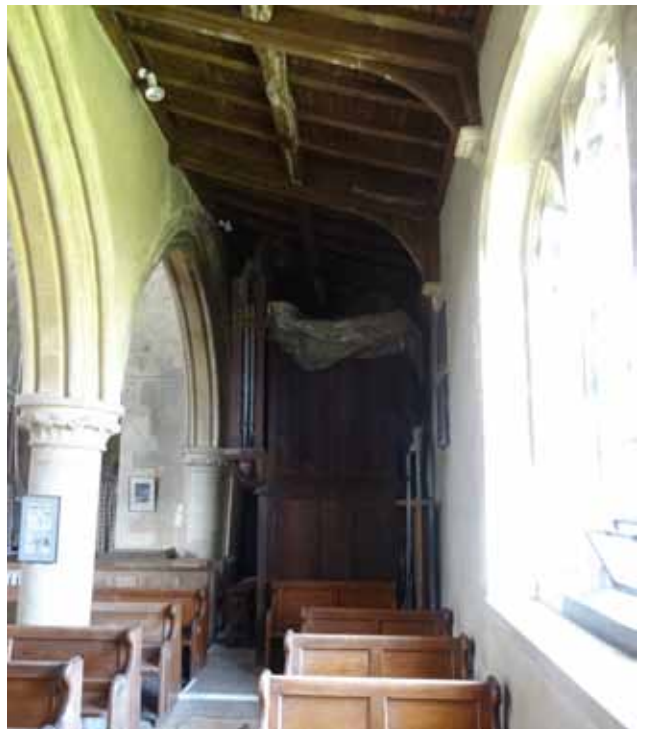
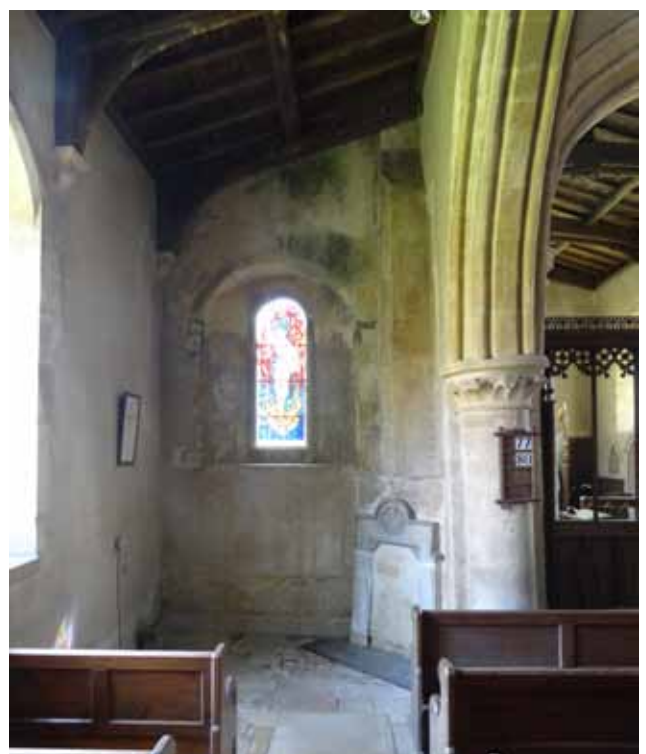
North:
Plaster.
Blocked off door behind the organ.
Two SAUNDERS wall monuments.
Window with slight movement crack to the
apex of the soffit.

East:
Plaster.
Movement crack to north abutment.
Window.
Blocked fireplace.

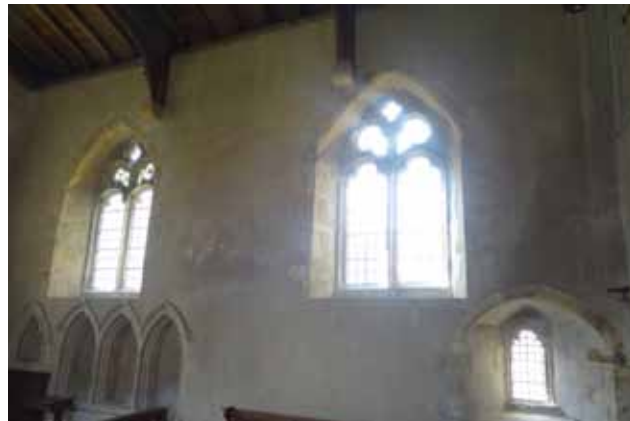
South:
Plaster.
Panels fitted to base of wall [suspected asbestos].
Dado panelling at east end.
Stone roof corbels.
Left window.
Picina.
Three bat Sedalia.
Slight movement cracks between the windows.
Central window.
Right window.

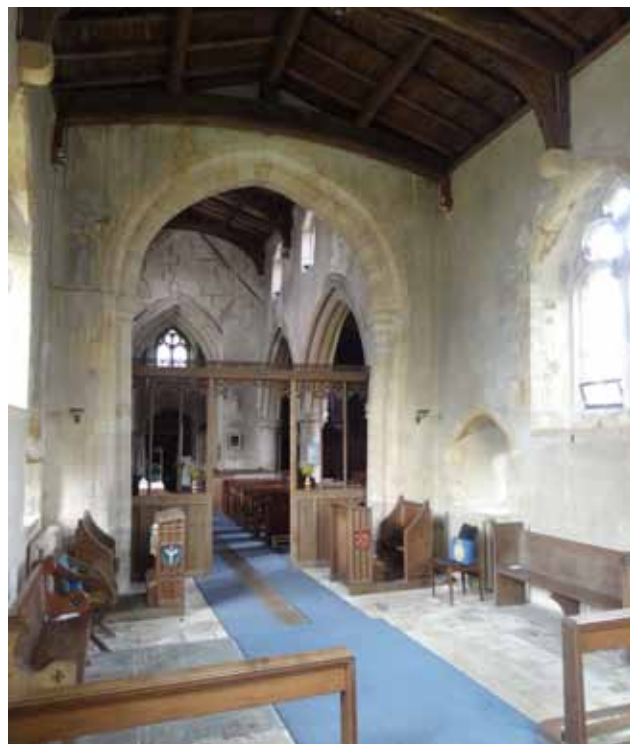
West:
Plaster.
Some spalling pair to south side [drainage issue].
Chancel arch.
Movement crack around the Chancel arch right jamb.

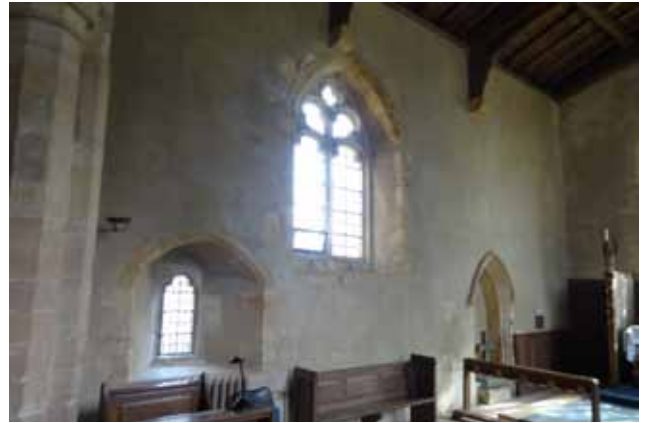
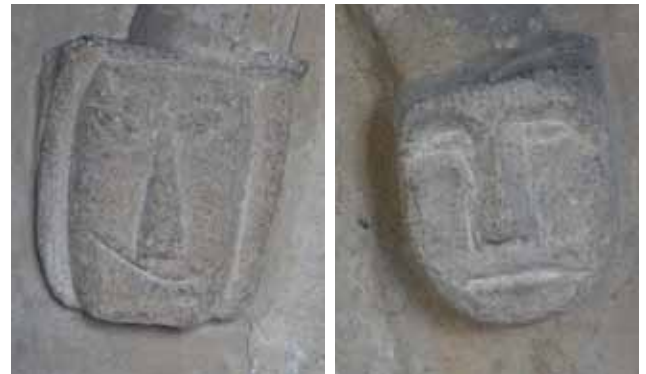
North:
 Plaster.
 Panels fitted to base of wall [suspected asbestos].
 Dado panelling at east end.
 Stone roof corbels.
 left window.
 Central window.
 Blocked doorway with good stop heads.
 Sacrament cupboard

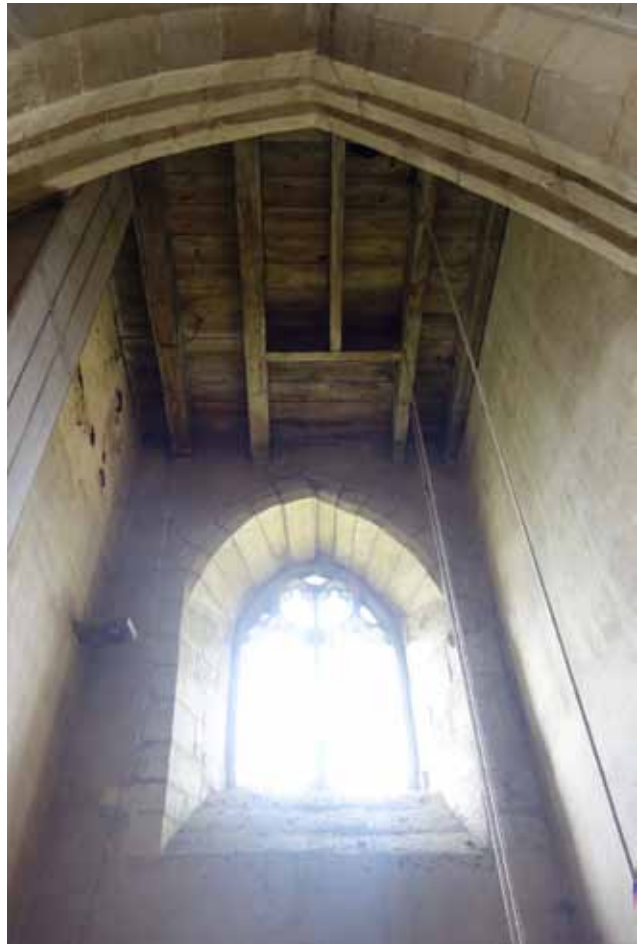
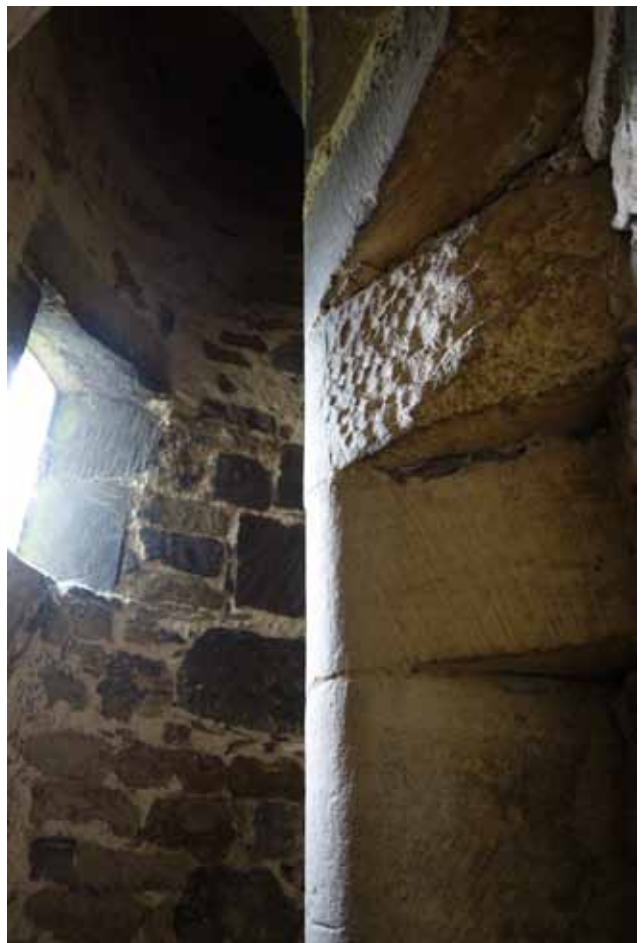
Tower base

South:
Plaster in very poor condition at high level
[issue of parapet abutment detail].
Door to stairway.
Clock weights boxing.

West:
Plaster:
High west window with movement crack to
the soffit and head.
West doorway with movement crack to the
soffit and wall above up to the window cill.
Doorway opening is boarded up.

North:
Plaster in poor condition at low level [issues
with the abutment of boiler house roof].

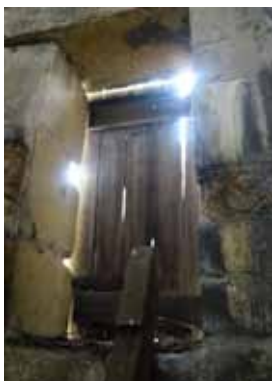
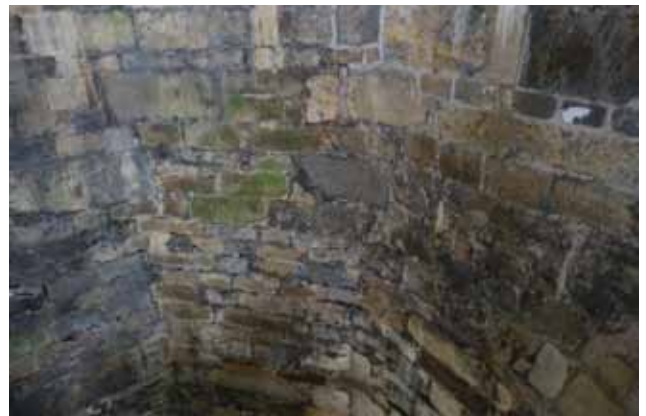
Whilst the stonework is in satisfactory condition there are significant water runs down from open joints.

Significant efflorescence at the base of the spire [under the line of the tower gutter] .

Access door to tower roof in poor condition.
